Tracing a Sacred Building Tradition

Wooden Churches, Carpenters and Founders in Maramureş until the turn of the 18th Century

by
Alexandru Baboş

**Department of Architectural History, School of Architecture
Lund Institute of Technology, Lund University, Sweden**

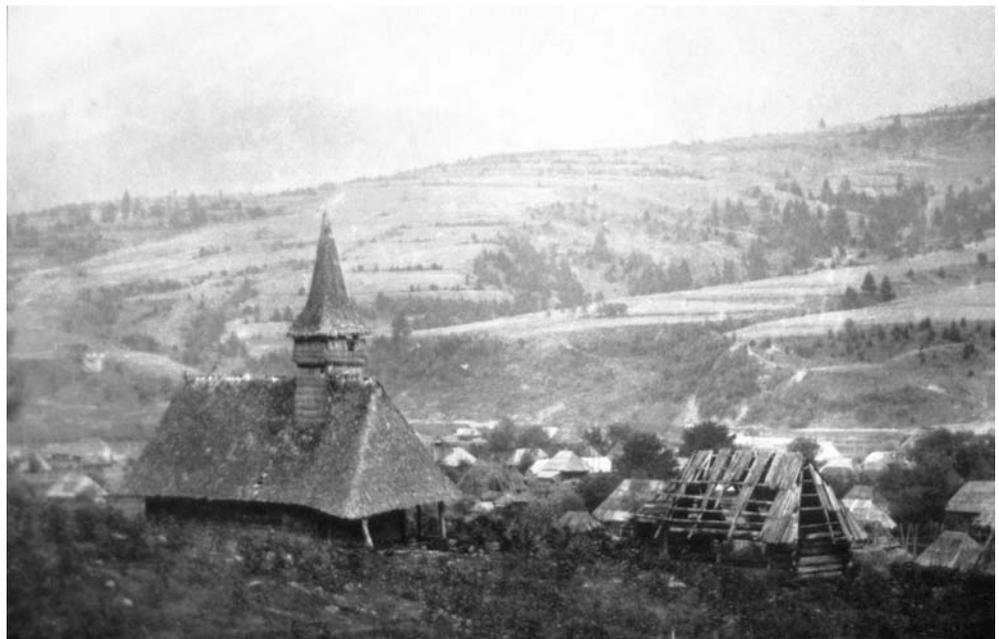
5 *Moisei Susani*. This was one of the first pictures illustrating a wooden church from Maramureș, seemingly taken around 1880 and processed in a studio from Budapest (Várady 1901, 291). The wooden church vanished soon thereafter.

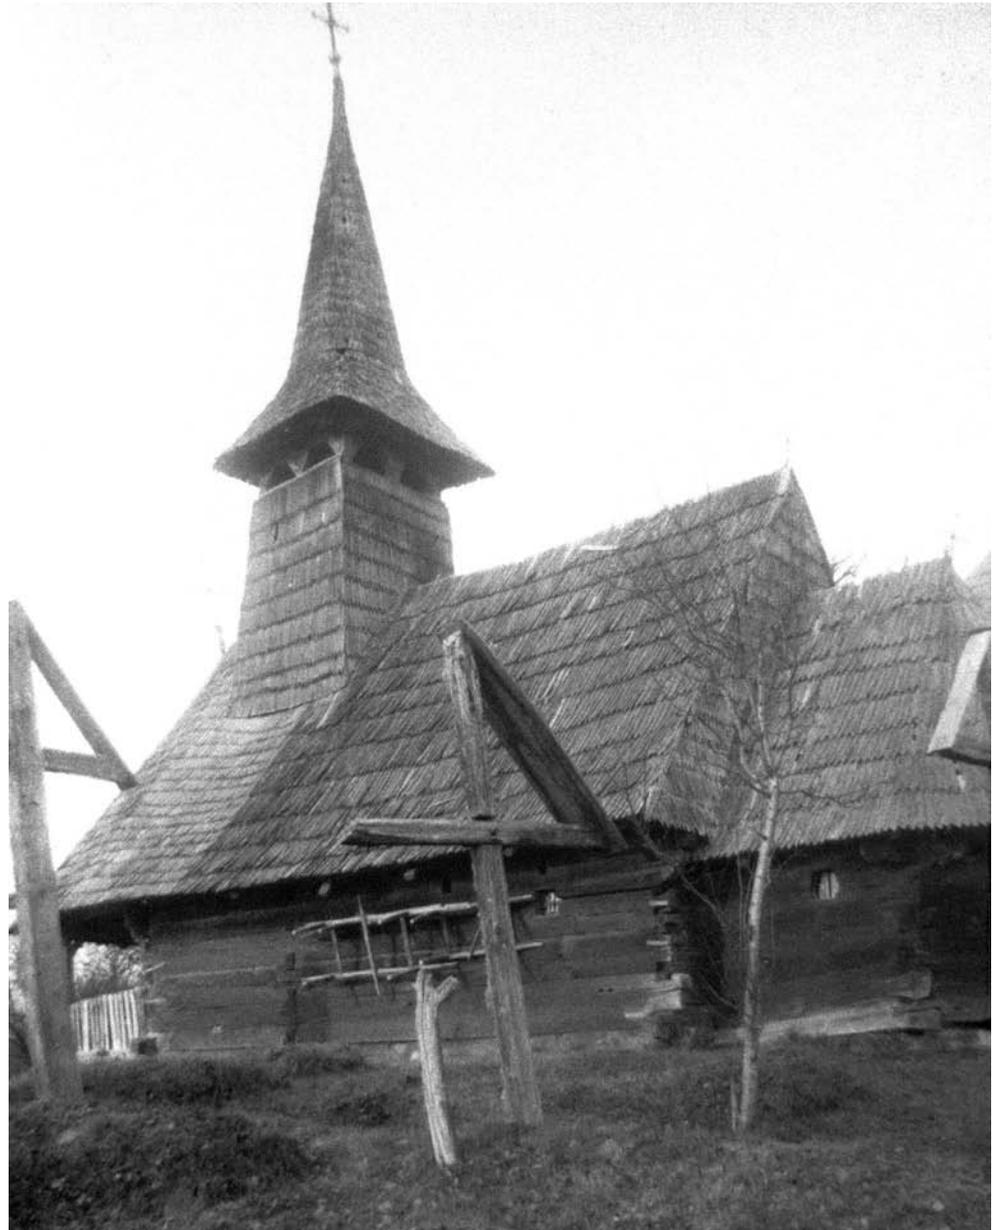
7 *Nănești*. A valuable close view of the church from 1928, before its demolition in 1936 (MET, Arhiva Romulus Vuia, H 350). The church was partly from the first half of the 16th century partly from the middle of the 17th century.

Transylvanian Section of the Commission for Historical Monuments, in the first years after the war. The commission elaborated a standard form and initiated a large inventory in 1921 urging for necessary series of pictures (7-8).²⁵ Atanasie Popa published a few monographic studies from the wooden churches he visited in Maramureș while Coriolan Petranu persistently debated about their importance along with the Transylvanian ones in the history of architecture.²⁶ In 1941, just before Romania entered the new war, the art historian Victor Brătulescu published the first comprehensive study dedicated to the wooden churches standing in the Romanian parishes from Maramureș, completed by 33 scale drawings prepared by the architect N. Chioreanu in 1937 (9). From an art history perspective, Victor Brătulescu indicated their Byzantine character inside and the Gothic appearance

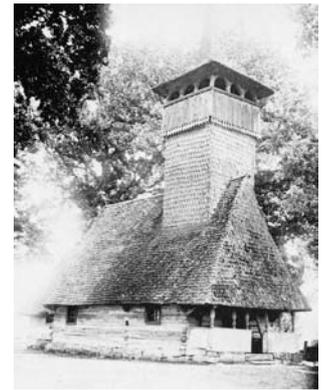
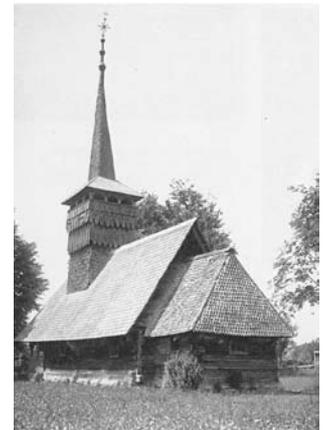
10-11 Ruske Pole (Domnești). Both wooden churches were demolished by local party officials and burned in 1965. Photos by Florian Zapletal from 1921 (upper parish, above) and 1925 (lower parish, below); Zapletal 1981, ill. 45 and 47.

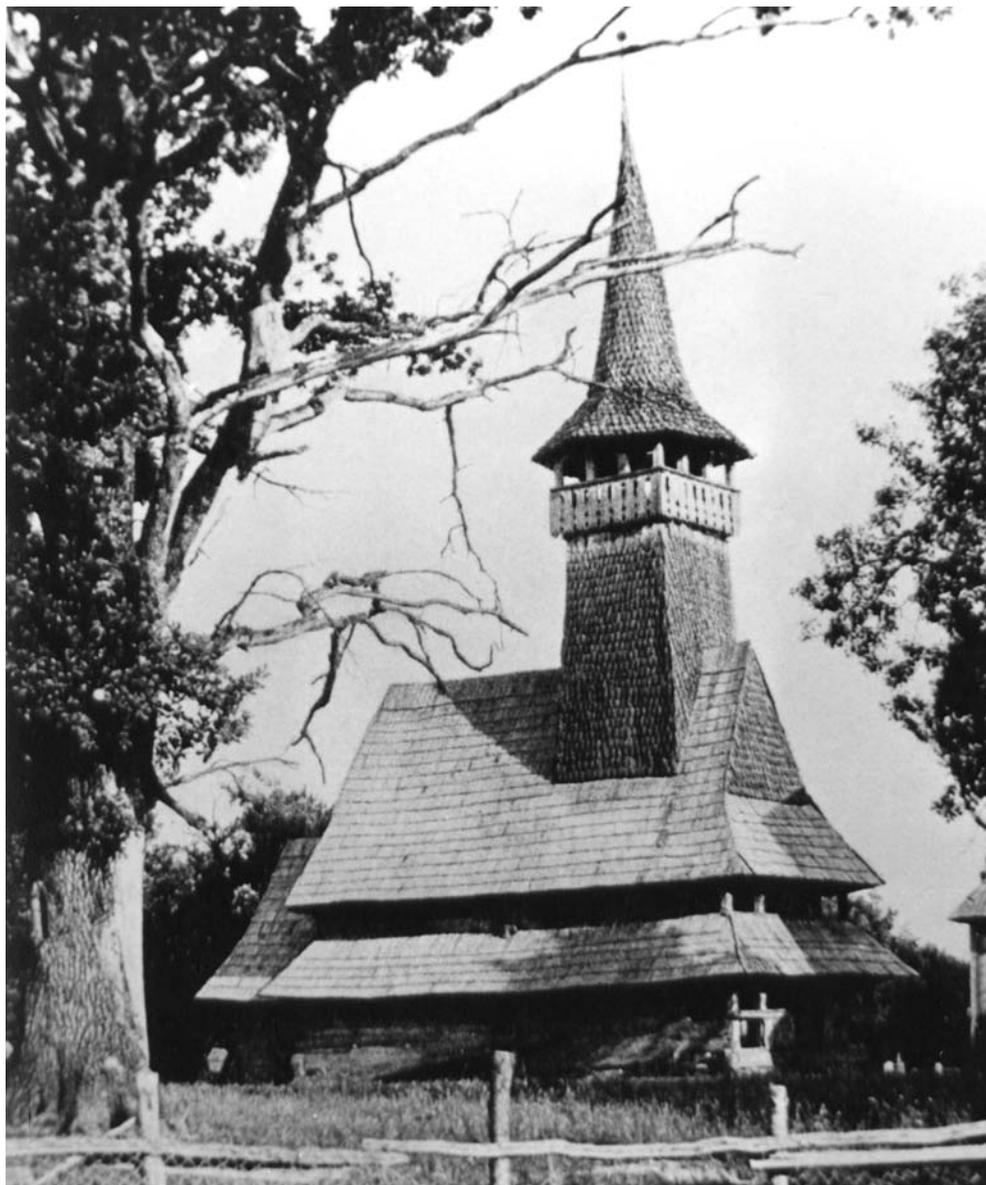
12 *Dulovo*. The wooden church, erected in between 1739-42, was demolished in 1946 and the timber reused for another church, in Chervone, Ung county, until 1992 (Syrokhman 2000, 506-508). Photo from 1924 by Bohumil Vavroušek (1929, 178).

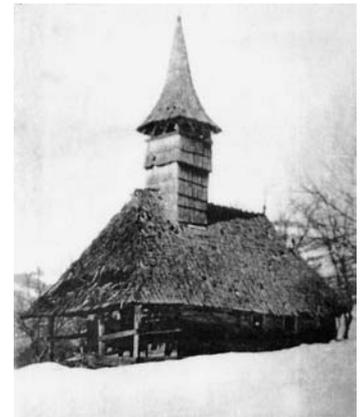
13 Repedea (Kryva). The wooden church, dated from 1769, was by all probabilities demolished before the law from 1955. Photo from 1948 (Slobodian 1995, 63) saved in the Parish Archive and kindly made available by priest Rahovan Petru.

On the Romanian side of Maramureș, after World War II, the parish churches were reverted from the Uniate Church, prohibited in 1948, to the Orthodox Church. Thus the old wooden churches remained open for worship and in the care of the parishioners. In 1955, all the wooden churches from the Romanian Maramureș enjoyed protection as historical monuments and in this quality they were continually repaired. The importance of this decision can be better understood after the rapid disappearance of the wooden churches from Văleni (1947), Crăciunești, Ruscova (1954) and Repedea (13), seemingly all demolished before 1955.³⁵

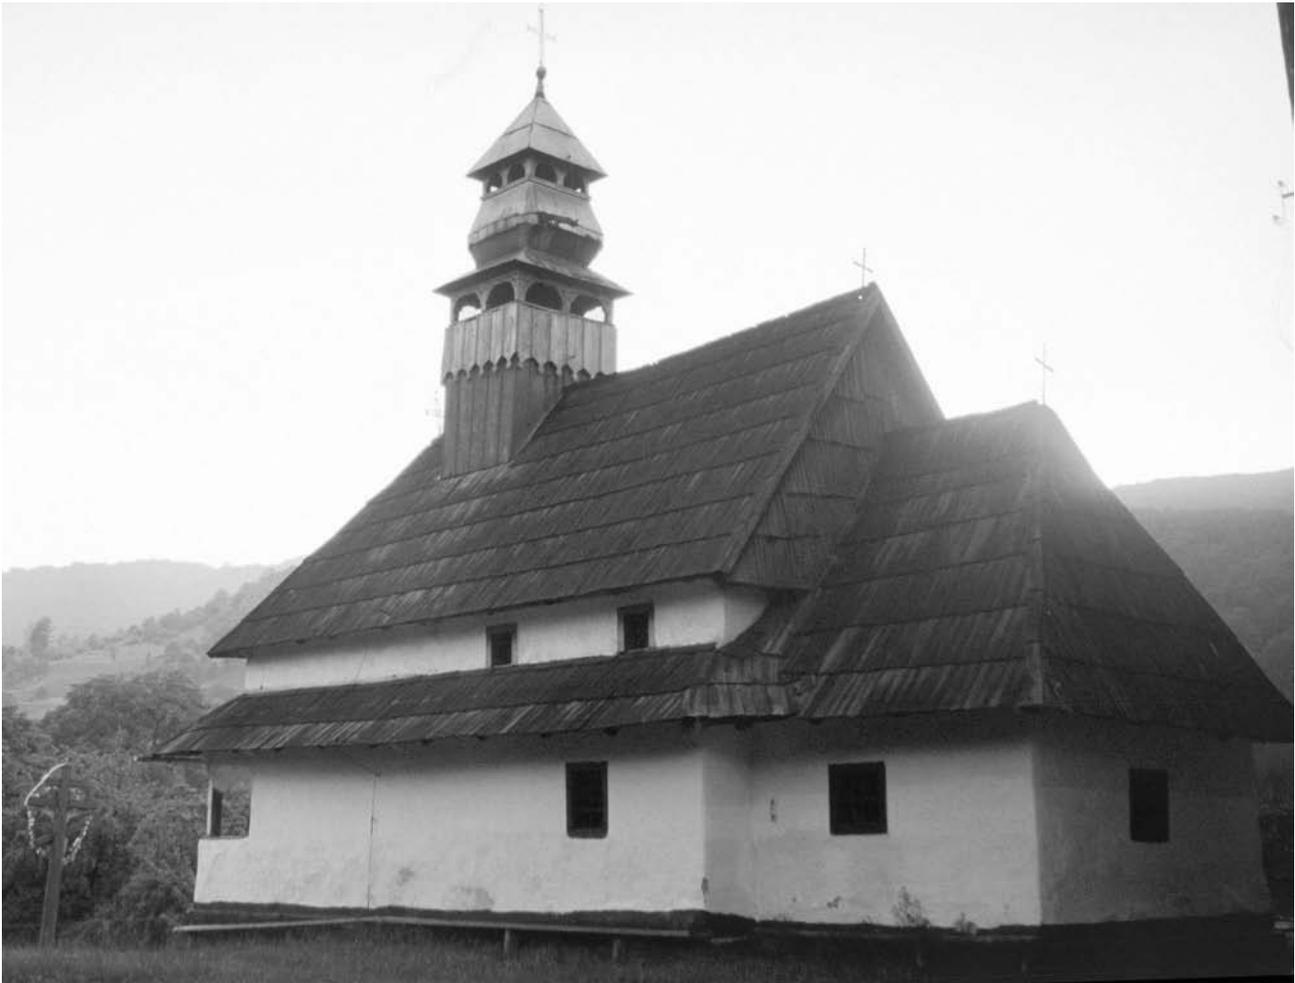
15 *Kobyletska Poliana*. This wooden church, datable from 1741, was demolished and set on fire in 1994, after the consecration of a new brick church, just 5 m from the rear of the old sanctuary. The reason of its demolition appears to be a local confessional conflict between Orthodox and Uniate congregations. Photo: July 1993.

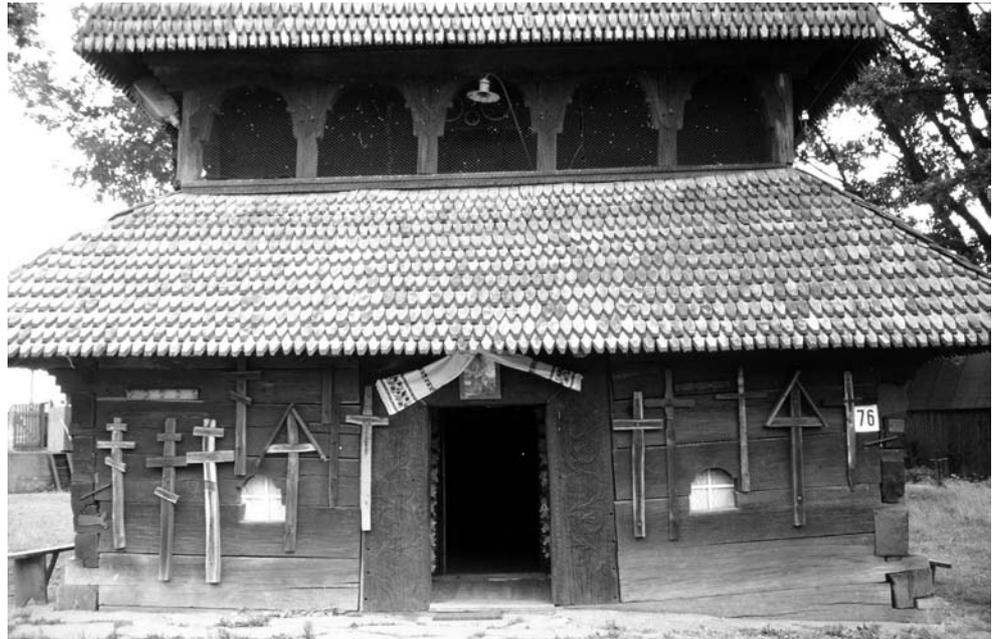
16 *Steblivka*. The wooden church from 1797, a few weeks before it was devastated by a fire. Photo: July 1994.

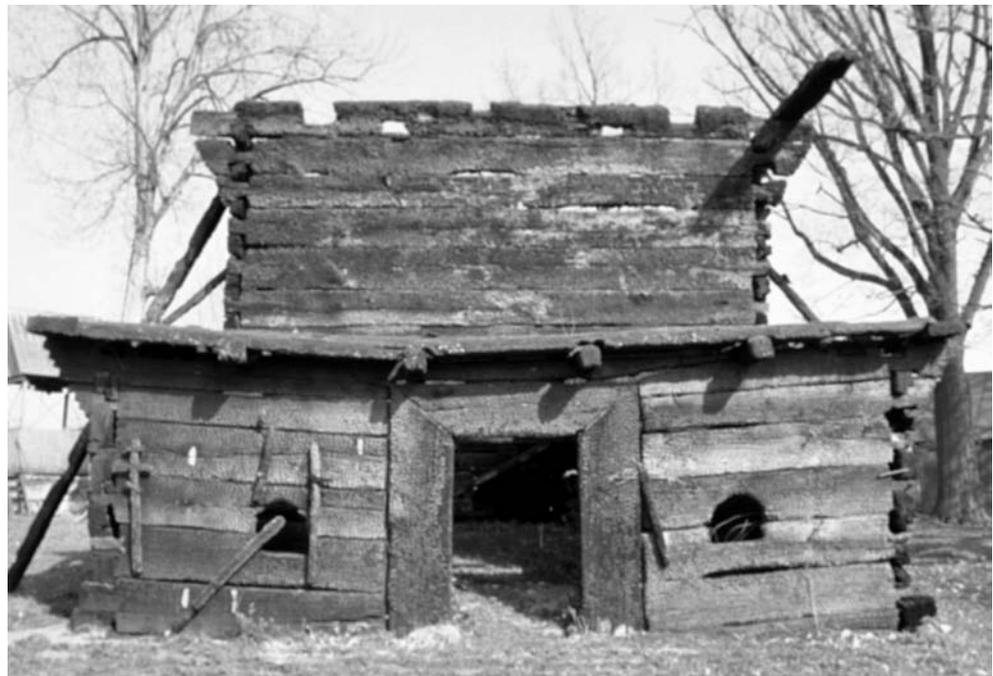
17 *Steblivka*. The burned carcass of the church still stands waiting for a careful documentation or a possible reconstruction before it would be too late. Photo: April 2002.

To improve the general picture, a number of 3 vanished churches were measured after the marks left on their site.⁴⁷ Fortunately, the timber material from Moisei Josani was partly saved during the third erection of a church from it, in Ruscova Oblaz, though only the sanctuary may still maintain the original sizes. Finally, the church in Steblivka, although devastated by fire, still enables good measurements of its plan.

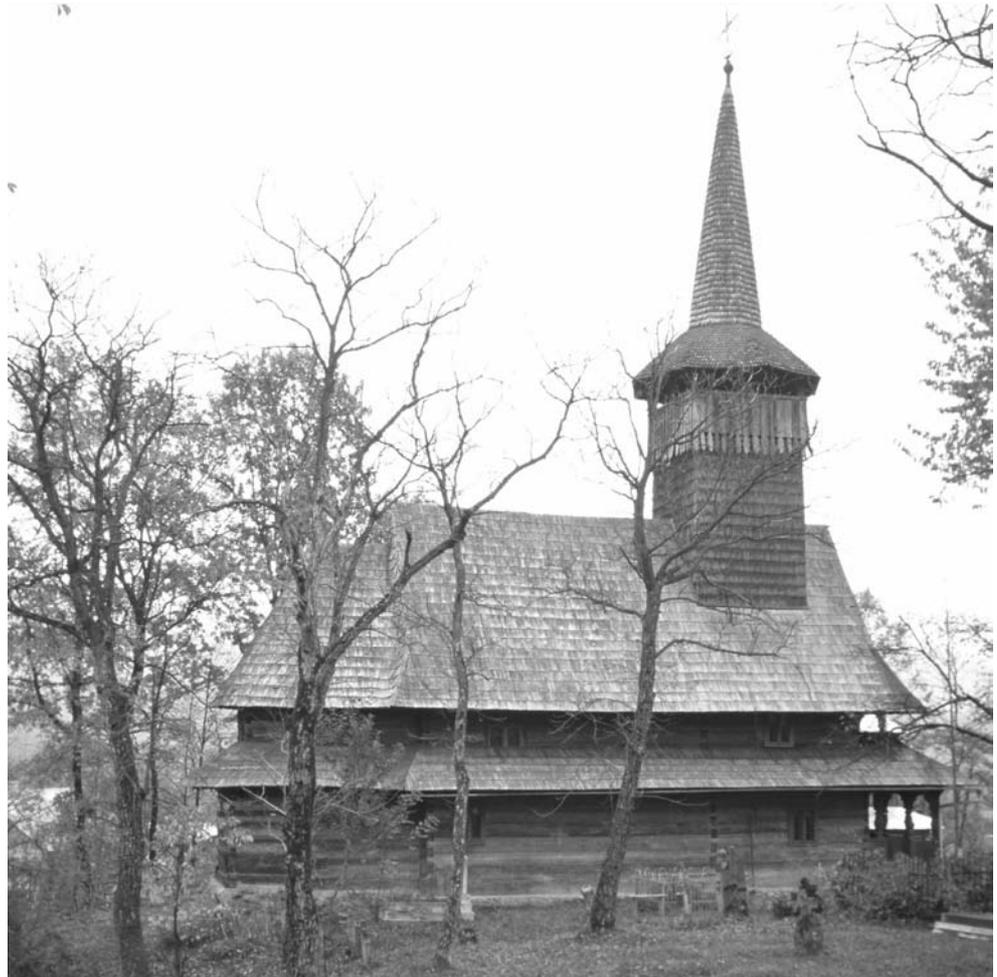
18 *Neresnytsia*. This wooden church, dated from 1813, is the latest loss in Northern Maramureş and the last one from the Taras Valley. The church burned in the early spring of 2003. Photo: October 2000.

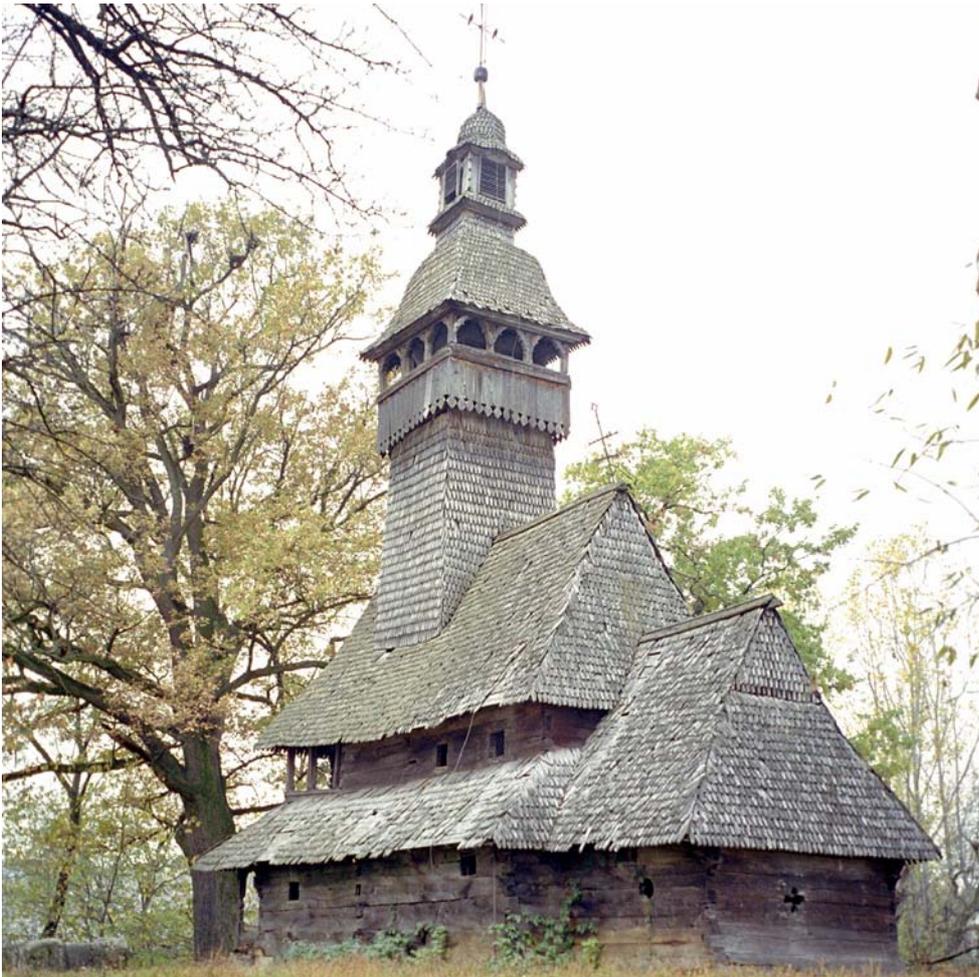
19 *Darva (Kolodne)*. Is this wooden church going to be the next to vanish away? If it still stands it is because the structure refuses to collapse, despite mismanagement and decay. This would be a great loss considering that this is the last one from the lower Talabor Valley and one of the oldest standing ones from the entire Maramureş. Photo: October 2000.

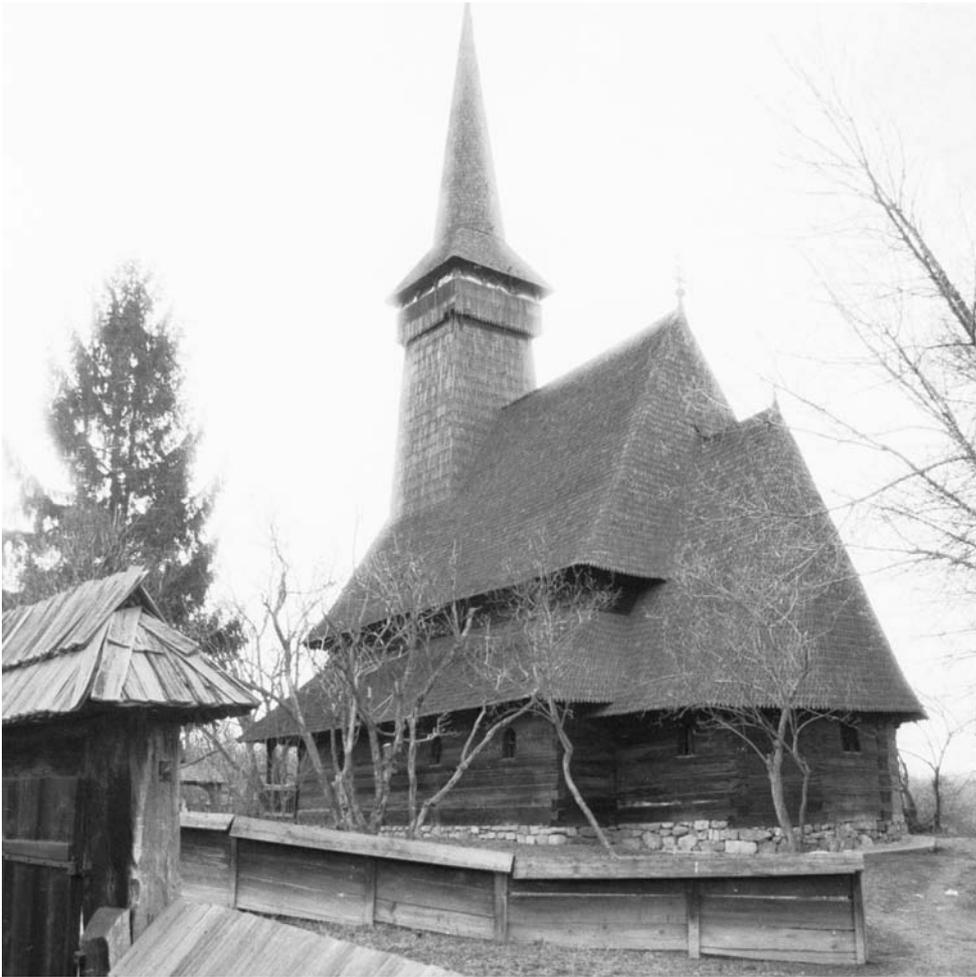
20 *Dragomirești*. One of the most spectacular and successful savings occurred in 1936 when this wooden church was transported from Dragomirești to Bucharest in the Village Museum. Photo: February 1995.

ruinous in Maramureș, like many other replaced wooden churches before, it was repaired and saved in the artificial village established by the Romanian King Charles II to illustrate the countryside of Romania.³¹ On the new location, the earlier damned church regained its dominant presence and austere dignity and became the best cultural ambassador Maramureș ever had (20).

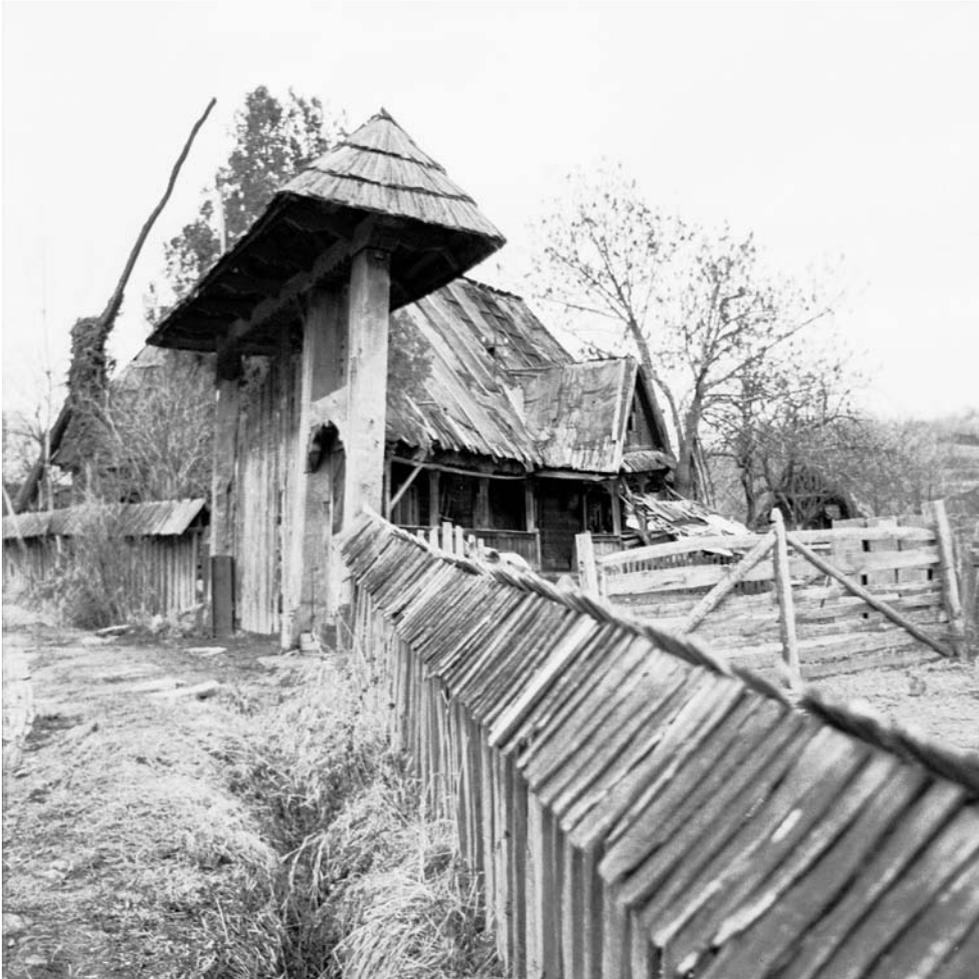
23 *Breb*. A farm at the margin of the village. A large roofed gate marks the entrance in the yard. Once, this was a distinct sign of nobility. The high pole at the left is the upper part of a draw well, placed in the garden for flowers and spices. The house faces south towards the yard and the barn with the stable on the opposite side. The simpler gate delimits the yard from the plough land. Photo: December 1993.

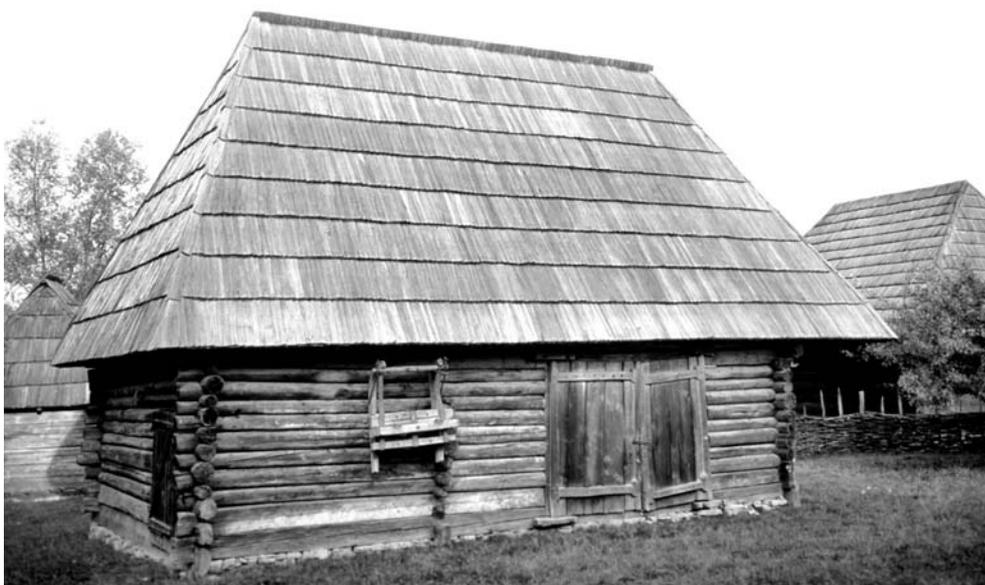
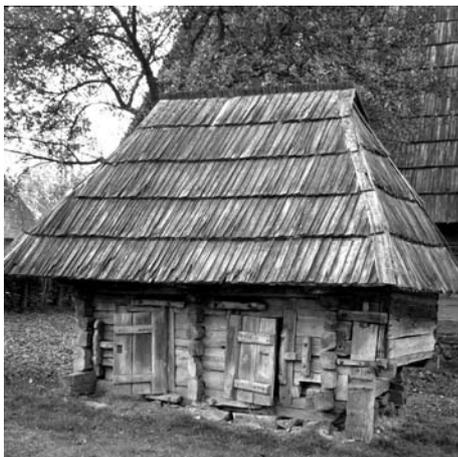
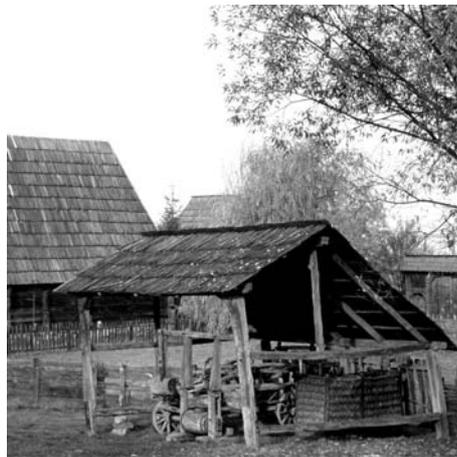
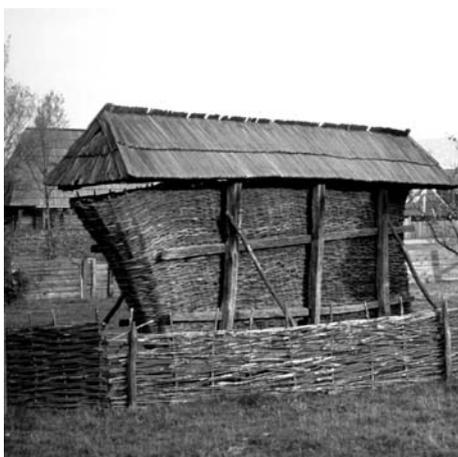
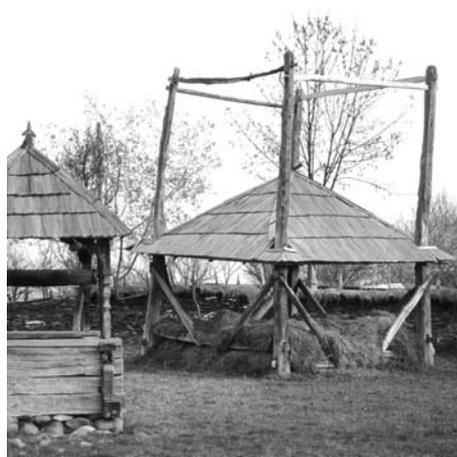
25 *The Ethnographic Museum of Maramureş, Sighet-Dobăieş.*

The specific outbuildings of a farm were dominated by the barn with the stable, usually in a single construction (A). The pigsty and the hen house could have been built in log technique as a stable in miniature (B). The other structures were often built in mixed techniques. A specific light roofed structure on posts provided shelter for the cart and farming stock (*colejna*, C). The hay was also regularly sheltered in a similar structure, though the roof was pyramidal and easy to lift or lower at needs (*şoprul*, E). A typical wheel fountain had a log structure at the base and a light one of 4 posts above, protected by a pyramidal roof (E). One of the most interesting structures appears to have been the wattle corn basket resembling in technique the regular wattle fences (D). The corn was needed outside to be at hands to feed the birds, while the grains were stored in more simple wattle baskets, sheltered safely in the garret of the house. Photos: October 2000.

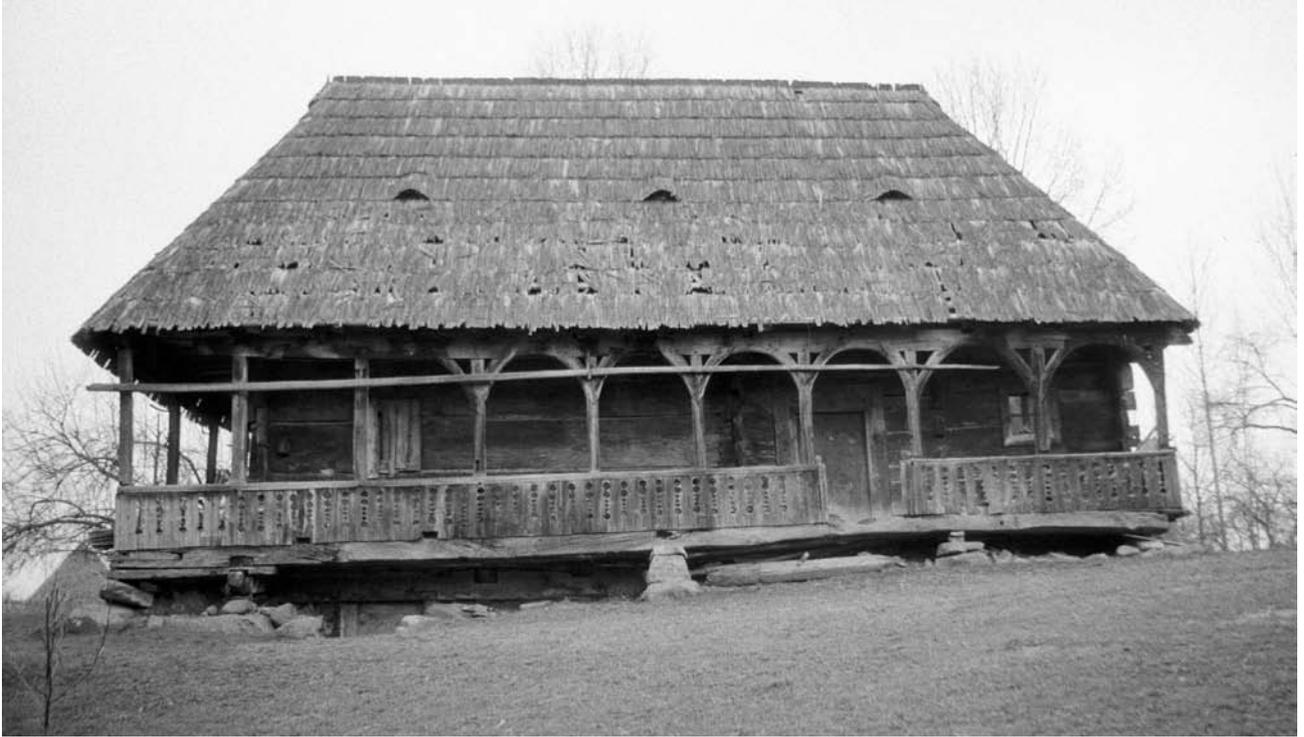
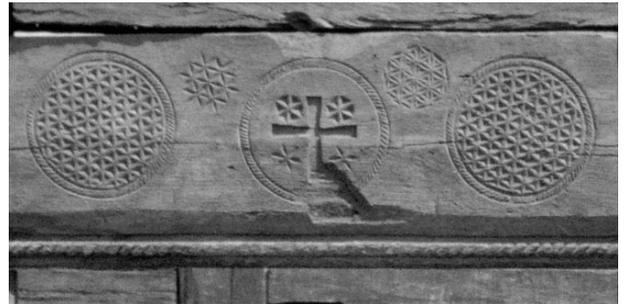
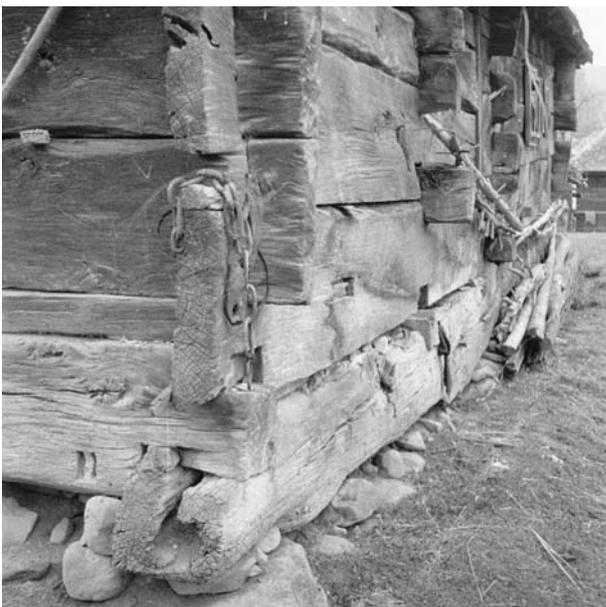
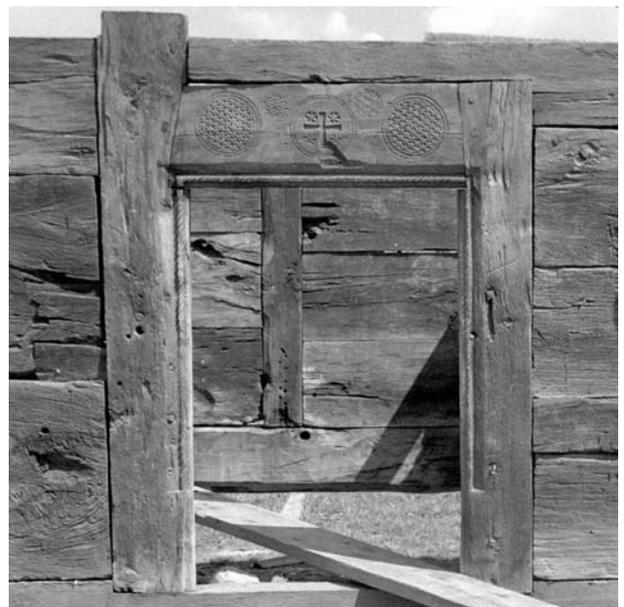
29 Sârbi. The manor house of the noble Dunca de Sârbi family (1690s). The corner joints present a small recess in the neck to improve the interlocking of the beams (below, left). Due to the limited length of the massive logs the house was extended lengthwise by posts, one of them also used as the left jamb of the entrance (below, right). Photos: March 1995, on the initial site (above and below), and August 1997, during its reconstruction in the Maramureş Museum.

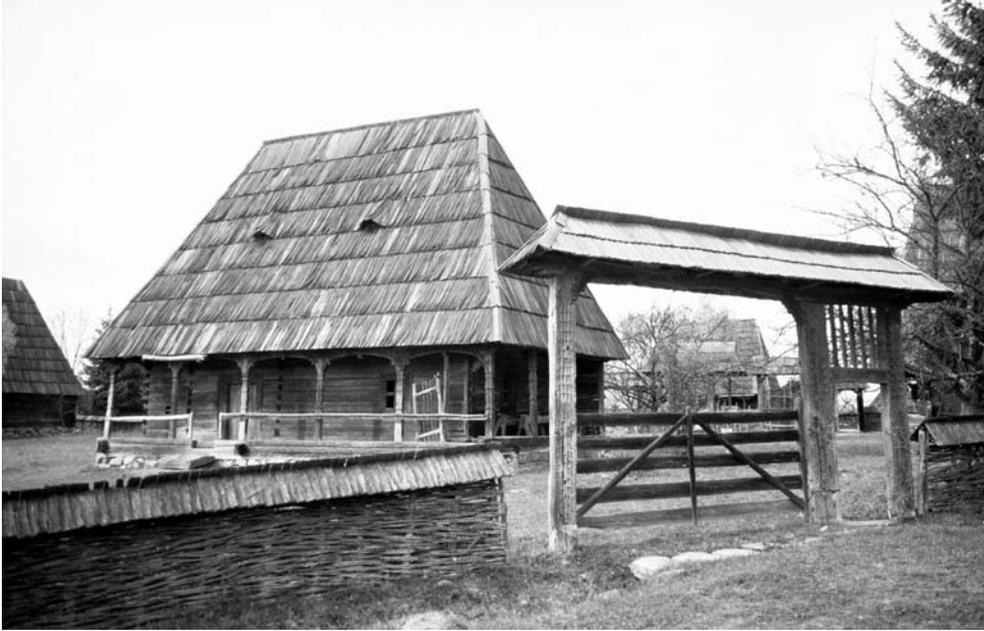
30 *Cuhea*. The house of the noble Buftea family, presently in the Ethnographic Museum of Maramureş from Sighet-Dobăieş. Photos and tracing of the portal's lintel: October 2000.

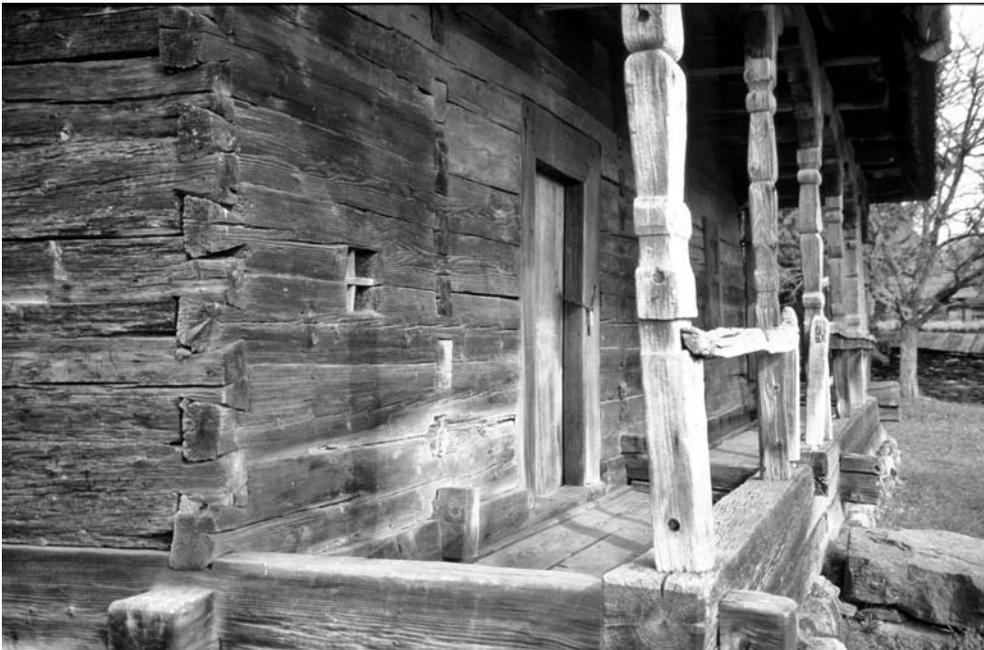
31 *Bârsana*. This is an excellent example of a typical house with *odolhaz*. Initially, the construction was limited to two rooms at the front with access through an ante-room in the middle and seemingly served since 1758 as refectory in the local monastery. After its transfer in the village, sometime around 1795, the house was consistently enlarged with dark rooms at the rear (*odolhaz*) and a porch at the front. Presently the house serves as local museum. Photo: view of the rear and one side, June 1997.

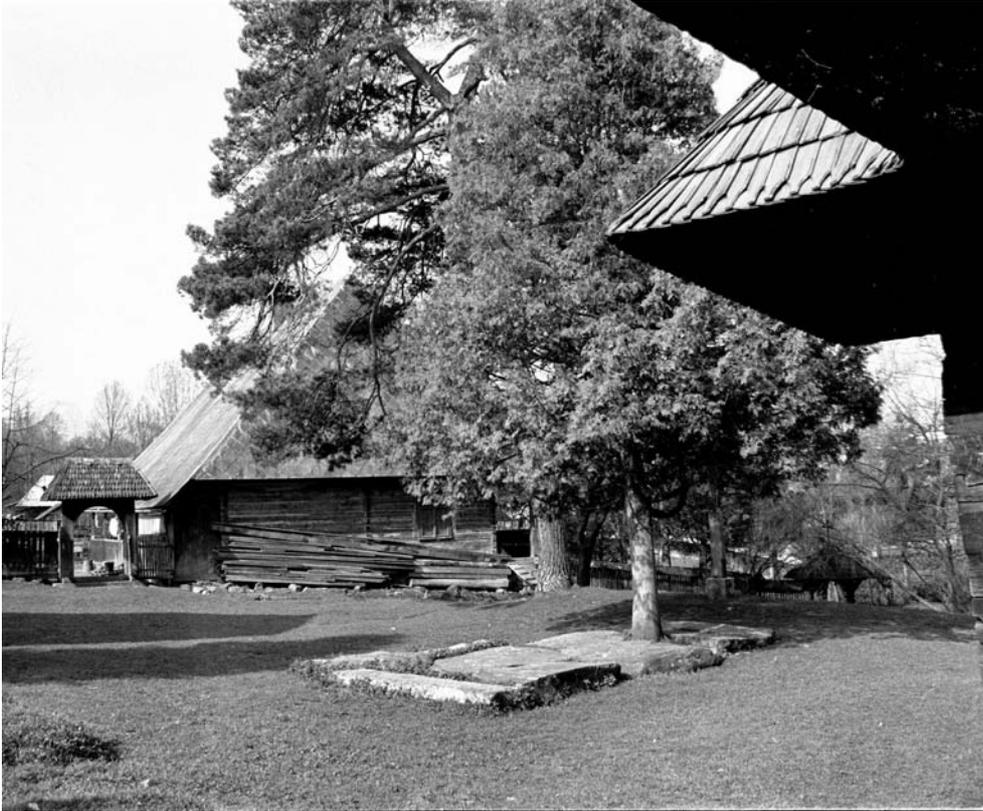
32 Breb. The present large parish wooden house with *odolhaz* and porch on three sides was built in 1903 replacing a similar one from 1801. Its high value derives from its traditional character and position close to the parish church forming an architectonic unity which has not changed significantly during the last two centuries. The small gate at left, separating the church yard from the parish yard, is a replica after one from 1790, saved in the Ethnographic Museum of Maramureş from Sighet. The recent religious division separated the parish house, resided by the Orthodox priest, from the church, used by the Uniate congregation. Hopefully the entire ensemble would be preserved. Photo: May 1995.

sold in 1903 to a local noble to become a manor-house and it was soon replaced with the present one (32).⁵⁴

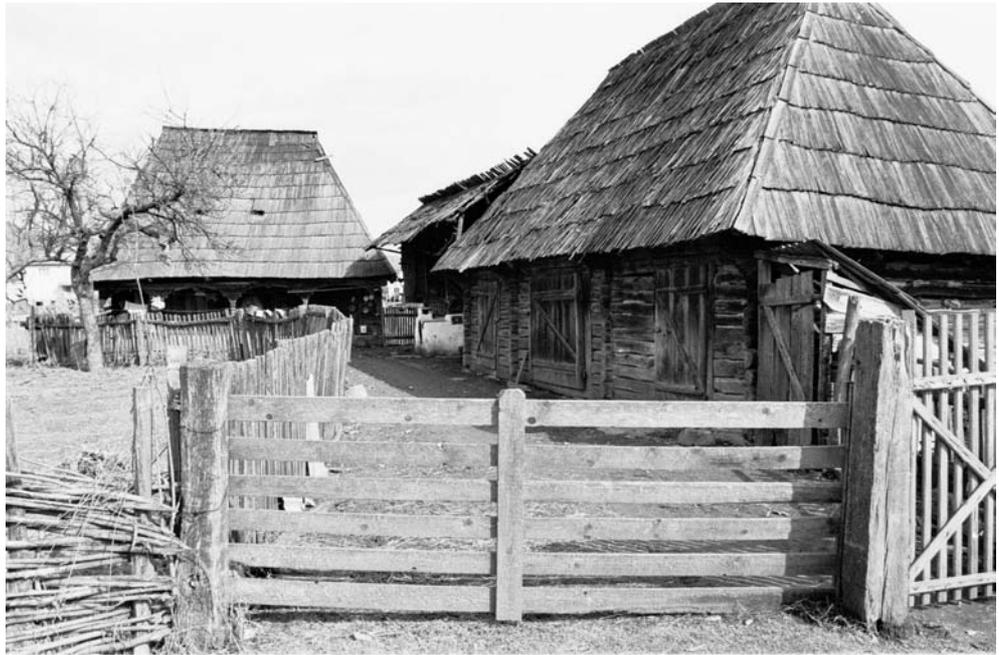
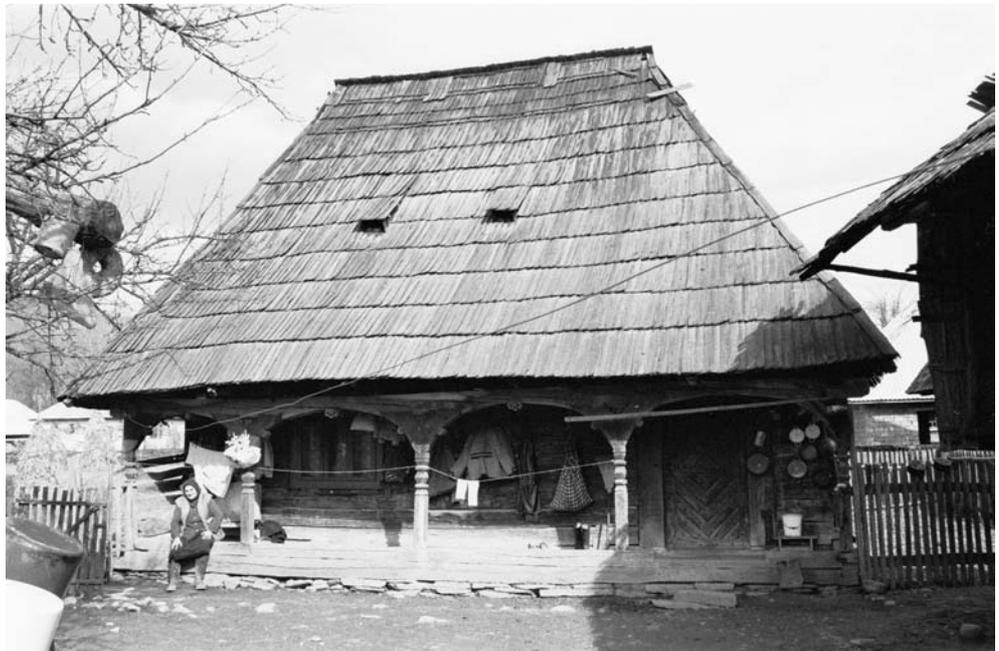
33 Strâmtura. This has been a common farmstead in the former serf village of Strâmtura. The low gate was once a clear sign of the serf status of the holder. The shingled roofs are now generalised if not competed by other modern materials, yet, for one or two generations ago the constructions were mainly thatched. The wooden house, situated rearmost from the street, has only a warm room accessed through an ante-room and a porch of 5 posts. The house was possibly built in the second half of the 19th century or at the beginning of the next one. Photos: March 1995.

centuries ago (33). The small one-room houses with wattle walls disappeared for some time ago but a few elders in isolated villages can remember their existence.⁵⁹ Even the thatched roofs, once dominant, became towards the end of the 20th century a rare mark of an ancient world. A curiosity today is the mud floor, once called the face of the house. The windows closed by an ox bladder, lasting longest in isolated Gypsy homes, are so well forgotten that some even believed the houses in Maramureş always had window glasses.⁶⁰ The change have gone so far during the last century that old manor-houses, not for a long time ago admired for their beauty and filling their owners with pride, are now identified with poverty. And everything connected with poverty is something to be ashamed of in Maramureş,

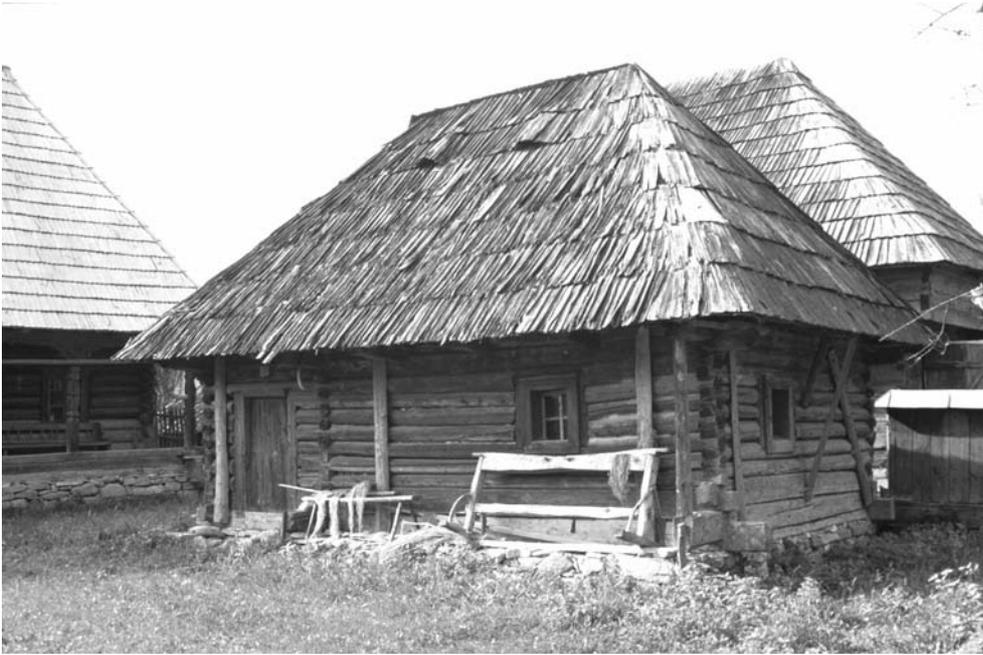
34 *Ieud*. Saved in a local private museum, the house of Moldovan Palaga Babii illustrates some of the simplest and oldest types of log houses, with only a small room and a dark ante-room, without any closed porch. However, considering the type of flush corner joints, the house can not be older than 100-150 years. Photo: September 2001.

A direct example of a former modest house is visible now in the private museum of the Pleş family, in Ieud (34). This small house, which once belonged to Moldovan Palaga *Babii*, was probably built about a century ago, of round logs interlocked with dovetail joints. The construction enclosed only a room and a cold entrance hall. A very simple, ancient solution can be observed at the entrance, where the door jambs were fixed upwards directly in the timber above.

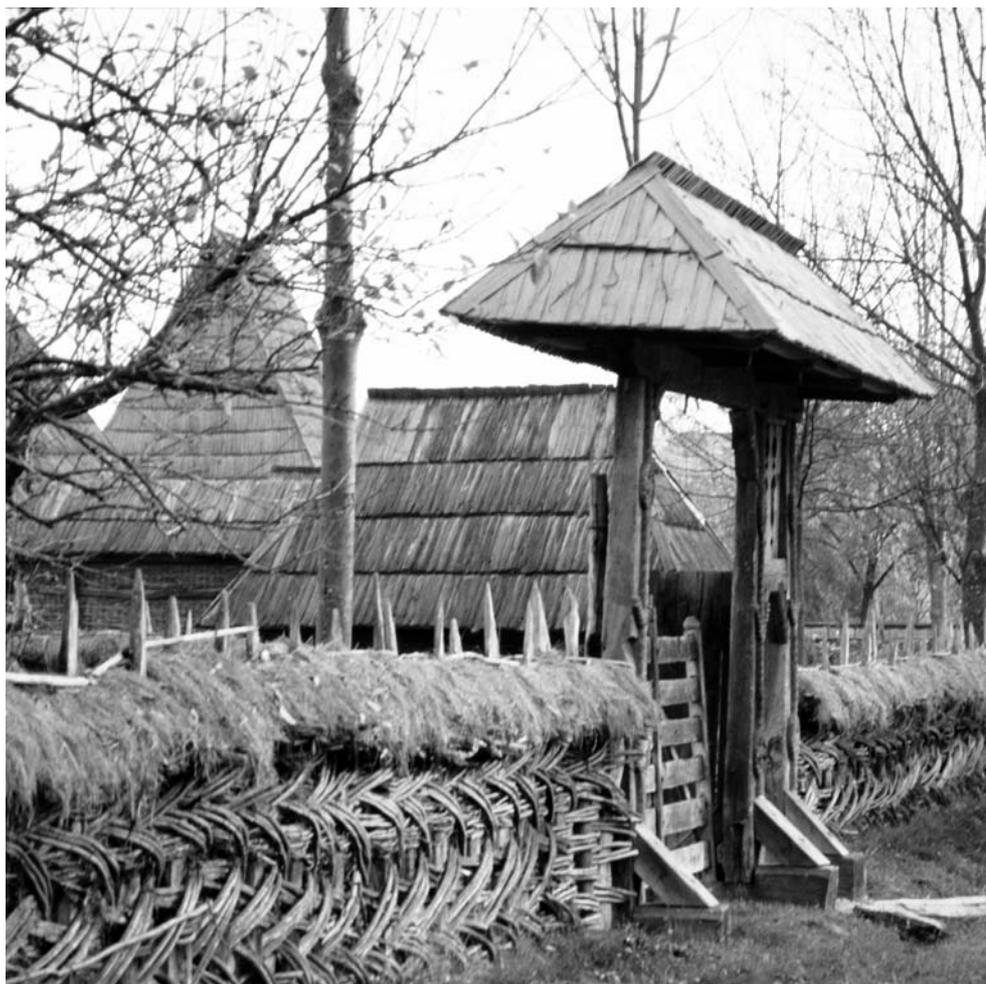
36 *The Ethnographic Museum of Maramureș from Sighet.* The high gate with roof has been for many centuries a clear sign of the status of the owner. Today there is a renaissance in building such gates, often richly decorated. The decorative pattern of wattle work in the fence on both sides of this gate is specific in some parts of Southern Maramureș. Photo: October 2000.

The house was not always the single one who best marked the social status of an owner. The sizes of the outbuildings or the type of gate (**36**) were as effective means to signal the social affiliation.⁶¹ In the old days it was the stable with the barn that was placed nearer the street exposed to the eyes of the foreigners while the house was drawn inside the garden. The separate pantry (*găbănaș*) was also said to mark the status of a farmstead.⁶²

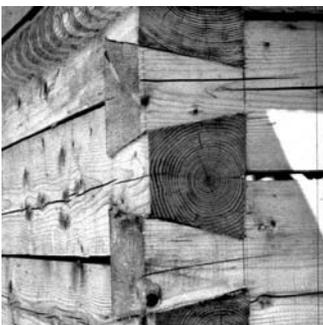
40 *Dragomirești*. The settlement gaps were plainly visible during the construction of a new wooden church in Dragomirești by master carpenter Găvrilă Hotico *Herenta* from Ieud. Photo: July 1997.

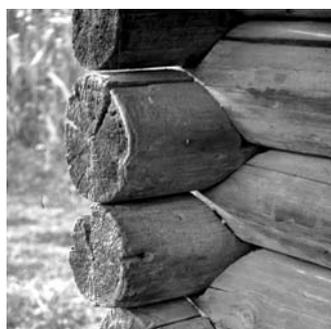
42 *Șieu.* Hollow joints at the house of Petrovai family, now in the Ethnographic Museum of Maramureș. Photo: October 2000.

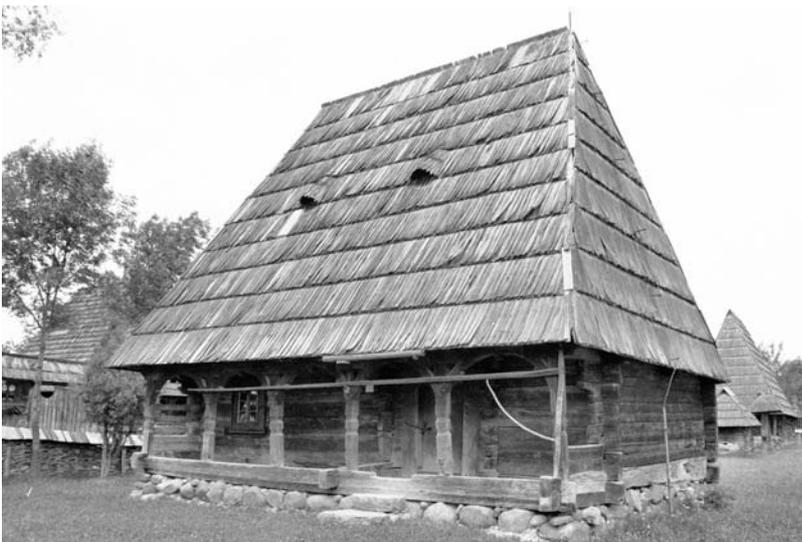
44 *Călinești.* The house of the noble Berciu family, now in the Ethnographic Museum of Maramureș, was built in the 17th or the 18th century entirely with squared logs of oak and *double-slot* joints. Photo: June 1999.

The *double-slot joint* was the suited alternative to the hollow joint when the logs were squared (41 B, 43-44). In Maramureș it was named the "straight" or more commonly the "Romanian" joint (*tyeotoare dreaptă, românyască*) indicating its wide use in the Romanian villages. The principle of cutting such a joint is
