Tracing a Sacred Building Tradition

Wooden Churches, Carpenters and Founders in Maramureş until the turn of the 18th Century

by
Alexandru Baboş

**Department of Architectural History, School of Architecture
Lund Institute of Technology, Lund University, Sweden**

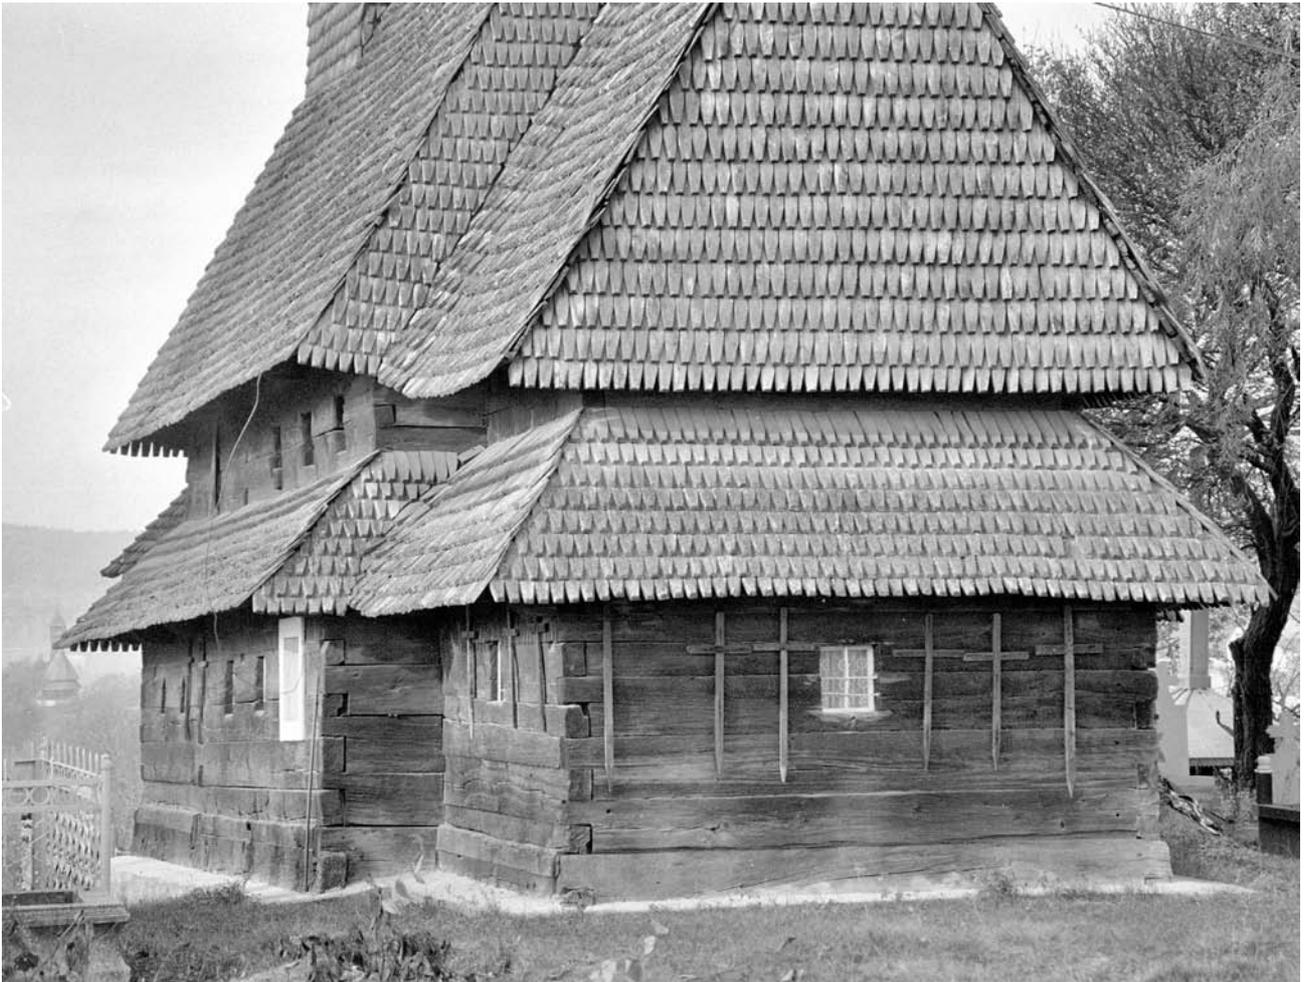
45 *Apşa de Mijloc Susani*. This medium sized wooden church, from the first decade of the 18th century, was excellently built with well levelled walls and flush covert joints. Photo: October 2000.

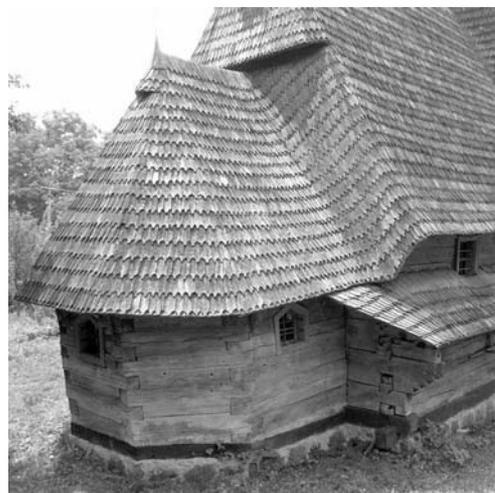
46 *Corneşti*. The sanctuary, erected in the first decade of the 16th century, displays well refined covert joints and a higher quality of wood work than the rest of the church (finished probably in 1615 and significantly repaired in the 1670s). The local oral tradition indicates the origin of the sanctuary from the Iza Valley. Scale drawing of the rear from August 1997, of a joint from June 1998 and photo from June 1996.

The oldest known church joint in Maramureş is the *covert* joint, and it can be seen at the polygonal shaped sanctuary from Corneşti, firmly dated from the first decade of the 16th century (46).⁹⁰ It was also currently used in the churches from the 17th century and rarely even in the 18th century, last time in the parish church from Slatina, in 1794. If we add the churches from the 15th century in Little Poland⁹¹ and Bucovina⁹² and many other later examples around, then we will have strong reasons to believe that this joint was widely spread in the church wooden architecture of the Northern Carpathians in the Middle Ages and afterwards. As this joint was not identified in the late secular buildings it is possible that its secret principle was forgotten in Maramureş with the last wooden church builders. Today, we have only the existing joints to tell us about their inner logic (47).

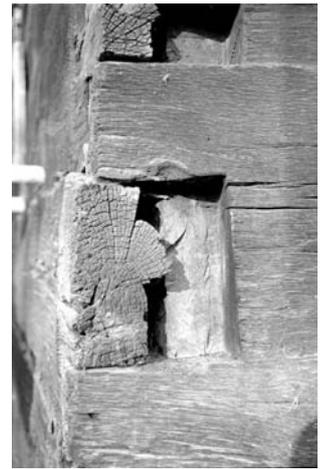
48 *Breb*. Settings in the north-western corner of the building damaged the hook in the picture exposing the covert cog. However, the damage was limited thanks to the presence of the heart of the tree in the hook. The visible traces indicate the cog was cut with an axe. Photo: October 2000.

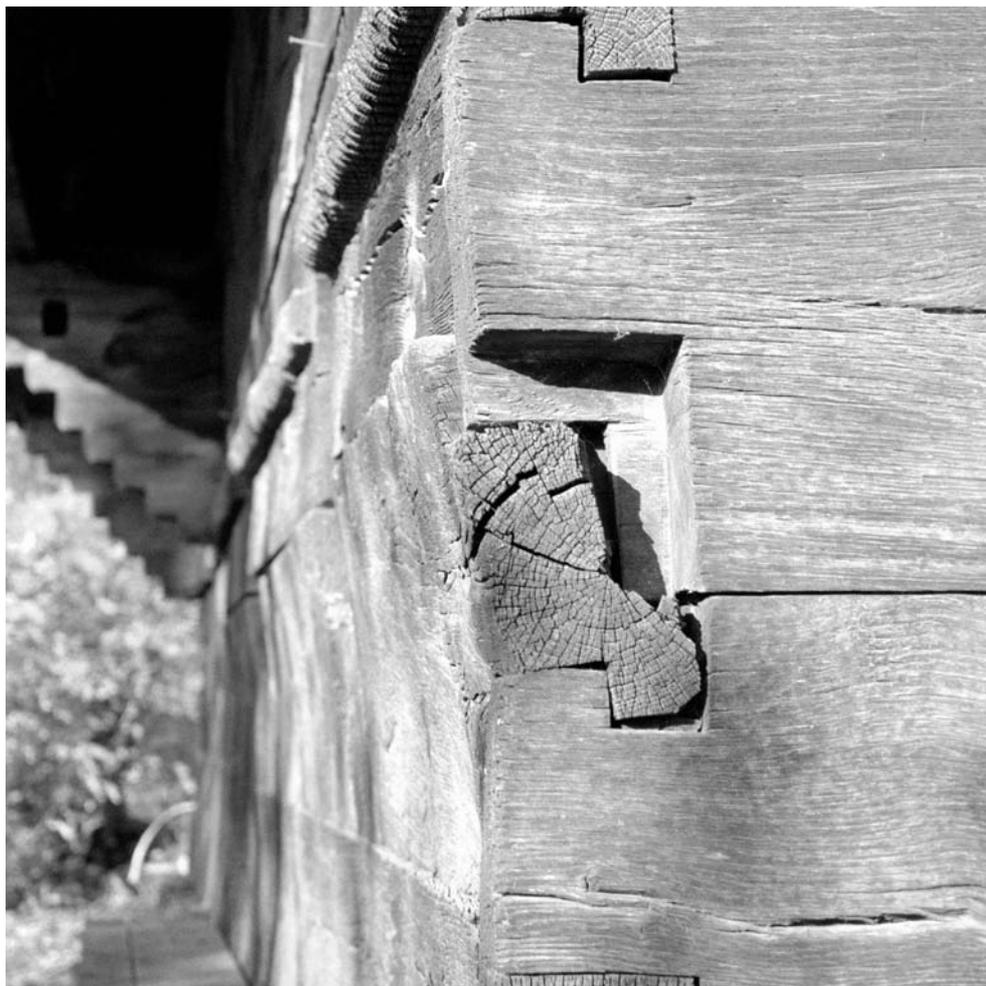
57 *Sârbi Josani*. This log twisted out of its allotted position damaging the joint and altering the plainness of the wall, possibly after a dowel broke inside. Photo: October 2000.

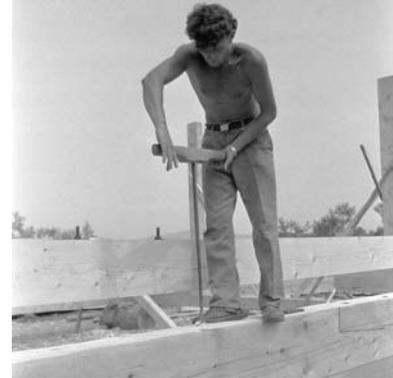
58 The Ethnographic Museum of Maramureş, Sighet-Dobăieş. Drilling a hole for a dowel was vital to stiffen the log but any deviation from the vertical direction could jeopardize the joints and the plainness of the wall. Photo: July 1994.

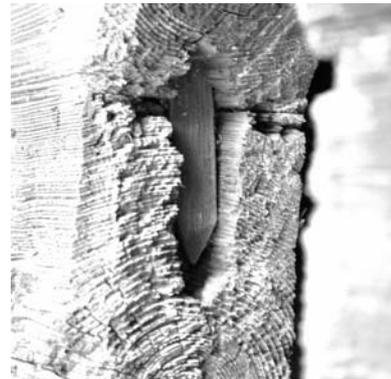
59 Ieud Deal. This dowel (about 18 cm long) became half exposed after an enlargement of the aperture of a small northern window in between the eaves. It has a square section (about 2.7 x 2.7 cm), a pointed end and a small empty space in the hole. Photo: July 1997.

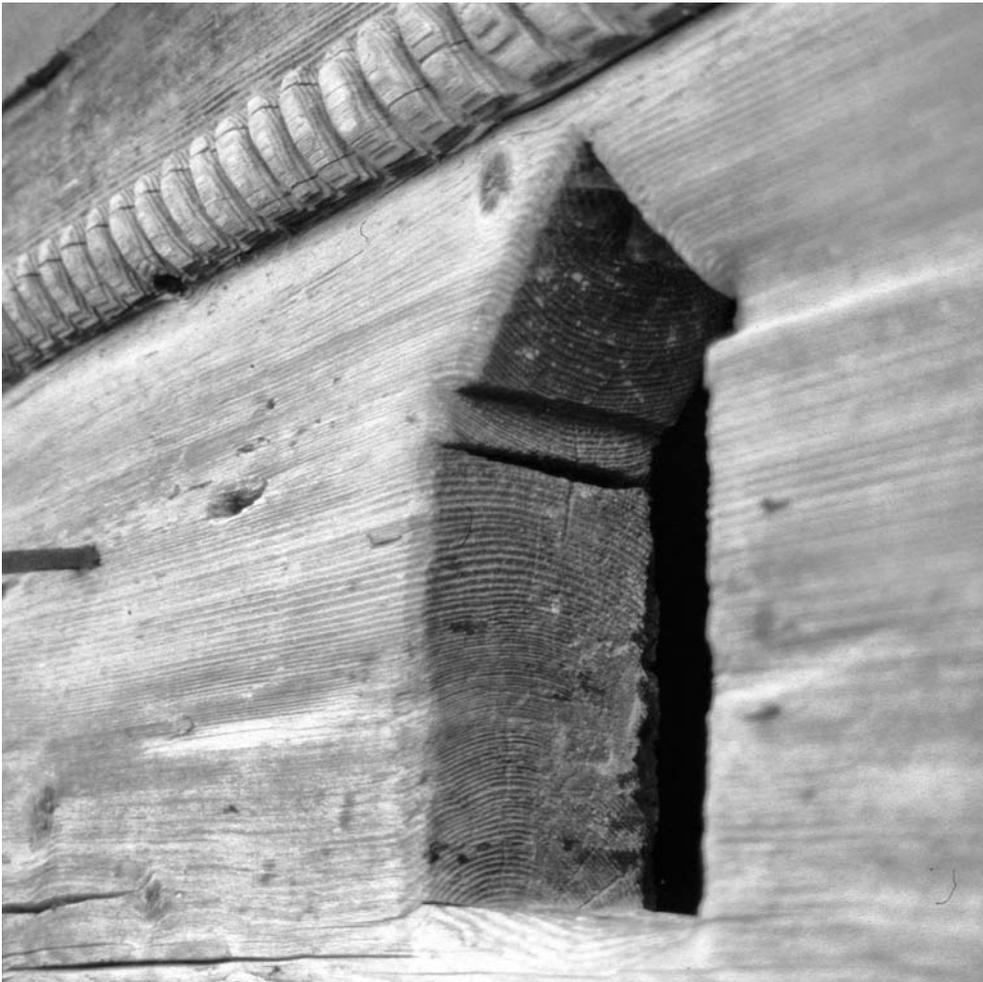
62 *Cuhea*. Difficult to capture in pictures, the grooves are however identified in most of the wooden churches from Maramureş. Here, the groove appears in the aperture of an original window. The small hole in the wall at the meeting edge of two logs, just a few cm at left from the aperture of the window, was made by a woodpecker, possibly taken in by the sound of the empty groove inside. Almost everywhere the grooves are used, there are countless holes made by these tireless birds. Photo: June 1997.

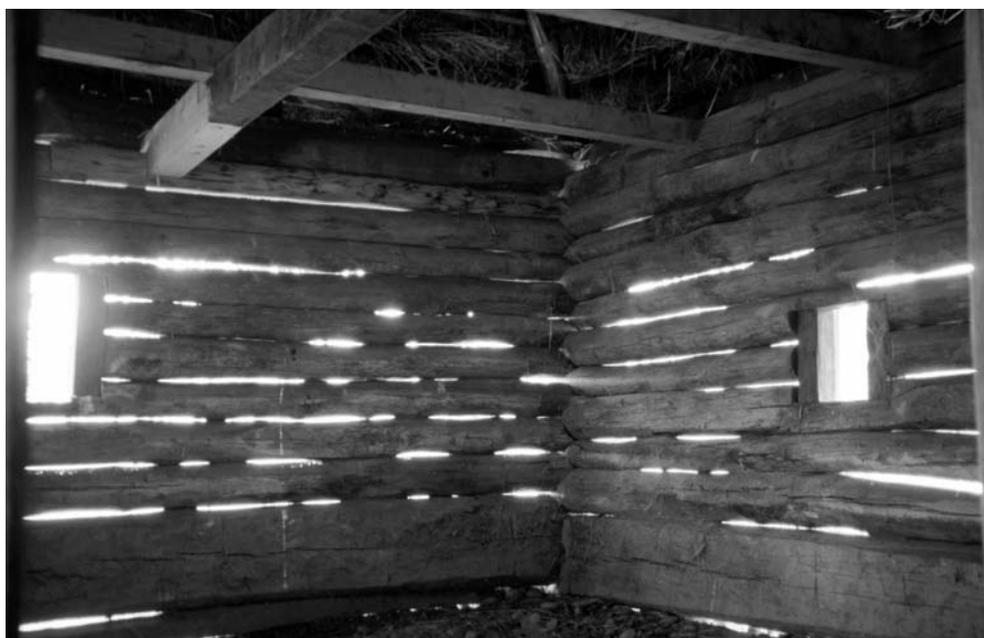
63 *Crăcești*. The house of Bohotici family after its transfer and reconstruction in the Ethnographic Museum of Maramureș. The faints of light reveal the irregularities between the rounded logs. The room would be sealed with daub as it was finished for 150 years ago. Photo: October 2000.

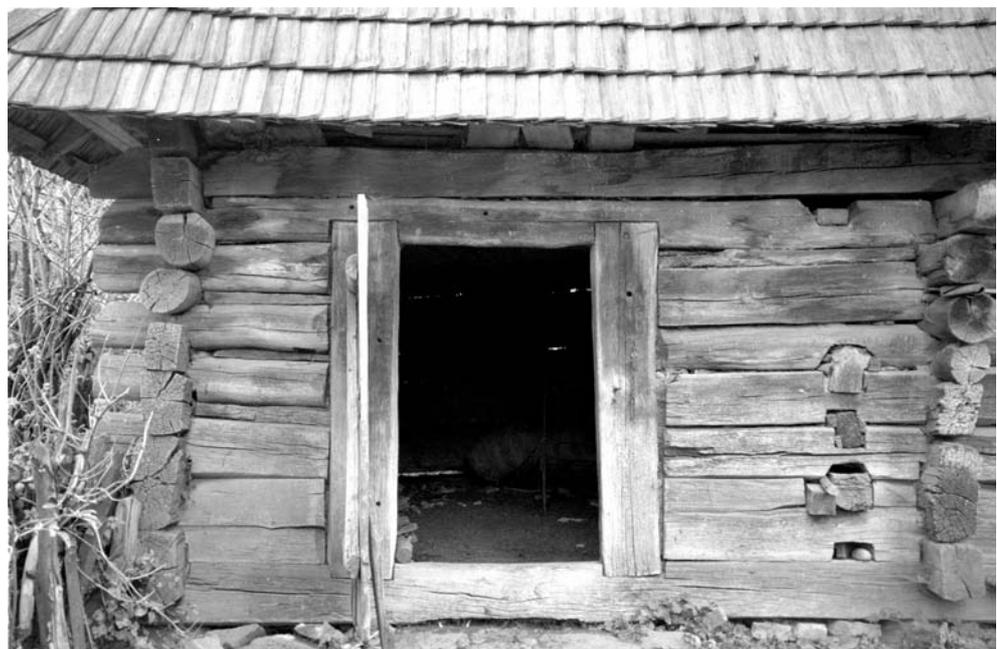
66 Crăcești. The poor stable of Costin Grigore a lu Zaharie retains a simple door sided by jambs and mounted in the sill bellow and a beam above without any tenon. It is hold in place by the slots carved from the sill and the beam above. The lateral grooves receive the tenon of the wall logs. Photo: October 2000.

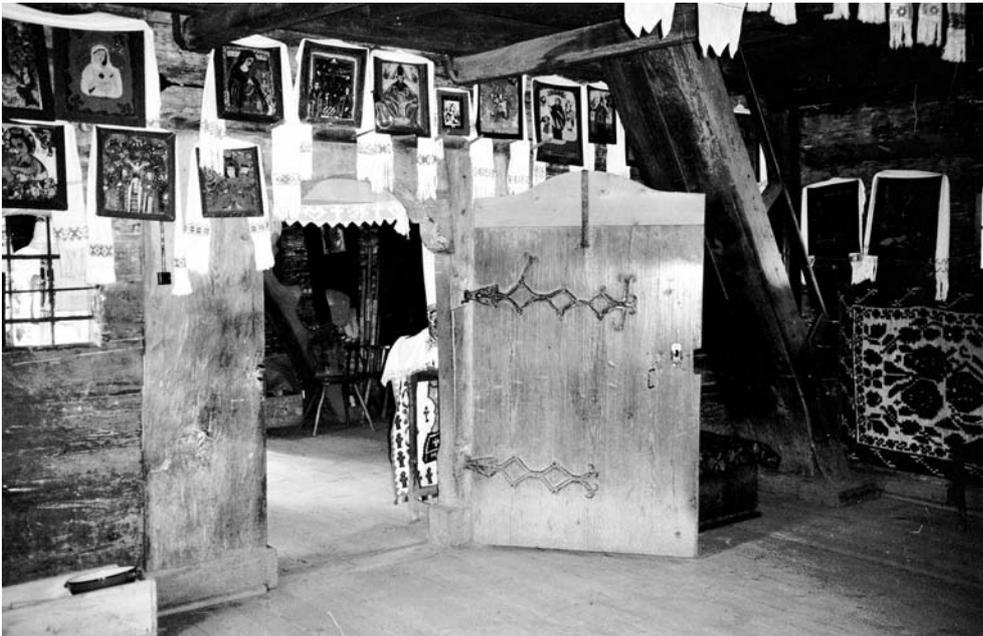
70 Ieud Șes. The decorative iron hinges of the inner door to the nave (below) remind of the surviving hinge from the inner door in the church of Dragomirești (above) indicating the work of a single smith behind both. The two close churches were also built soon one after the other in the 1710s. Photos: July 1997 (below) and June 1999 (above).

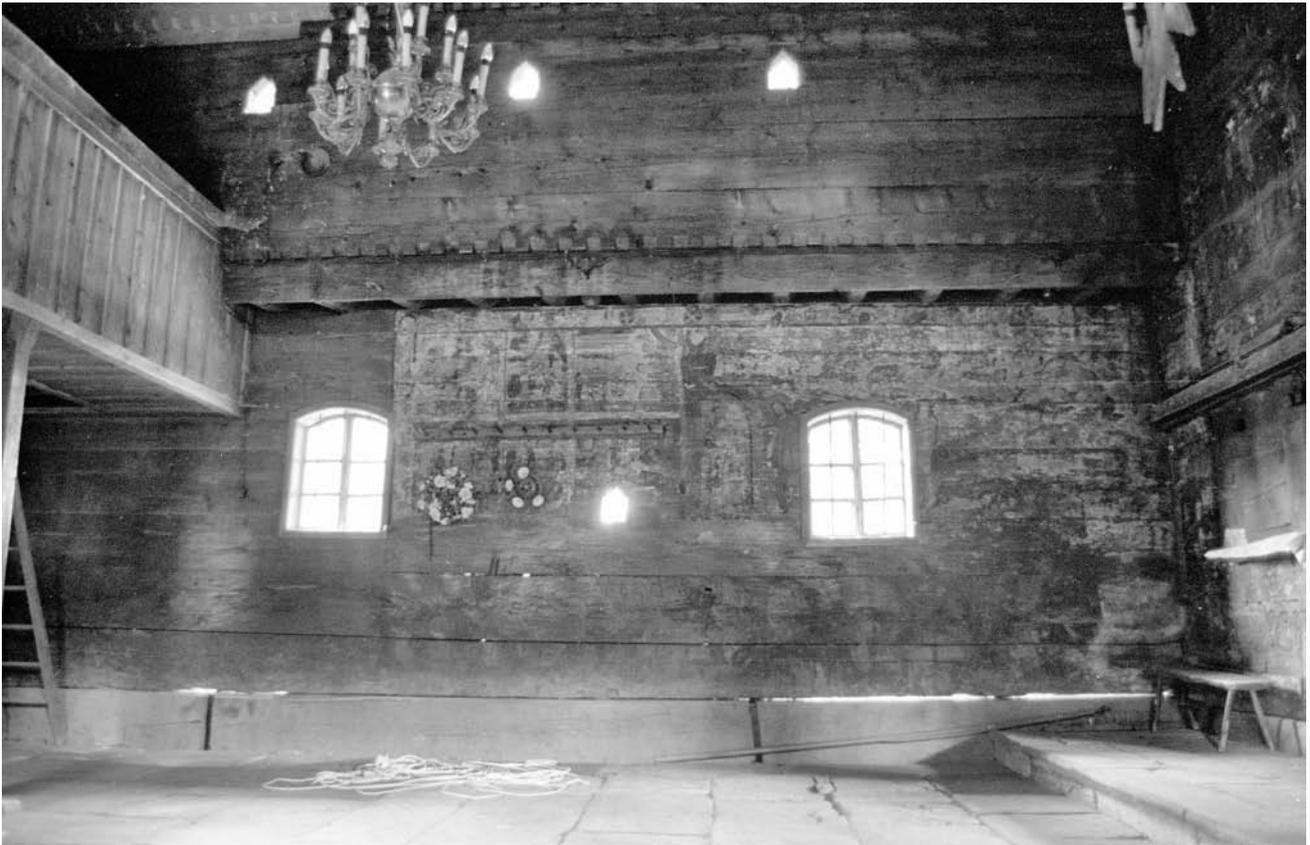
75 Budești Josani. This nave, the largest known sacred room in wood from Maramureș until the end of the 18th century, was lighted by two rows of three small windows from both sides. In 1923, on both sides, two of the lower windows were enlarged changing significantly the light inside. Fortunately, the small one in the middle (enlarged at right) remained untouched, witnessing the intricate work to frame every small piece of glass. A large unbroken bottle glass was about 14.8 cm in diameter and a small one about 9.6 cm. The frame was fixed to the wall in the groove around the aperture and was by all appearances never opened. Photos: August 1997 (right) and June 1999 (above).

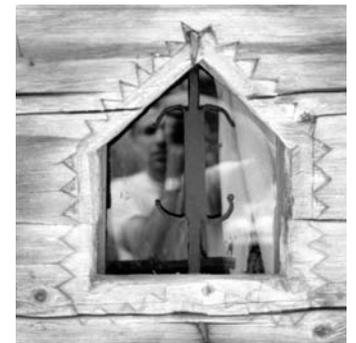
79 Desești. The window in the axis of the sanctuary retains a pointed aperture specific for churches and an indented pattern around. Photo: June 1999.

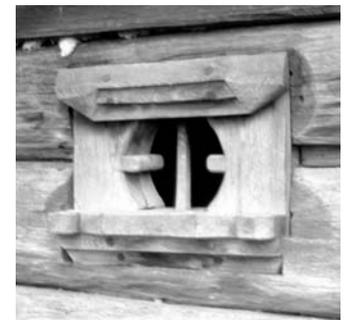
80 Călinești. The window with shelf at the rear of the house of Cupcea family. Photo: June 1999.

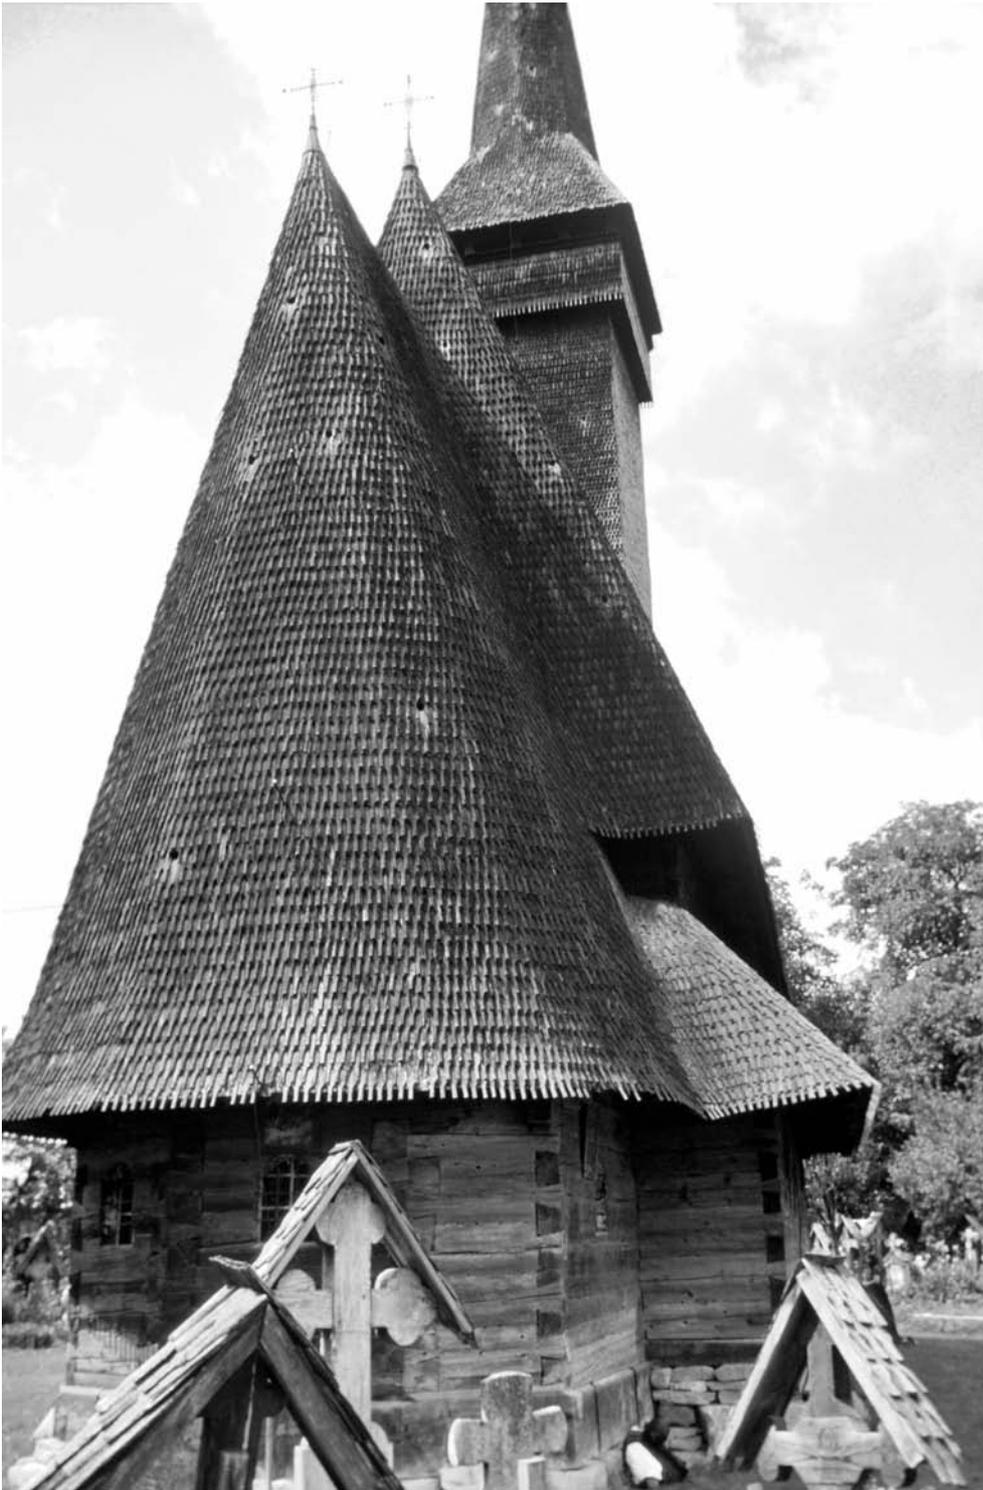
82 *Ieud Șes*. This church, particularly known as the wooden cathedral of Maramureș, built probably in the 1710s or in the previous decades, retains the steepest roof of all known in the region. The rafters over the sanctuary might measure two times the width of the sanctuary or more. Photo: July 1993.

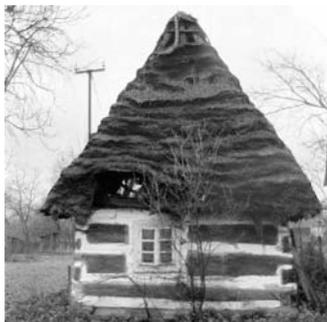
85 *Tereblia*. In some villages from the lowlands of Northern Maramureș it is still possible to observe ruinous thatched houses as this one of Hrulia Vasilina from Tereblia, probably erected in the 19th century. In this part of Maramureș the strips of daub sealing the walls are specifically emphasised in colours like white and blue. The low opening in the roof allowed the smoke to come out. Photo: November 2002.

Most of the vernacular dwellings were until a century or two ago thatched (83, 85). Intentionally or not, this choice seemed salutary since the thatch on the roofs became in difficult years a critical reserve for the cattle. In 1740 the priest from Budești Vințești noted on a church book about the year of famine that plagued the village as he was forced to uncover the barn to feed the livestock.¹¹⁹ This experience was repeated once again in 1914, in the preamble of the World War I, and it is still remembered.¹²⁰

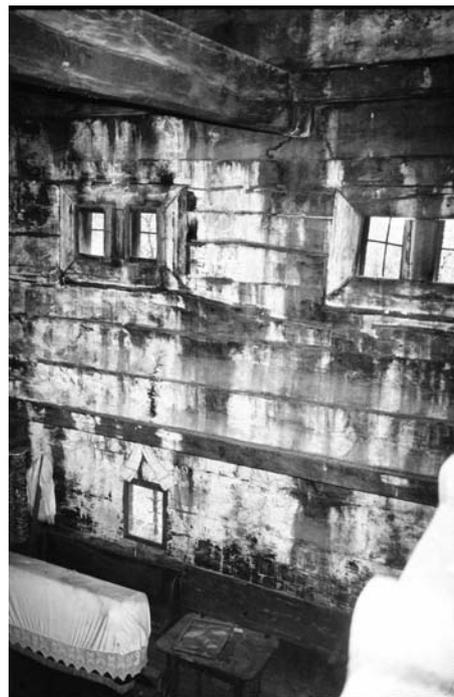
93 *Rona de Jos*. The cross beam penetrates the interior under the spring of the vault in between the two upper pairs of windows. Photo: October 1997.

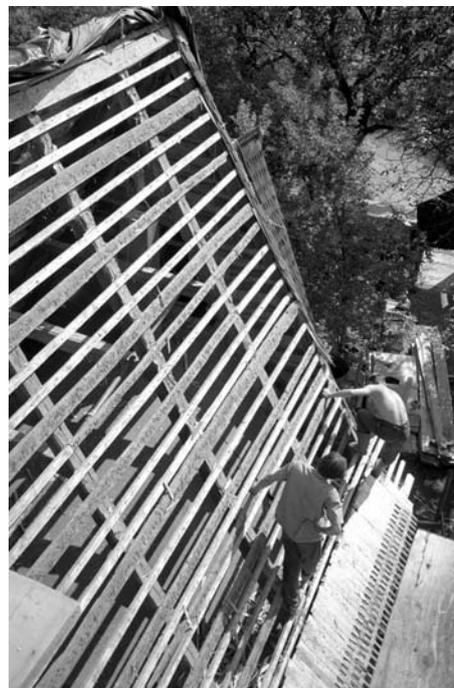
94 *Ieud Deal*. The old lathing was easily distinguishable by its massive appearance under the repair of the roof. Photo: August 1997.

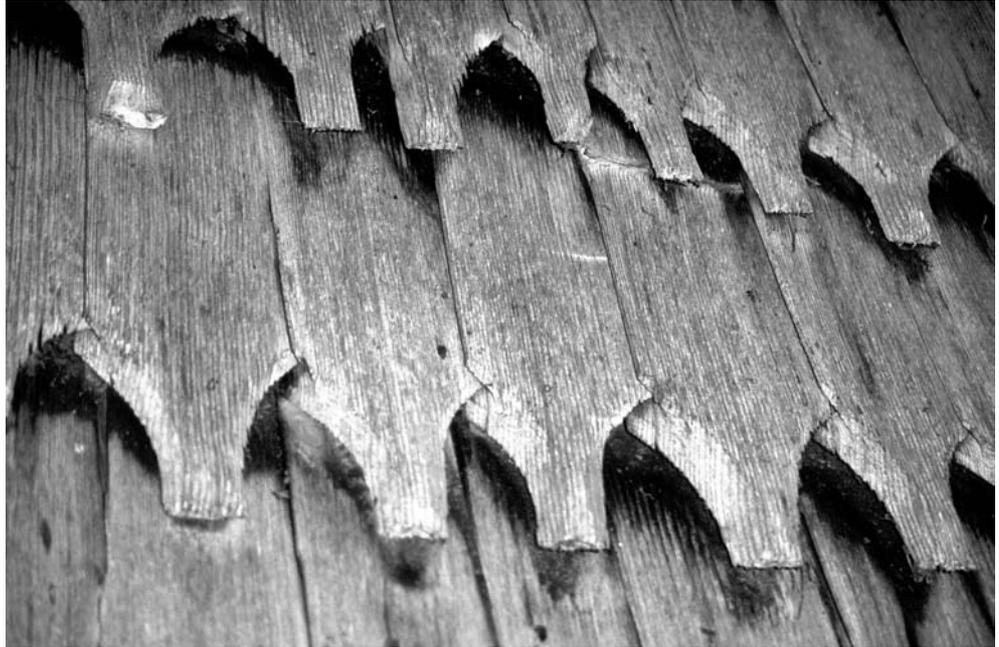
95 *Budești Susani*. The oldest types of shingles were grooved on one side and cut with a beak end to prevent them from splitting. Photo: October 1997.

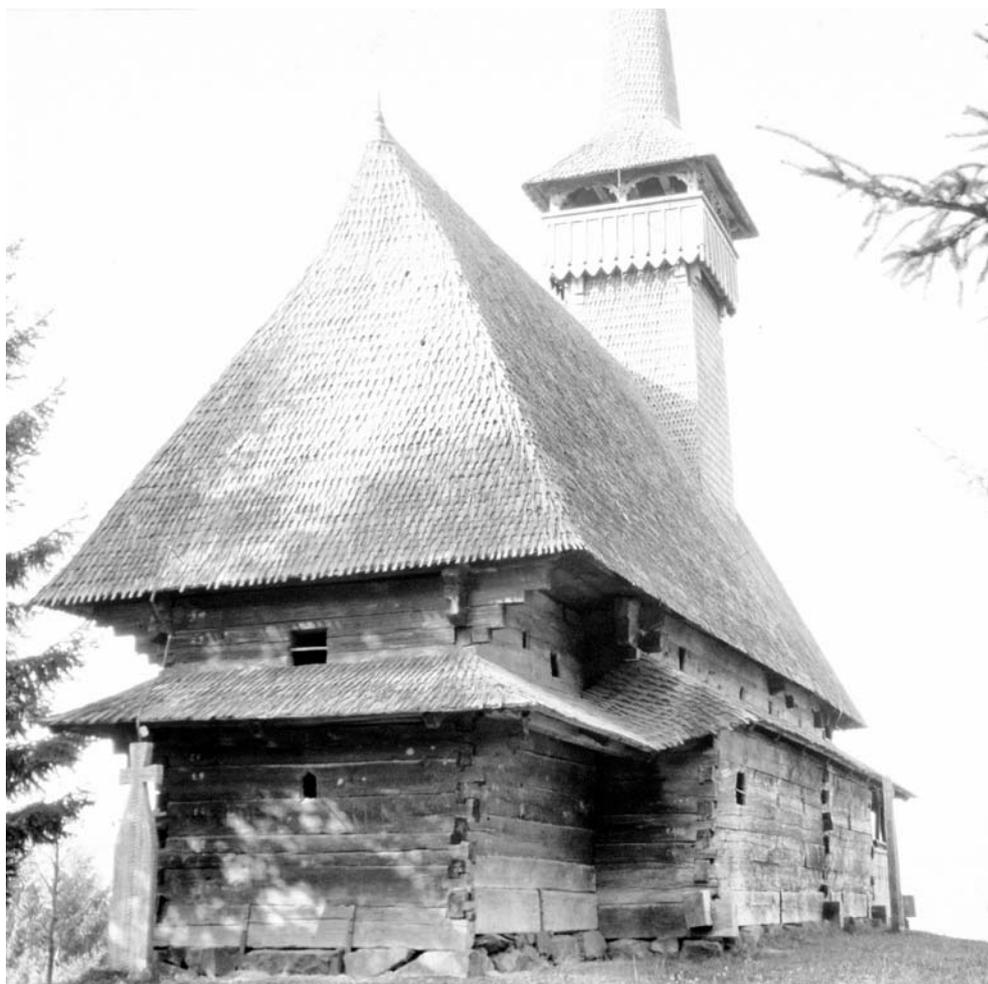
97 *Onceşti*. Of the standing church only the log fabric can more definitely be connected with the signature of master Gavril. The church stands today in the Ethnographic Museum of Maramureş in Sighet. Photo: October 2000.

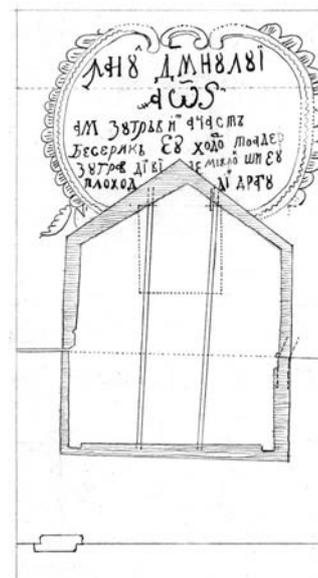
99 Bârsana. The signatures from 1806 of the mural painter “*Toader Hodor from Vișeu de Mijloc*” and of “*Plohod ... from Dragomirești*”. Scale drawing: July 1997.

One of the first places where we find the signature of Ioan Plohod is the church from Bârsana Jbâr (99). There, in 1806, he signed on a wall after the

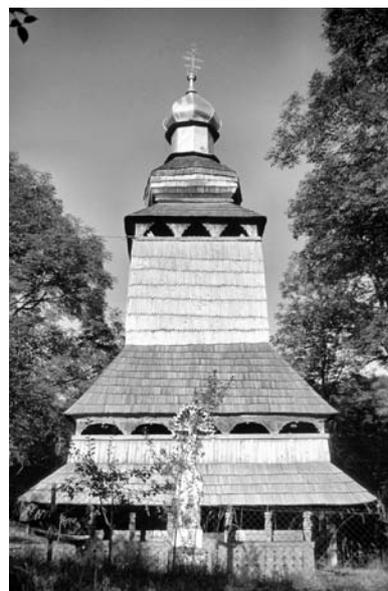
101 Evaluation costs to erect a new wooden church in Bukovets (DAZO, 151, 1, 3017/ 1782, 12), lost from its main document, but identified as an appendix to the Parish Regulation of 1798. According to the inscription above the entrance, the church was finished in 1808. Photo: August 1993.

The estimative costs to build the new church from Bukovets are especially important since the construction still stands. The master carpenter (*alts mester*) Bárnits Ivan was mentioned as a counterpart by the district notary Jacobo Szilagi, the one who wrote and signed the text (**101**). The moneys, 240 Rhenish florins, were asked from the Religious Fund.³⁶ No less than 100 Rh fl were meant for the

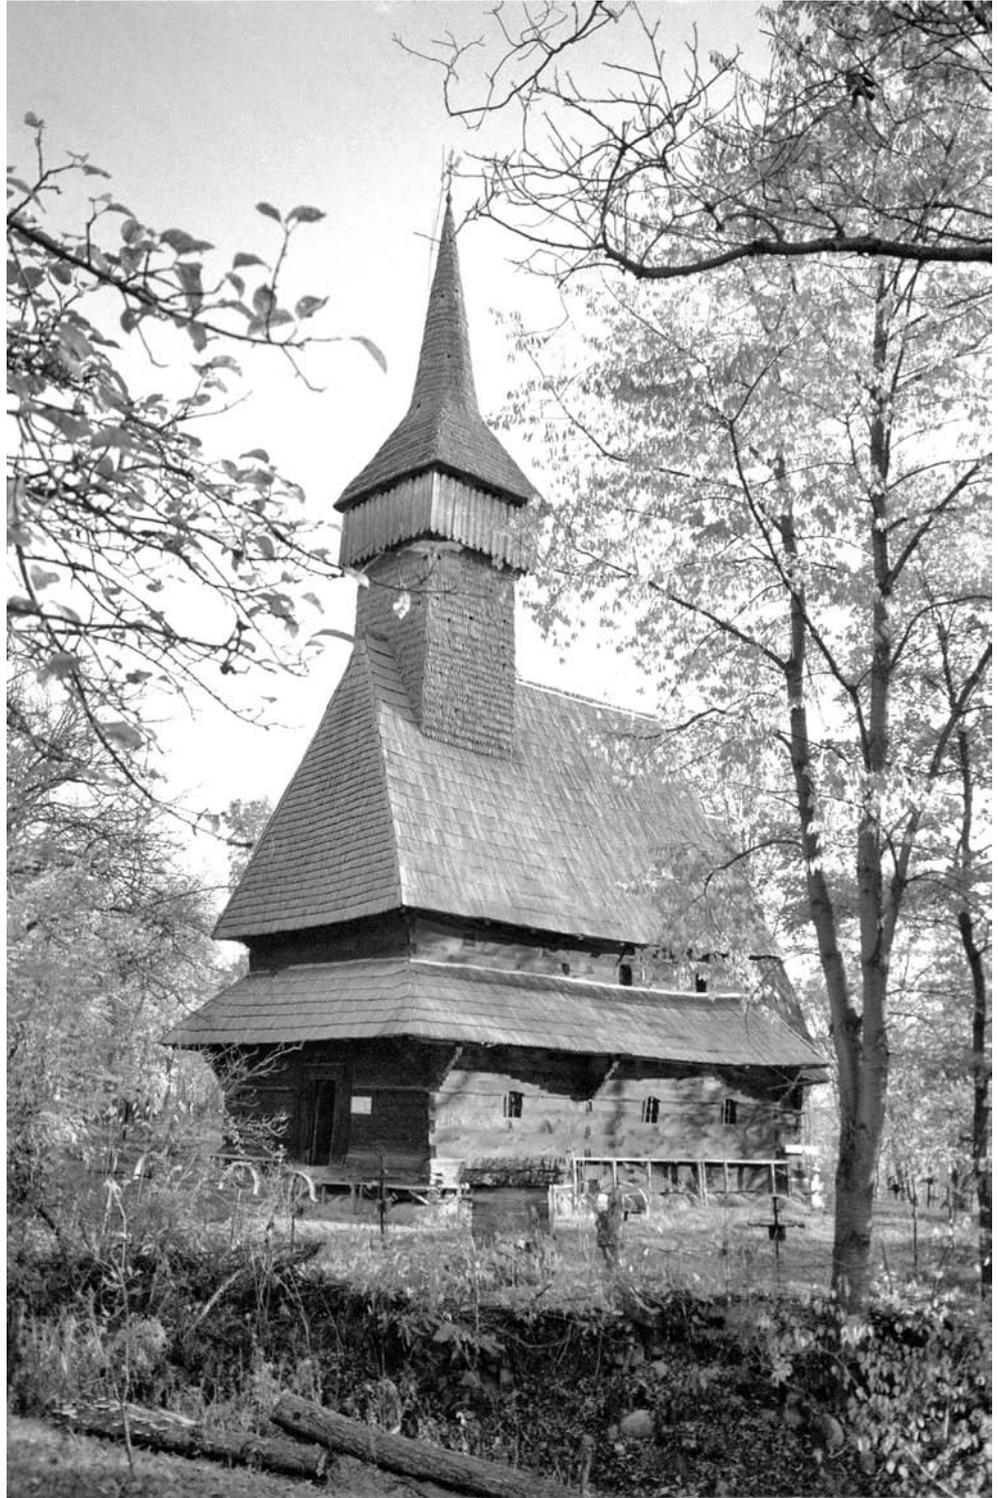
102 *Sârbi Susani*. Was the width of this church just coincidentally alike with that of at least 5 other churches or was it a clear size, easy to communicate and negotiate between carpenters and founders? What was the thought behind the identical room division both here and in Sat Şugătag? Photo: October 2000.

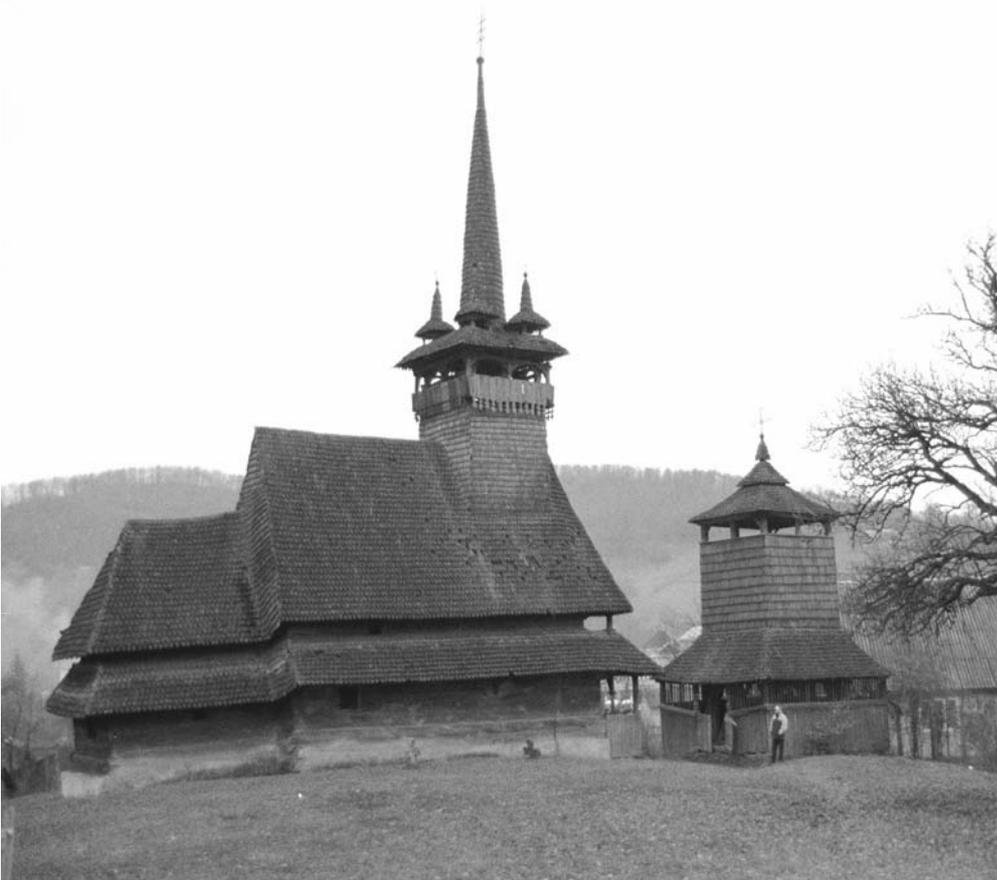
- a porch
- b women's church or narthex
- c men's church or nave
- d solea or the platform in front of the iconostasis
- e sanctuary

108 Oleksandrivka (Șăndrești). The particularities of this church are difficult to observe on the site and capture in pictures, unless careful measurements are preceded. There are few wooden churches with perfect oblong plans and right angle at the corners, but this church is especially warping at all sides, creating difficulties in reading the starting width and the way of planning. However, it appears quite clearly the intention to dimension equally the women's (b) and the men's churches (c). Photo from the north side (top) and scale drawing of the plan (bottom) from November 2002.

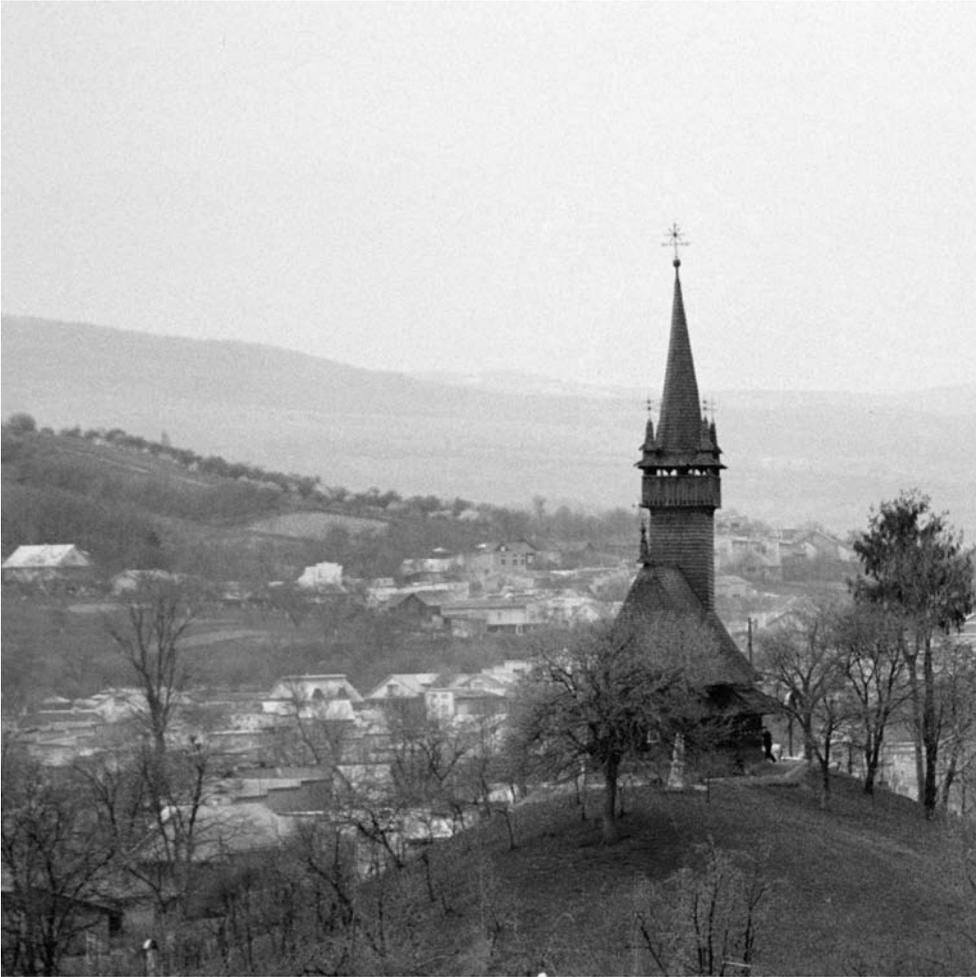
118 *Apşa din Jos (Dibrova)*. The church was beautifully sited on a hill naturally elongated towards the sunrise in the summer solstice. The Moholiţă Hill, from where the picture was taken, just a few hundred metres away, would have permitted a more flexible orientation, which was preferred by a part of the village. According to the local oral tradition the two sides competed one early morning for the future location by preparing the first logs on the heights. The winning location offers wide perspective over the surroundings and elevating experiences of the sunrise and sunset. Photo: April 2002.

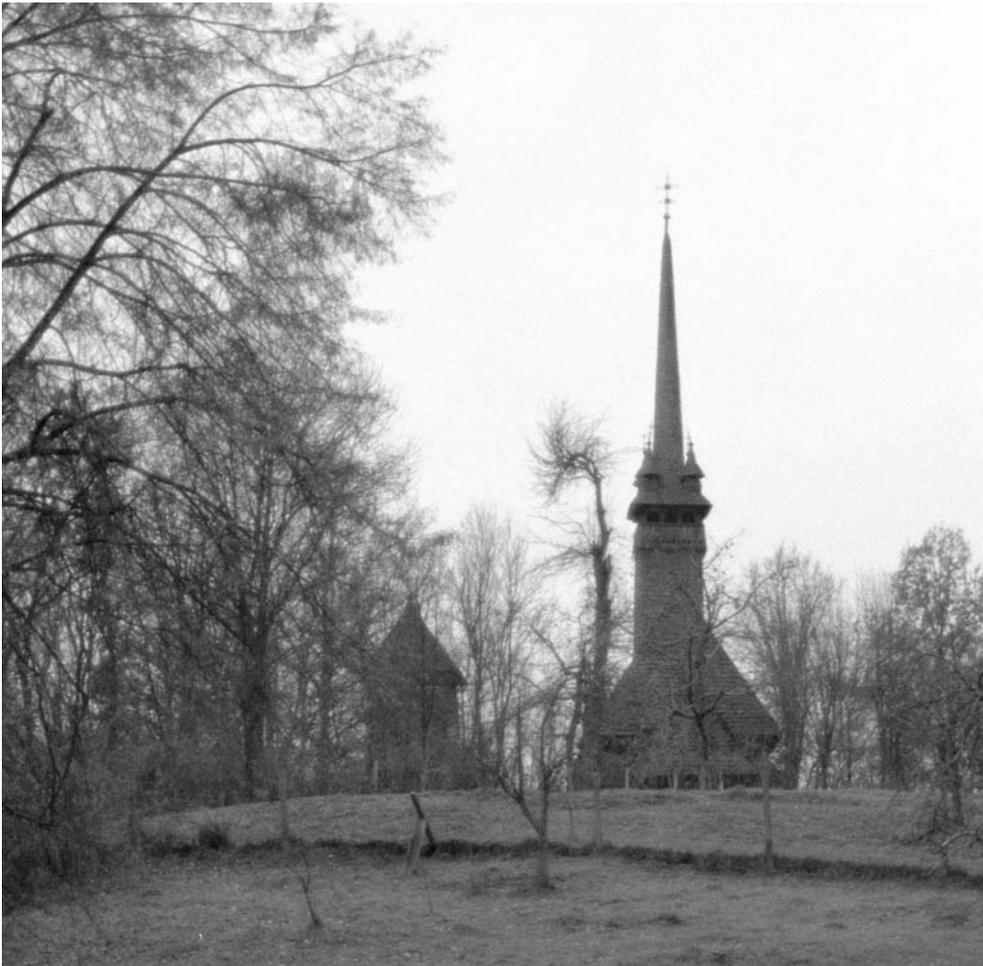
123 *Danylovo*. This wooden church retains its extremely pointed old tower and the side belfry for the large bells. Photo: November 2002.

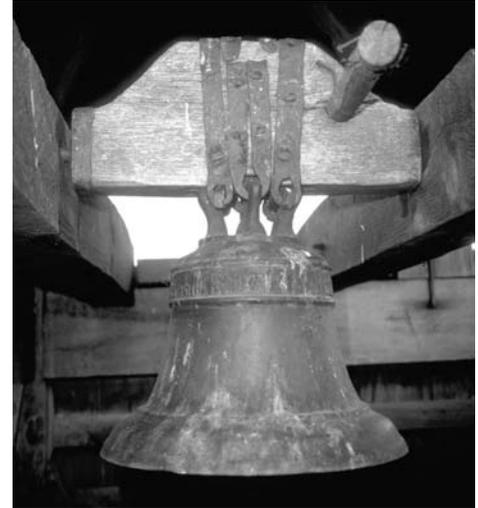
124 *Rona de Jos*. One of the oldest dated bells from Maramureş survived in this church since its consecration in 1637. Other old bells are preserved in the Reformed church of Hust, dated from 1587, in Vodytsia (Apşita) from 1618, in Călineşti Susani from 1656, Giuleşti from 1679 and so on. Photo from October 1997 and tracing of the inscription from April 2002.

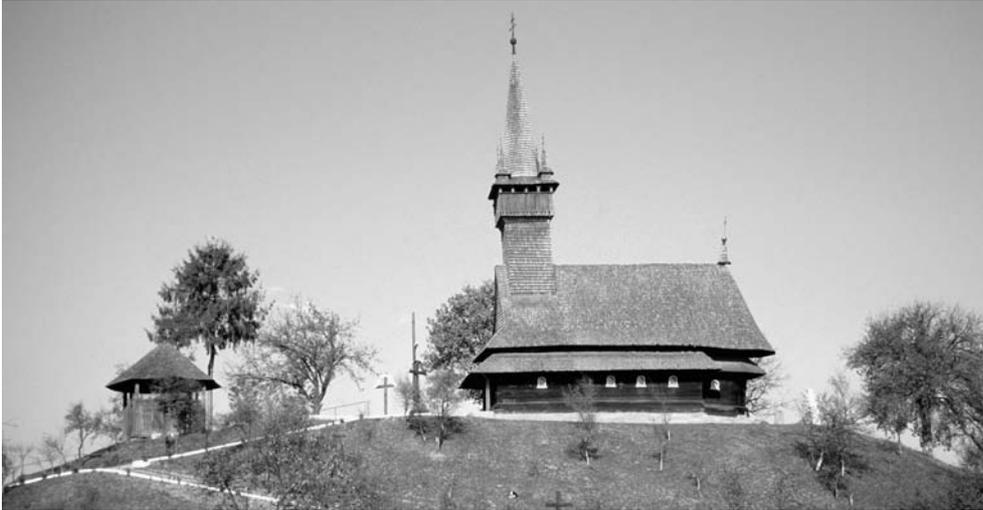
125 *Apșa din Jos*. The heavy bells were moved from the massive tower and housed in the lower but secure belfry in front of it. Photo: October 2000.

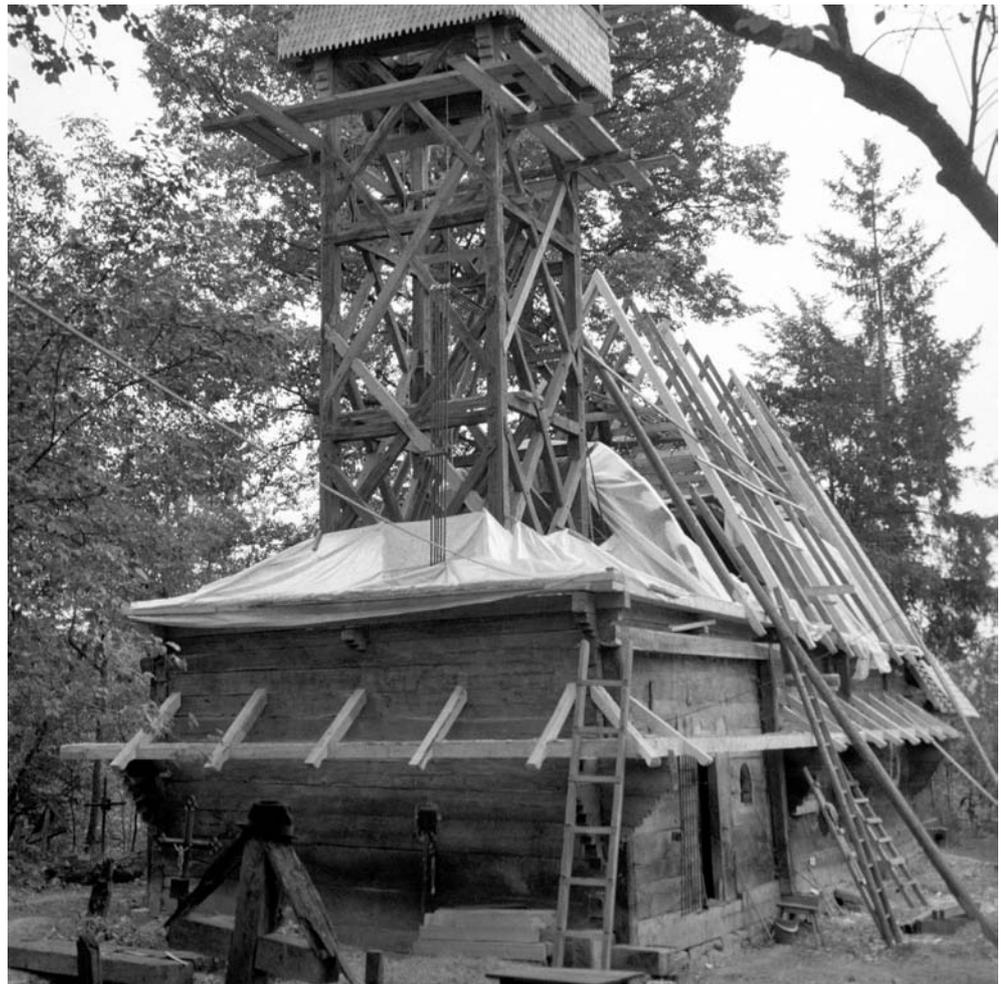
126 *Hărnicești*. The tower framing as well as the raftering were plainly exposed during the last repairs. Photo: August 1997.

A tower framing consisted of four main parts with well determined functions: the *base*, the *neck*, the *gallery* and the *spire*. The meetings between their timbers required a particular collection of joints, unlike those from the log building parts. They were designed to work as a single body and stand firm against all the inner strains caused by either the strong winds or the swings from the bells.

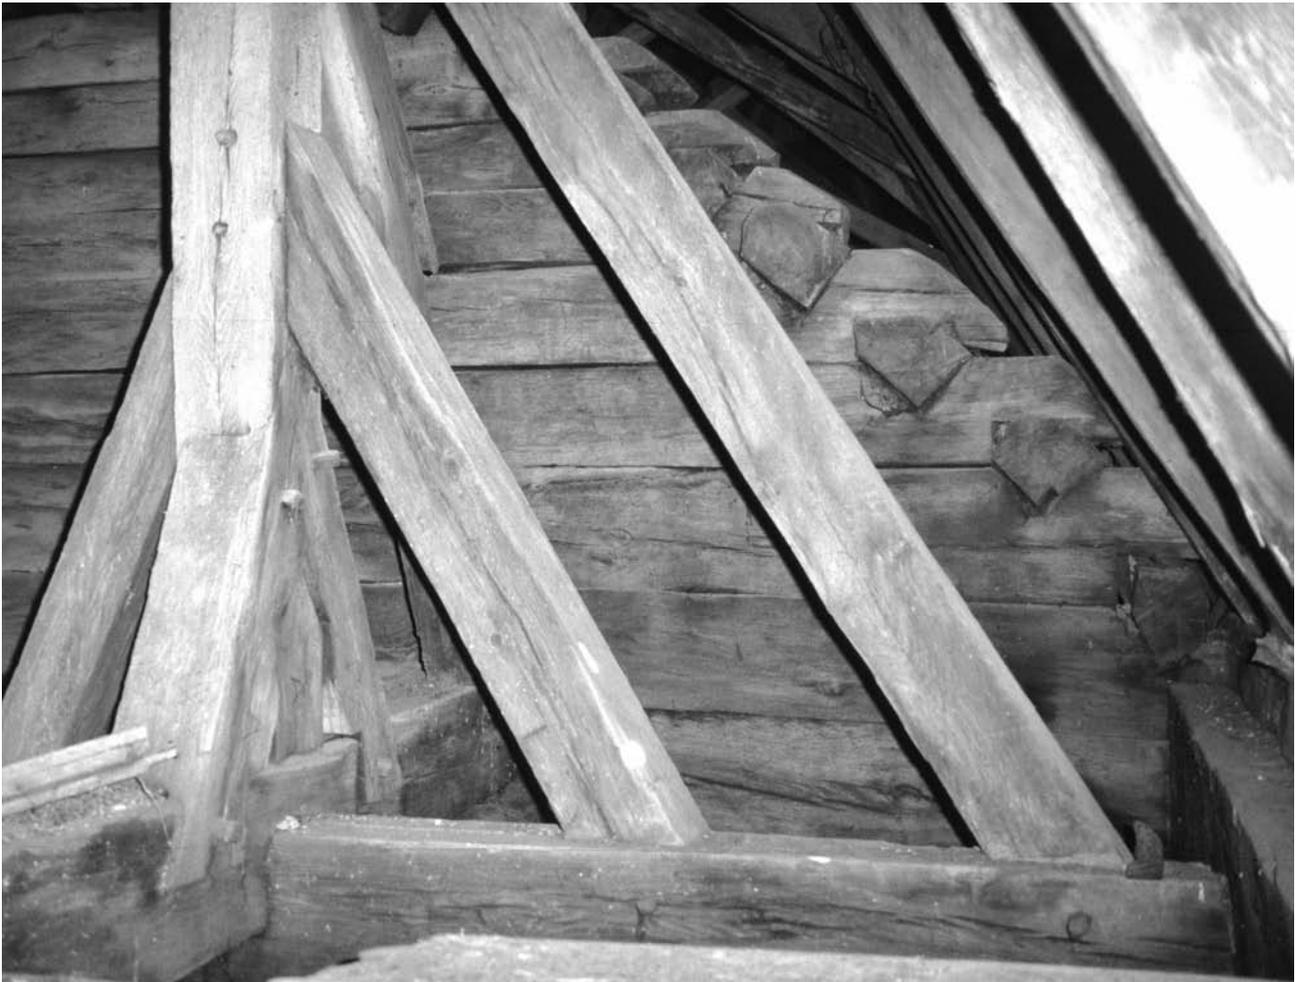
127 *Apșa din Jos*. The anchoring of the south-eastern upright in the massive transoms of the base. The transoms were interlocked with the lateral walls while the log fabric was still in construction assuring a stable connection between them. Photo: October 2000.

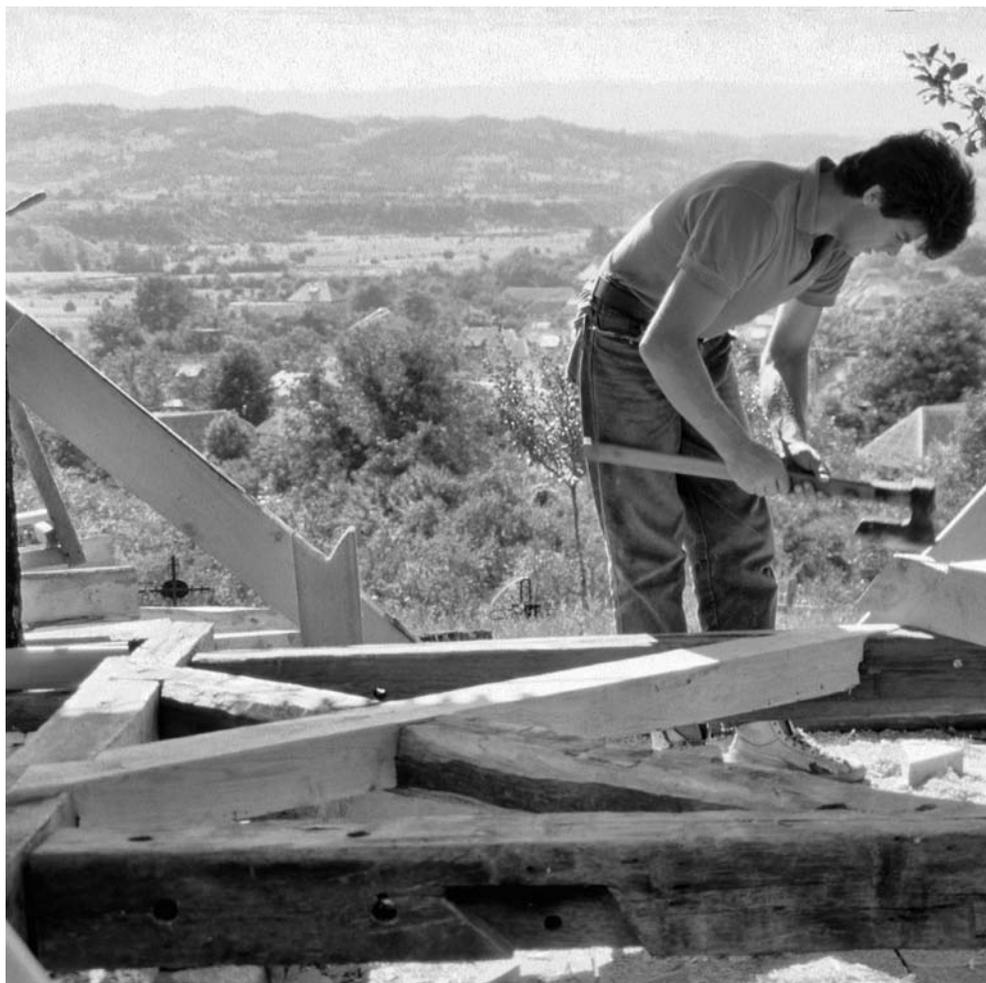
132 *Bârsana*. The work with a tower frame required a plane place where the pieces were cut and marked to be reassembled above the church. Here a carpenter cut a new cross brace for the tower of the former monastery church of Bârsana during the last repairs. Photo: July 1997.
