Tracing a Sacred Building Tradition

Wooden Churches, Carpenters and Founders in Maramureş until the turn of the 18th Century

by
Alexandru Baboş

**Department of Architectural History, School of Architecture
Lund Institute of Technology, Lund University, Sweden**

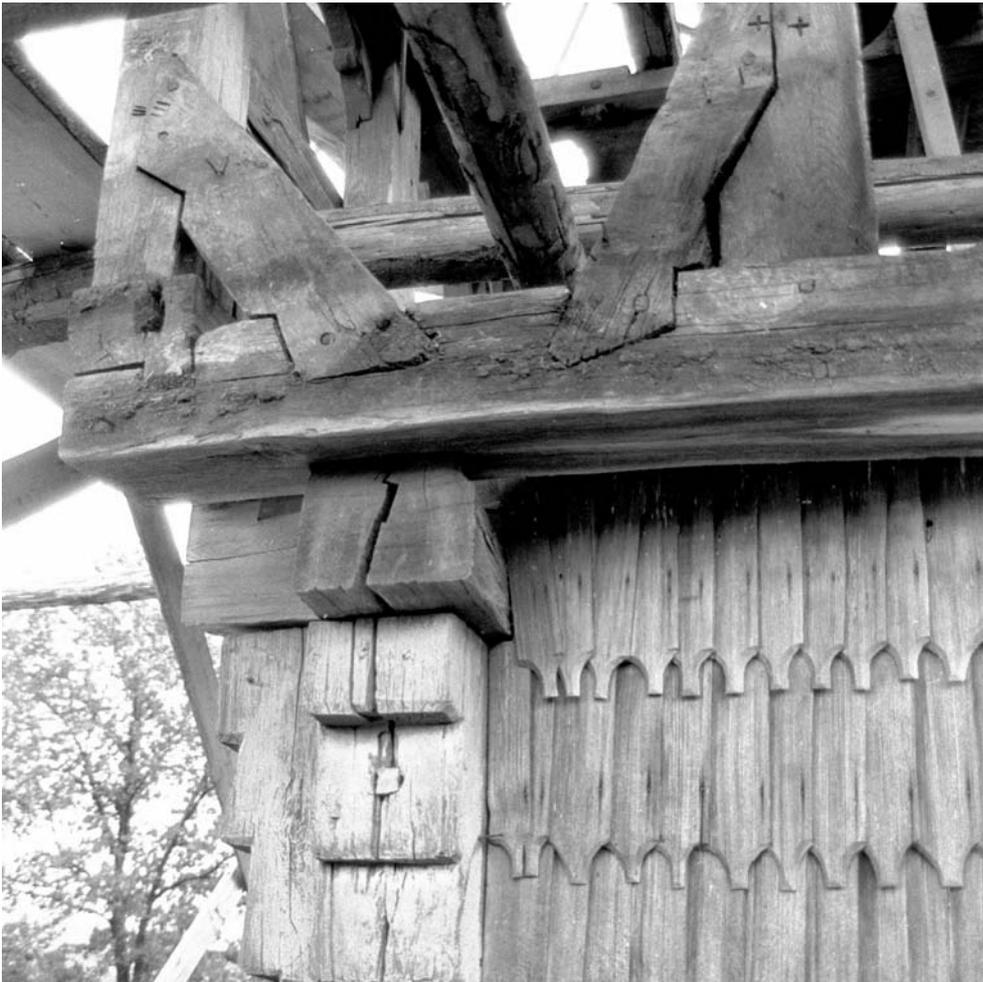
133 *Desești*. During the repairs from 1996, the hidden parts of the tower were exposed revealing numerous assembly marks of great variety. Here there can be observed the graphic signs “+” and “III” on both the gallery posts and their respective downward angle ties. Unfortunately, some of them were lost with the replacement of some original pieces and some due to the “cleaning” of the surface with an axe without any thought for their historical value. Photo: June 1996.

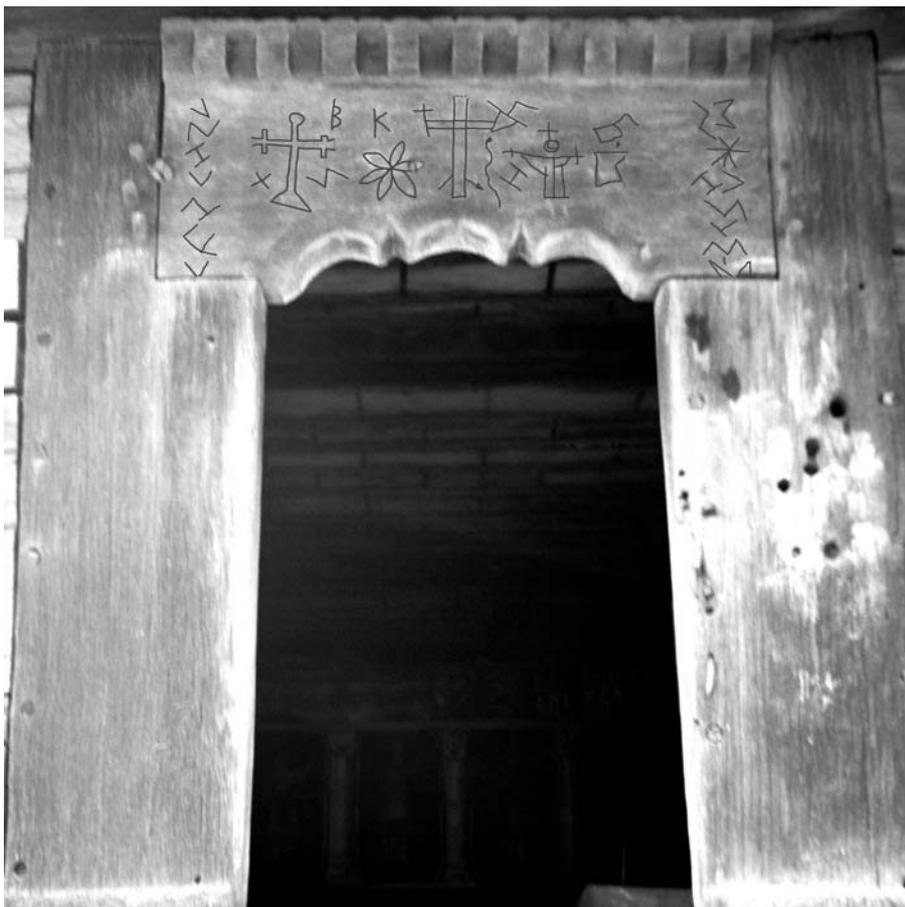
139 *Suciul de Sus*. The entrance retains only the lintel from the formal portal with the unusual writing. The wooden church stands since 1883 in Rogoz and is known as the Saint Paraskeva church. Photo: June 1993.

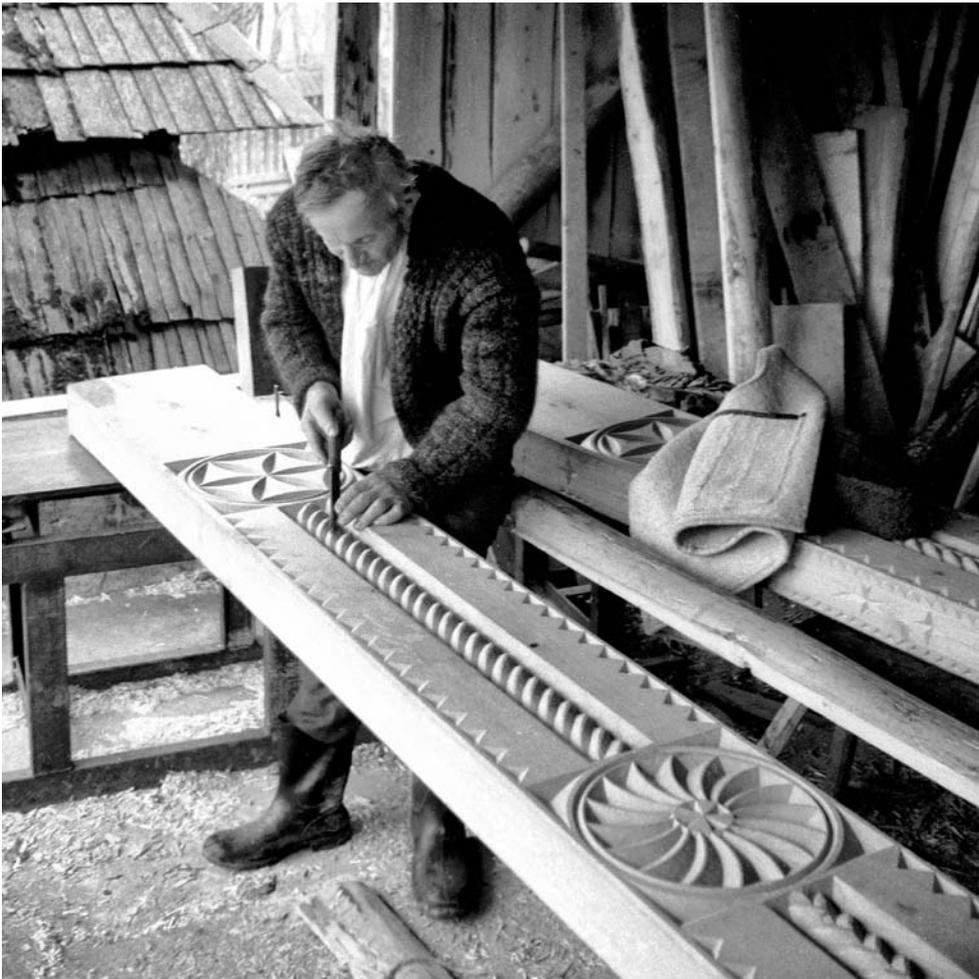
143 *Breb*. The portal of the new church from Breb was designed by the former parish priest Mircea Antal and cut by the local wood carver Pop Pătru Niții. Photo from his workshop: April 1994.

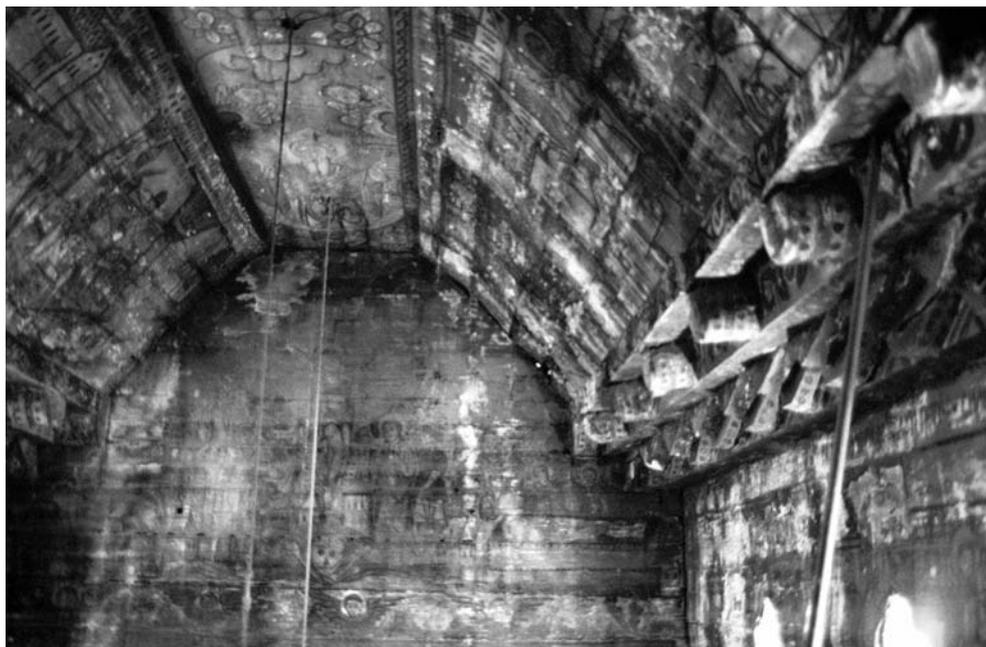
144 *Ieud Deal*. The austere appearance of this church is softened by the sculptural treatment of the inner consoles, a single but efficient decorative element, increasing the sense of depth in the nave. Photo: July 1997.

In addition to these, the spring of the vault, the median wall timbers around the church, the porch galleries, the consoles or the altar foot could offer the church carpenters alternative places to manifest their art. It is, though, important to notice that, in these places, the carpenter cut deep in the mass of the wood unveiling a rather three-dimensional attitude towards the ornament, unlike in the earlier ones.

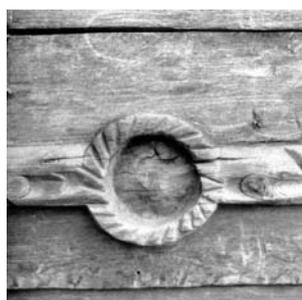
145 *Bârsana*. Medallion marking the moulding on the northern façade, carved from the wall beam. Photo: August 1997.

One of the most distinctive decorative features was the mouldings rope carved from the median wall timbers all around the church. This feature prided many of the churches from the Cosău district, a district where the oak forests provided excellent material for elaborated decorations. Although the oak forests continued downstream in the Tisa Valley the most accentuated decorations can be mainly found in the wooden churches from this small district.

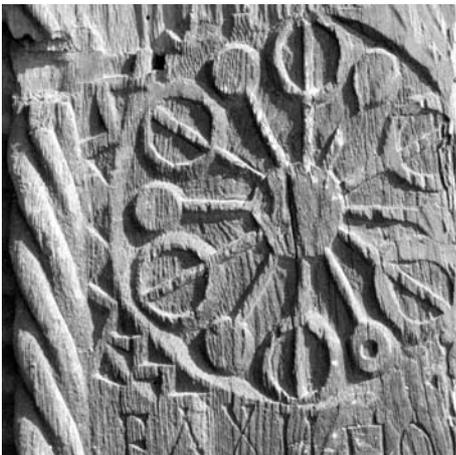
148 *Budeşti Josani*. Detail from the portal of the entrance. The rosette motive was cut in a bas-relief technique while the lateral moulding in relief from the same piece of jamb. Photo: June 1999.

for the most part made in a bas-relief technique, with figures slightly carved from the plain surface of the jambs and the lintel above (148). At a closer look we can sometimes discover the traces from the straight and curved working lines, testifying in details about the intricate geometry the carpenter imagined behind his elaborated designs. Following these traces on the entrance portal from Sârbi Susani (1639), for example, it is possible to learn about the carpenter's practical use of a compass, a square, a sharp iron tool and nevertheless a measuring device since the sizes of the figures don't appear to be accidental. If the focus is shifted from the figurative patterns to the small cuts, it is possible to find also traces from the carpenter's work with an axe, eventually a saw and evidently various chisels, mallets and knives. In some later portals, like in Călinești Susani (1784) and Steblivka (1797), the carpenters might have also used templates for the rich floral patterns and planes at the edges.

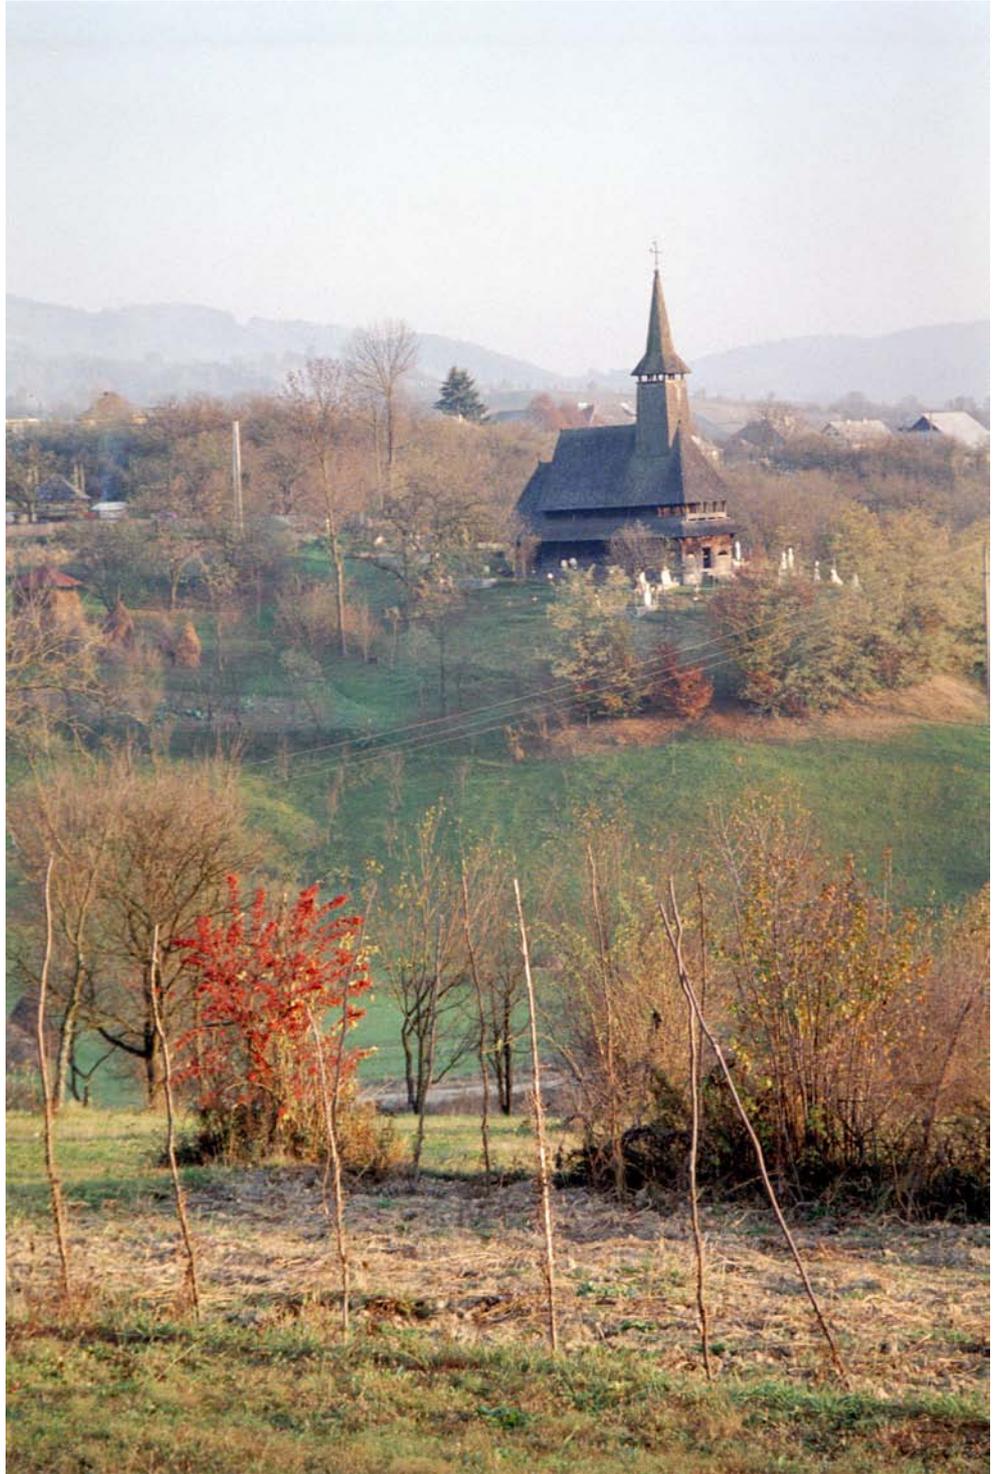
150 *Rona de Jos*. The wooden church from Rona de Jos distinguished itself in Southern Maramureş and was nicknamed the church “*with eyes*”. In fact it was built by a church carpenter from the Alch family school and it is closely related with the standing wooden churches around Hust, among which it is the oldest one. Photo from the Dolini Hill, where the logs were said to be felled, October 2000.

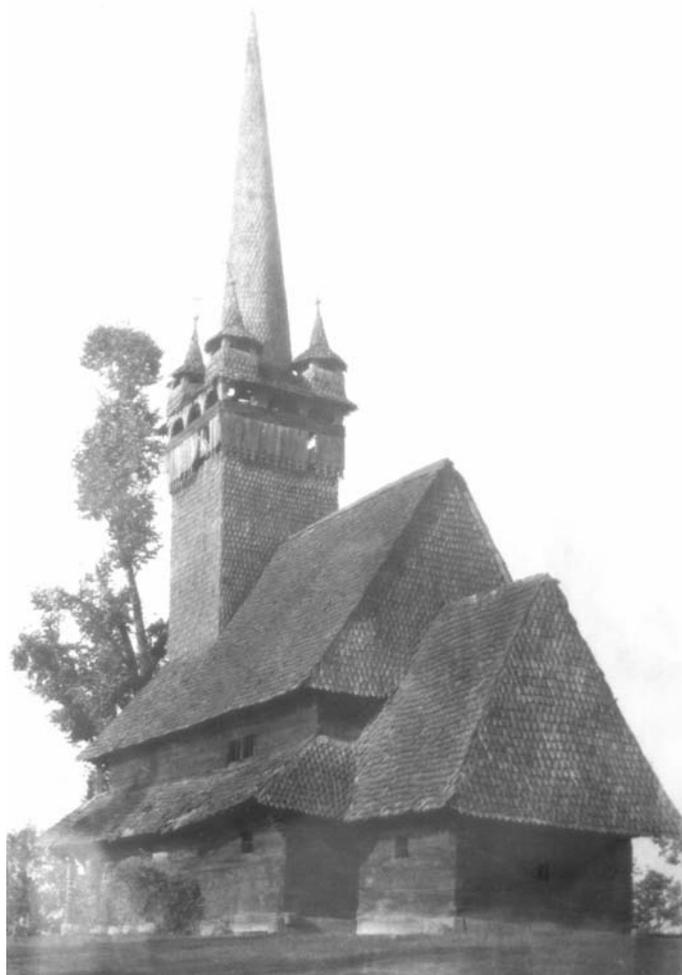
151 *Nyzhnie Selyshche (Săliște de Jos)*. The church was by all probabilities erected by the family of church carpenters *Alch* in their home parish in 1641. The picture was made before its transfer in 1936 to Blansko, Czech Republic, where it was enlarged to take in a Hussite congregation. Photo held inside the church.

Among all the wooden churches built by the church carpenters here or there, those built in their own parishes must have motivated them to perform at their very best. This appears to be the case in Nyzhnie Selyshche. Here, the parish wooden church was consecrated in “рок ВЖ АХНН МЦА ЮЛ КѠ”, i.e. 29 July 1641, according to the inscription from the second porch. Considering the technical standards, the spacious rooms and the ambitious elevation, this church was an excellent achievement.

The church was built with plain, straight walls and flush covert joints. The walls were pierced by a few windows of which the double one in between the eaves, with a frame around, should be especially noticed. Another typical detail is the rounded shape of the serrated consoles supporting the eaves purlins (154).

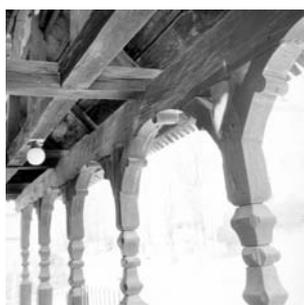
152 *Nyzhnie Selyshche*. If the western porch with a double gallery of posts is original it is the oldest known one of this type from Maramureș. Photo from Blansko, Czech Republic, April 1997.

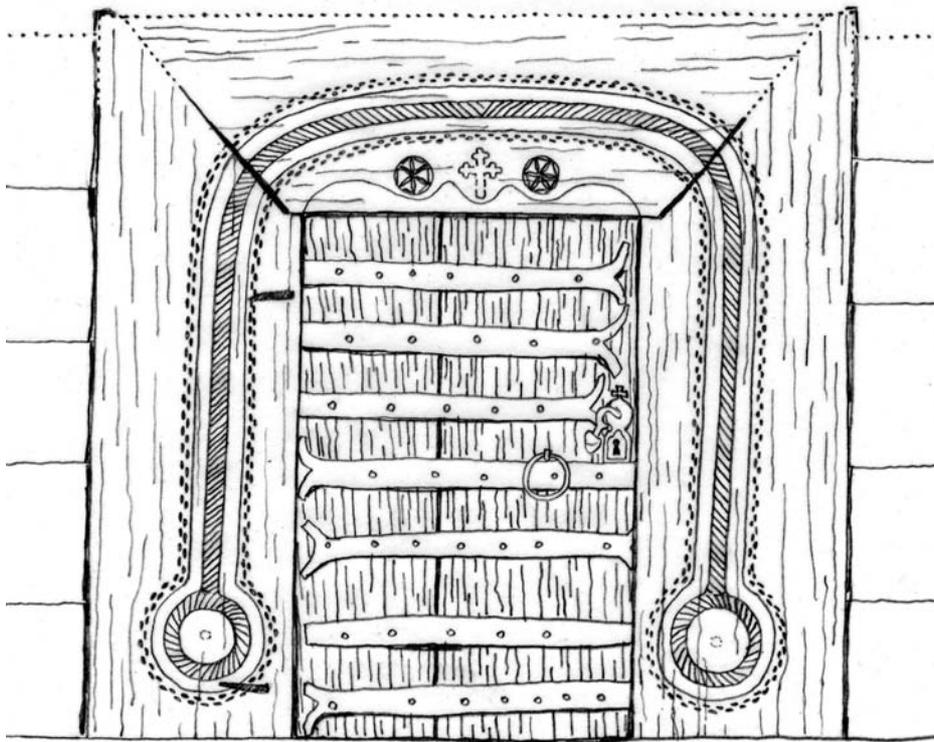
153 *Nyzhnie Selyshche*. The portal of the entrance after a photo from 1925 by Florian Zapletal (1982, 63). It is uncertain if it was removed or preserved after the transfer to Blansko. In the later case it maybe stands in the original place but covered by the fragments from the inner one with the inscription.

The entrance impresses through the portal's decoration and the massive ironwork on the leaf of the door. Despite the low quality of the old pictures we can still observe the massive portal, where the lintel was mounted flaring upwards (**153**). Its decoration is also distinguishable and it basically presents a moulding rope (carved deep from the surface) that goes round the aperture and ends on both lower sides in a circle. All around this moulding seems to have been cut a pattern resembling drops of rain. Reading the rope as a snake binding together and surrounding two moon discs and adding the presence of the water, these elements build an iconography seeking fertility. Another symbolically important part was concentrated above the aperture, where a slightly carved accolade underlines a cross in the middle and two small rosettes at sides. Some rosettes were cut on the second portal, too, and there the small oval drops of rain are more visible.⁹⁹

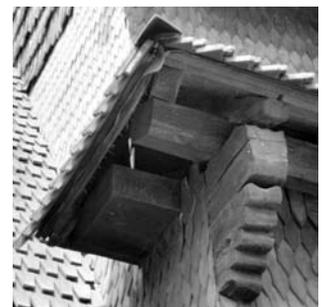
154 *Nyzhnie Selyshche*. The serrated consoles with slightly rounded edges were specific for the oldest churches of this itinerary. Photo from Blansko, Czech Republic: April 1997.

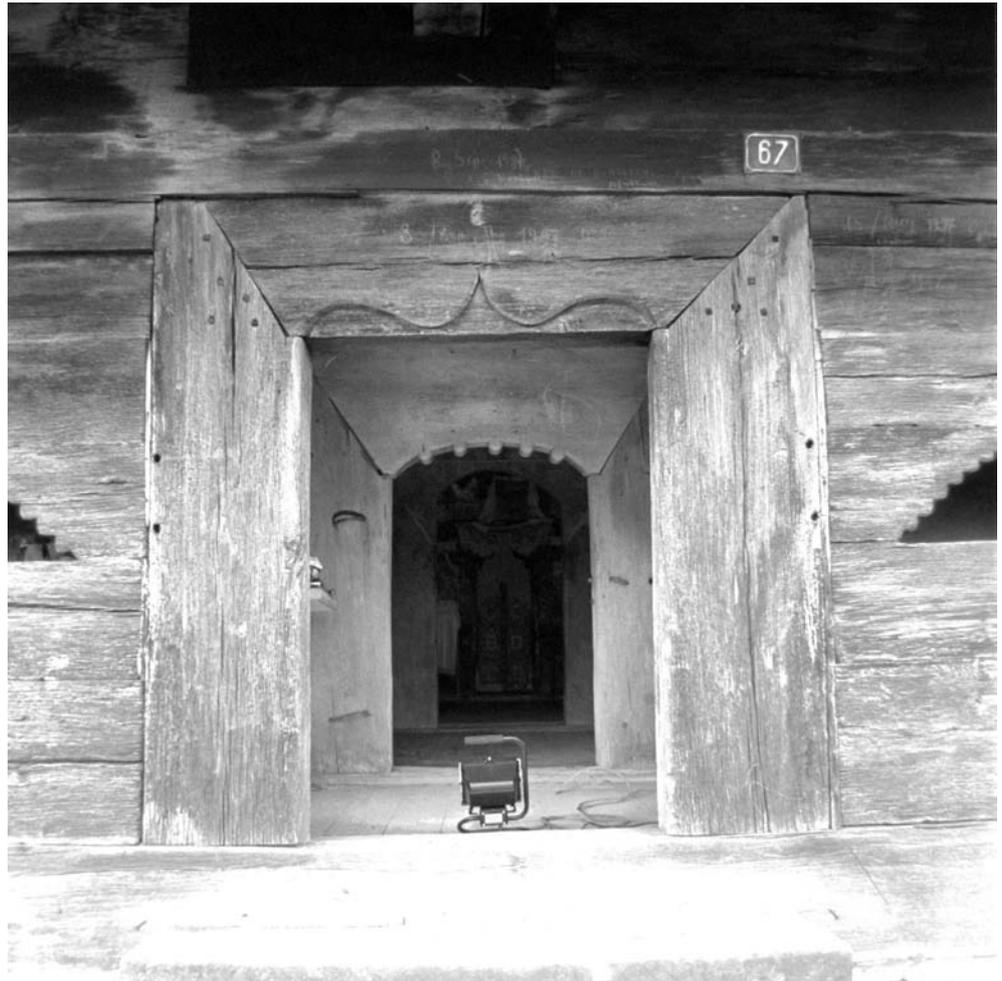
155 *Rona de Jos*. Due to the addition of a walled antechurch the access became accentuated by a succession of three massive portals. Photo: October 2000.

The three successive entrance portals are more or less preserved in both churches (155). Curiously enough, the second portal from Rona de Jos was not adorned, and thus the most important mark of the church carpenter is missing. The aperture is, though, arched and the underside of the lintel indented with 5 round cuts resembling pearls on a necklace. In Sokyrnytsia, instead, the second portal, of the entrance in the proper church, is richly adorned, displaying an original composition of a mature church carpenter (158). The aperture here is also arched but the cuts in the underside of the lintel suggest the indented pearls were roughly removed. The single detail at the entrance that still reminds of the church from Rona de Jos is the joining system of the jambs with the lintel above.

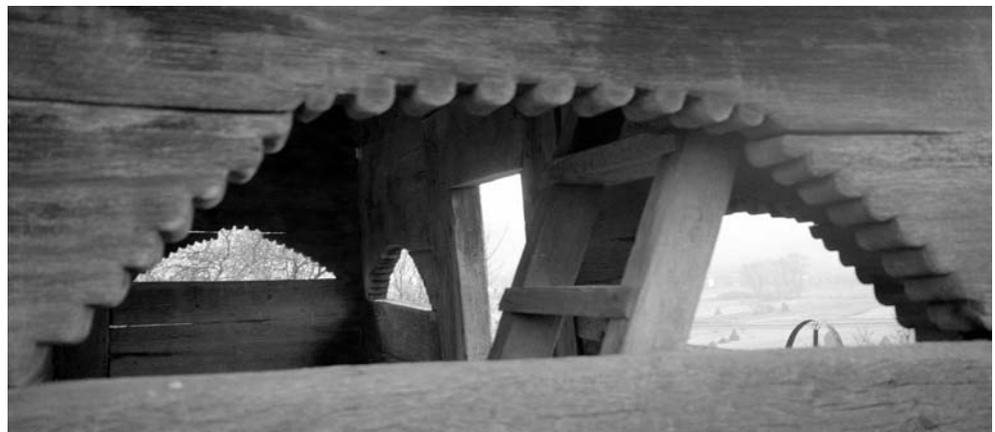
156 *Rona de Jos*. The "eyes" of the antechurch. Photo: October 2000.

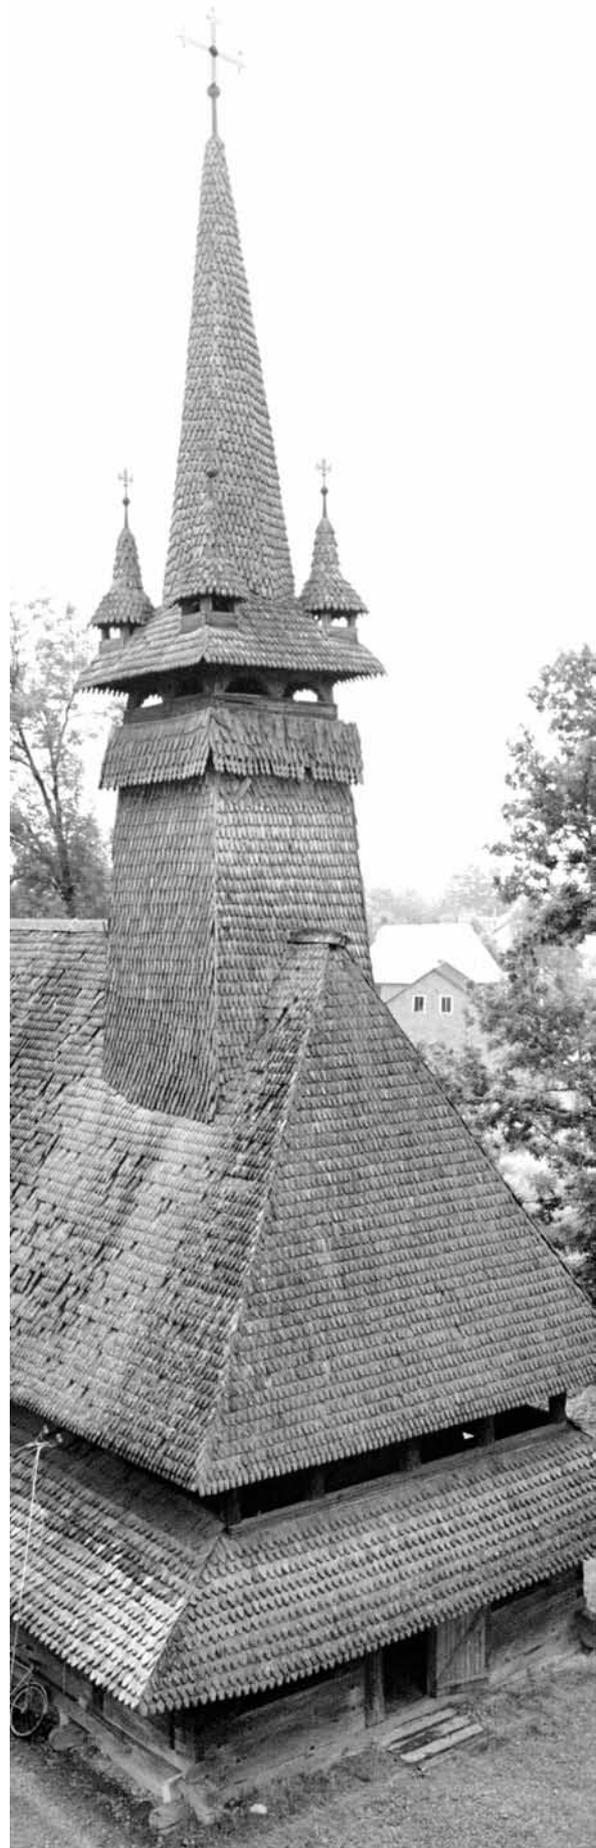
160 *Sokyrnytsia*. The tower was anchored over both the structure of the narthex and porch beneath. Photo: July 1998.

Both the middle church from Rona and the large one from Sokyrnytsia unveil a confident and experienced master carpenter. It seems to me that he strived to achieve as fine plane walls and flush corners as he could to underline the status of the building as a whole. The joints were laboriously thought leaving no significant maintenance problems afterwards. The resistance of the log structure from Sokyrnytsia was proved once by a lifting, maybe during the replacement of the sills in 1747, an event from which the numerous holes in the wall timbers all around the building originate. The parishioners and the carpenters involved were probably confident in its resistance and therefore secured it with pillars and wooden nails instead of taking it into pieces. The wooden nails were thereafter cut plane with the wall remaining discernible, but the church was safe. The advanced state of decay that presently marks the church from Sokyrnytsia is mainly caused by the lack of maintenance of the roof covering during the last decades (160). Hopefully, the church will be saved for the next generations.

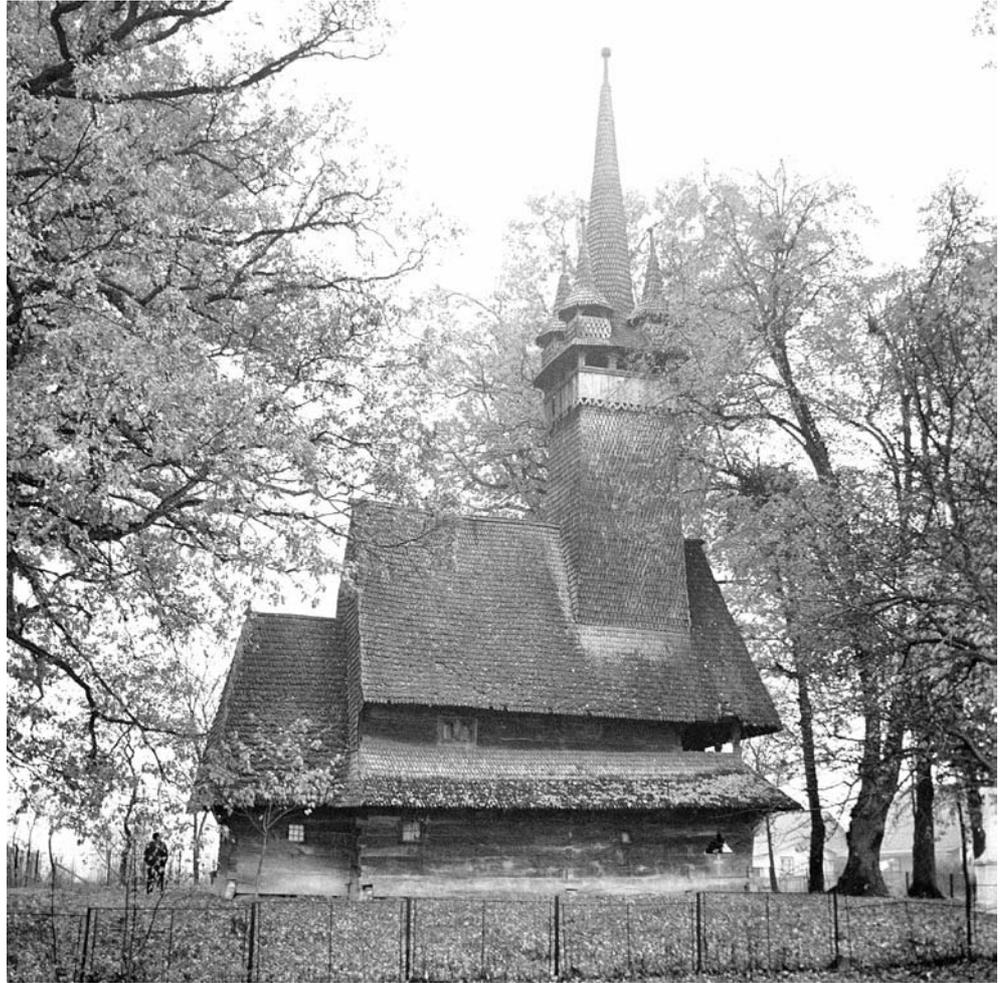
161 *Krainykovo*. The last standing wooden church in Maramureș built by the church carpenter Marko Alch. Photo of the northern side: October 2000.

The first known in this new series of churches was the parish church from the village of *Krainykovo* (**161-163**), only 10 km over the hills from *Selyshche*. This construction was dated by an inscription on the first portal, of the entrance to the antechurch: "рок Божъ НХЗС мца юлиа 21 суча НХЗи". If we read the text appropriately it firstly records the date of 16 July 1666, when the works probably started, and secondly states that the construction was finished sometime in 1668. In the case my interpretation of the text is correct; we have the first record of how long it took a church carpenter to fabricate a middle church like this.

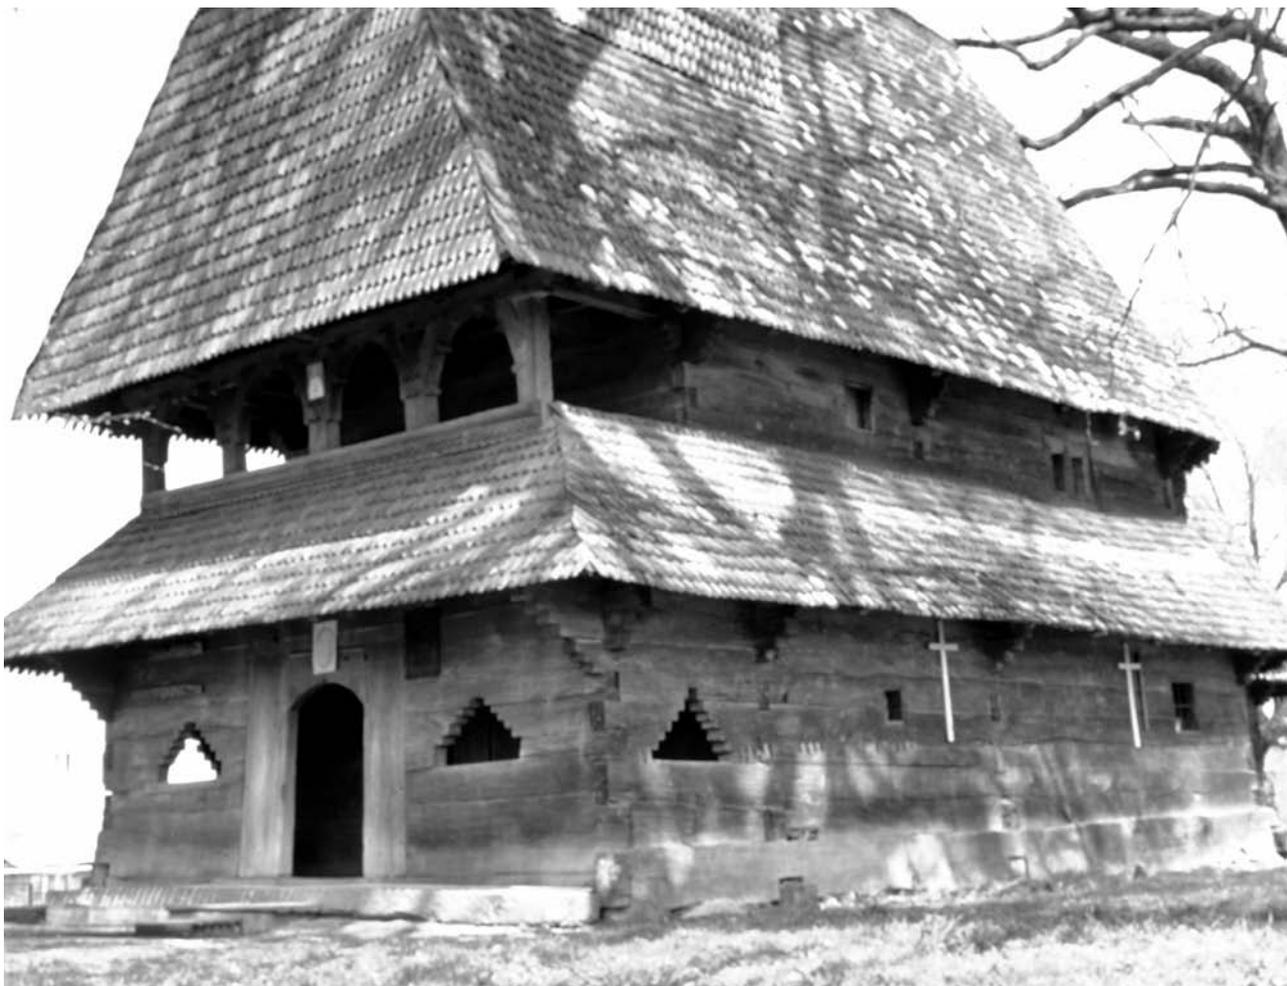
162 *Krainykovo*. In comparison to the earlier churches with eyes the antechurch was built here from the same wall beams as the rest of the church. Photo: April 2002.

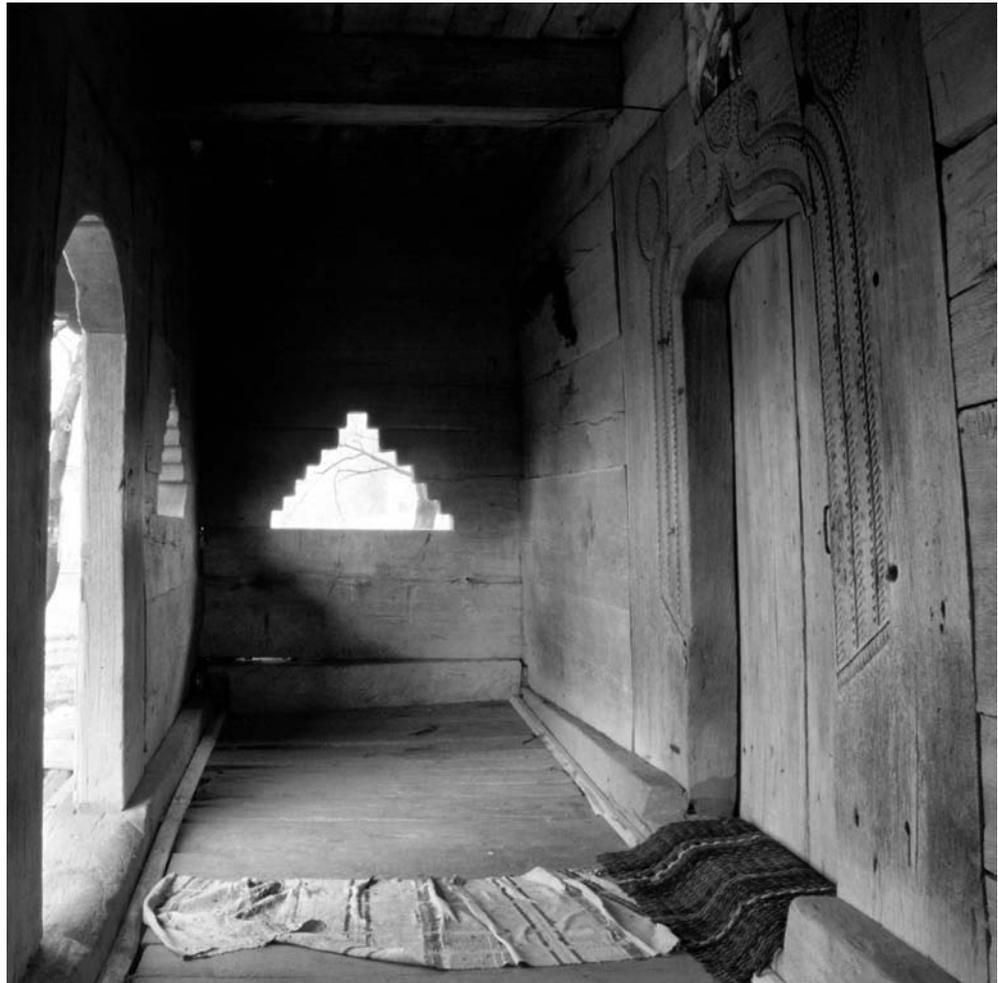
163 *Krainykovo*. View inside the narrow antechurch. Photo: April 2002.

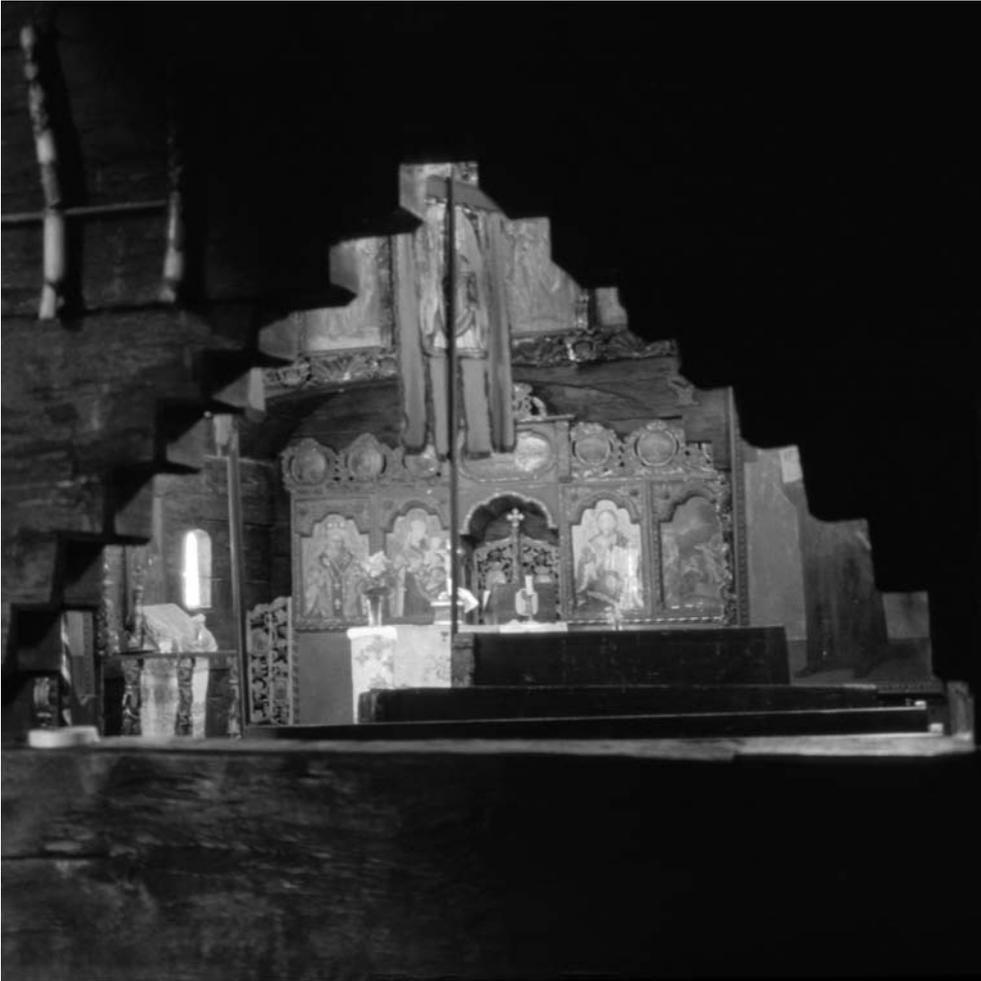
164 *Velyka Kopania*. An inner “eye”, in the wall between women and men. Photo: April 1997.

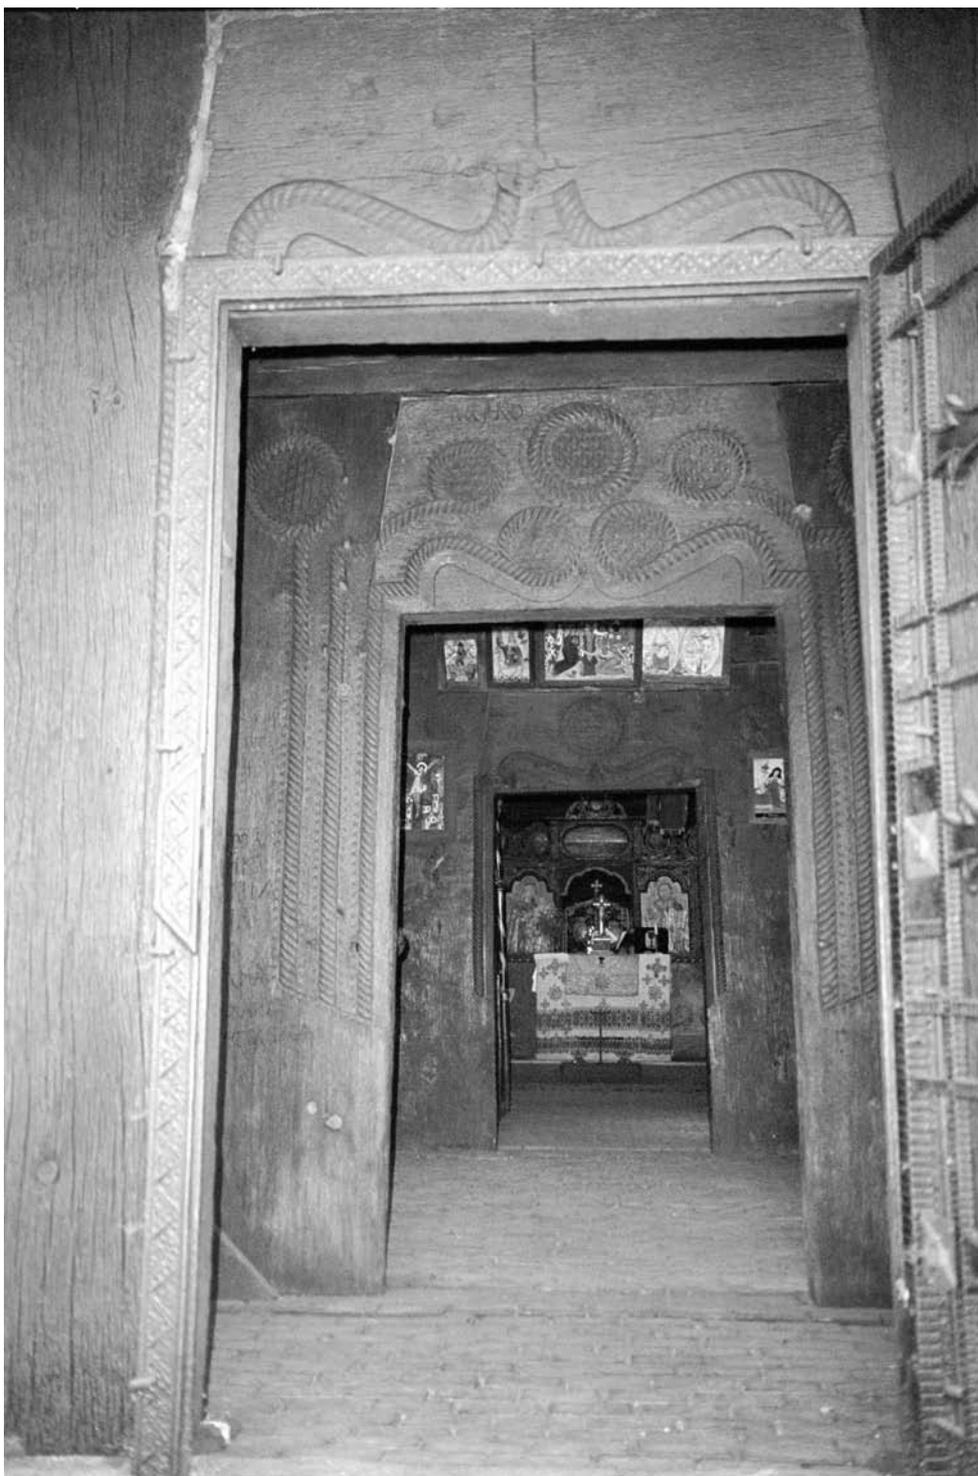
166 *Velyka Kopania*. The succession of portals marking the passages to the sacred room. Photo: April 1997.

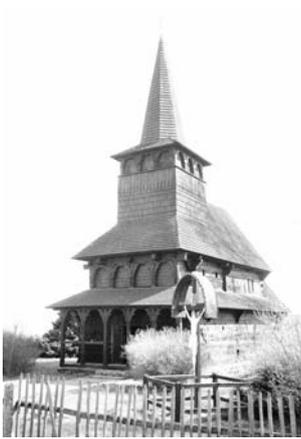
167 *Velyka Kopania*. The church stands since 1930 in Dobřkov, Czech Republic. The lower porch of posts is a later addition. Photo: April 1997.

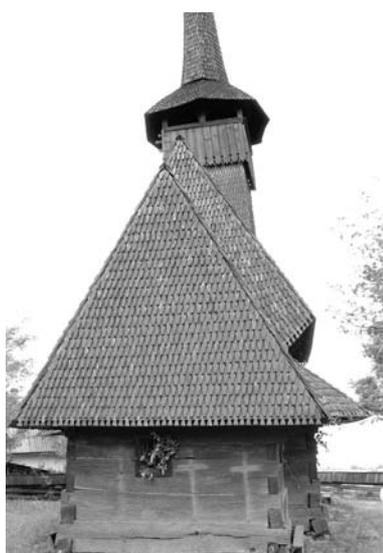
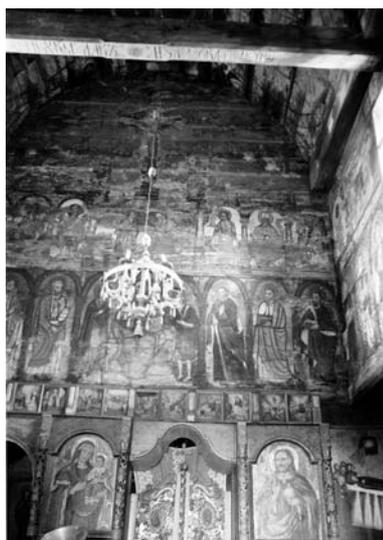
169 Novoselytsia, Ugocea County. The small church does not reveal outside what a lofty nave was hidden inside. Photos: July 1994.

The church from Novoselytsia (**169**) was built in a remote corner of the Ugocea County, under the forested heights at the border with Maramureş. From the very beginning we remark the small scale and the lack of an antechurch. This church was planned with a narrow start width, of 472 cm, to receive up to 155 worshipers. In the main, it is a modest house of worship retaining some ancient features. The narrow rooms allowed only two doors to the sanctuary and therefore the master carpenter decided to shift the eastern window from the axe to correspond with the royal doors and the altar table inside. Because the community lacked resources to buy iron, the entrance door was hung in wooden hinges and the crosses above the roof were made of wood. Despite these poor proportions and details, the vault was strongly elevated inside and the tower accentuated outside. The only adornment we can identify is the design of the portal (**170**), which almost entirely copied the model elaborated in Velyka Kopania. An interesting detail in its composition is the small cross cut just above the entrance in between the sun rosette and the sunflowers bowing under it, combining both signs representing the Christ. In this way, master Marko concentrated in one portal the signs from all three portals in the previous two churches. Unlike the earlier portals the aperture was kept very low reminding the proportions of the oldest entrances, as the predecessors of Marko designed in Sokyrnytsia and Nyzhnie Selyshche.

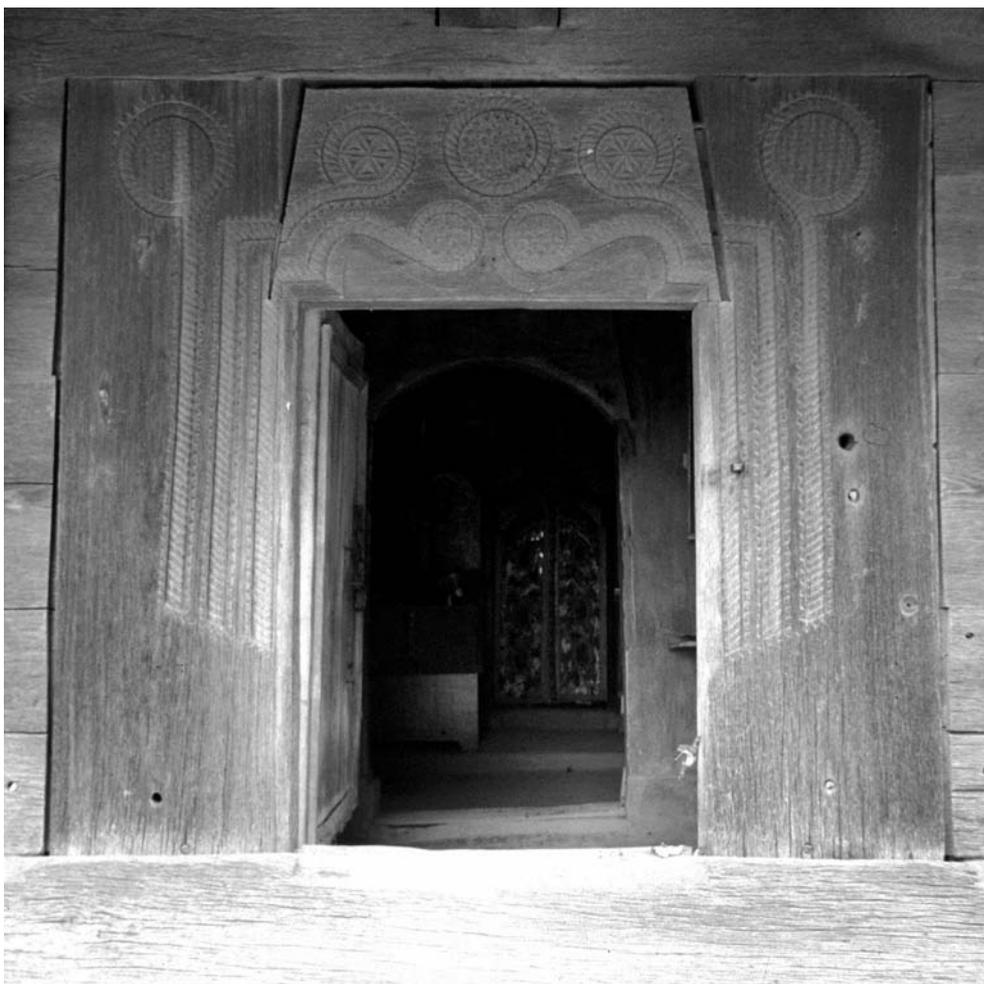
170 *Novoselytsia, Ugocea County.* The portal of the entrance and details from the upper part. Photo from July 1994 and tracing from April 2002.

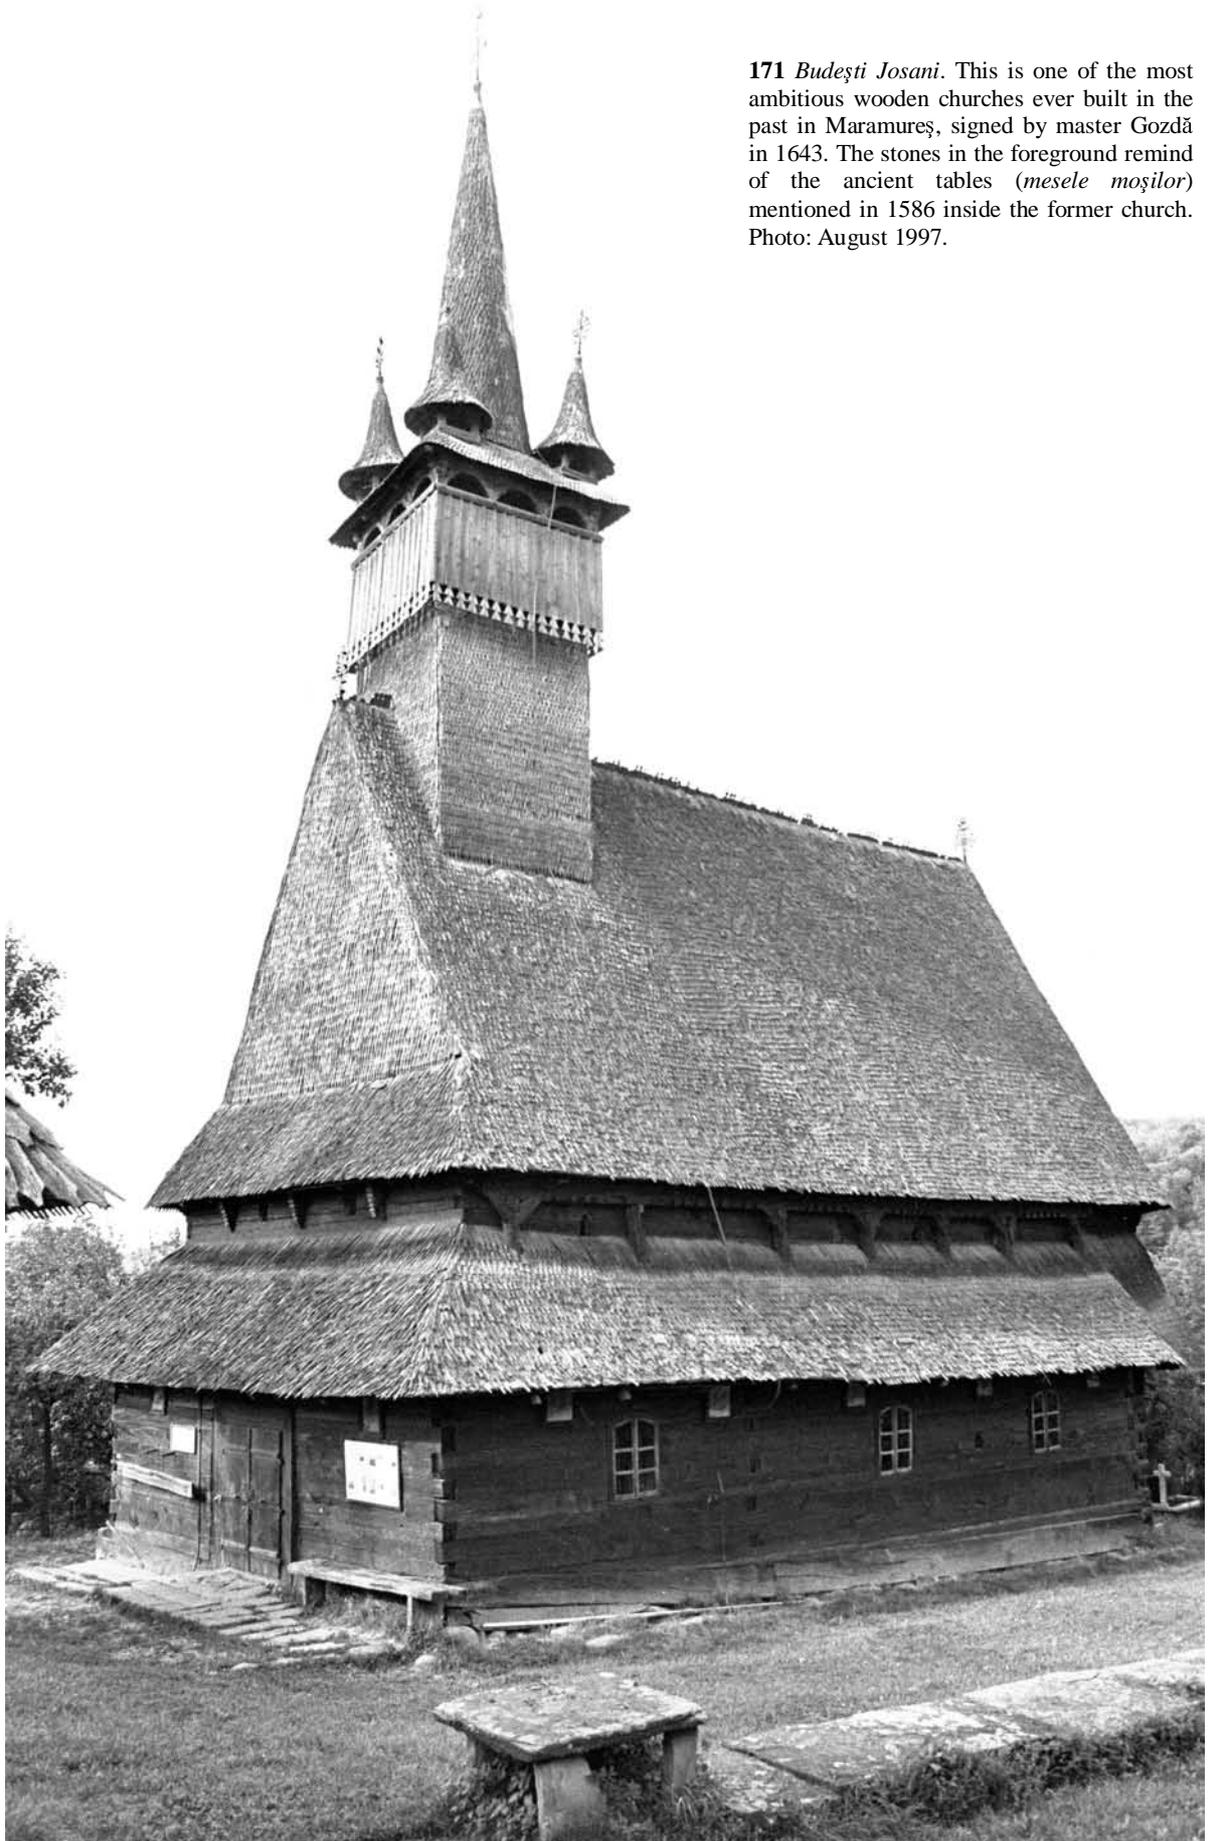
171 Budești Josani. This is one of the most ambitious wooden churches ever built in the past in Maramureș, signed by master Gozdă in 1643. The stones in the foreground remind of the ancient tables (*mesele moșilor*) mentioned in 1586 inside the former church. Photo: August 1997.

not wanted bells for a tower, iron for the hinges of the doors, carved stones for the altar table or glasses for the windows. Whatever was the situation, the carpenter had to solve the shortage of resources in a very traditional way, replacing the missing materials with pieces of wood. These could have been the reasons why the church from Sârbi Susani retains the most ancient features in the local architecture. Although he was limited in his work by the poor resources of his customers, the master carpenter succeeded to impress them and the communities around in such a degree that he was soon engaged to build the ambitious church in the neighbouring parish of Budești Josani (91- 92, 171 and 177-179), only 3 km away.

Indeed, it was this refined church carpenter who became responsible for the largest known wooden church built in Maramureș in the past. This time he had to respond to the high ambitions and expectations of some wealthier noble founders with a fine technical competence and courage. With the same technique as in Sârbi Susani he built up a sacred room at the limits of the local model of church. We can remark the same massive wall timbers, the same flush joints with covert cogs and especially the same positioning for the eaves purlins outside the wall, unloading the roof on the cantilevered consoles of the last wall timbers. I suppose it was the church carpenter who was bound to this later detail, and we already noticed that it led to serious later concerns. Despite this overlook, the result was at the level of the expectations, the very large construction signalling far around and ever since then the pride of the founders and the high technical performance of the local church carpenters.
