Tracing a Sacred Building Tradition

Wooden Churches, Carpenters and Founders in Maramureş until the turn of the 18th Century

by
Alexandru Baboş

**Department of Architectural History, School of Architecture
Lund Institute of Technology, Lund University, Sweden**

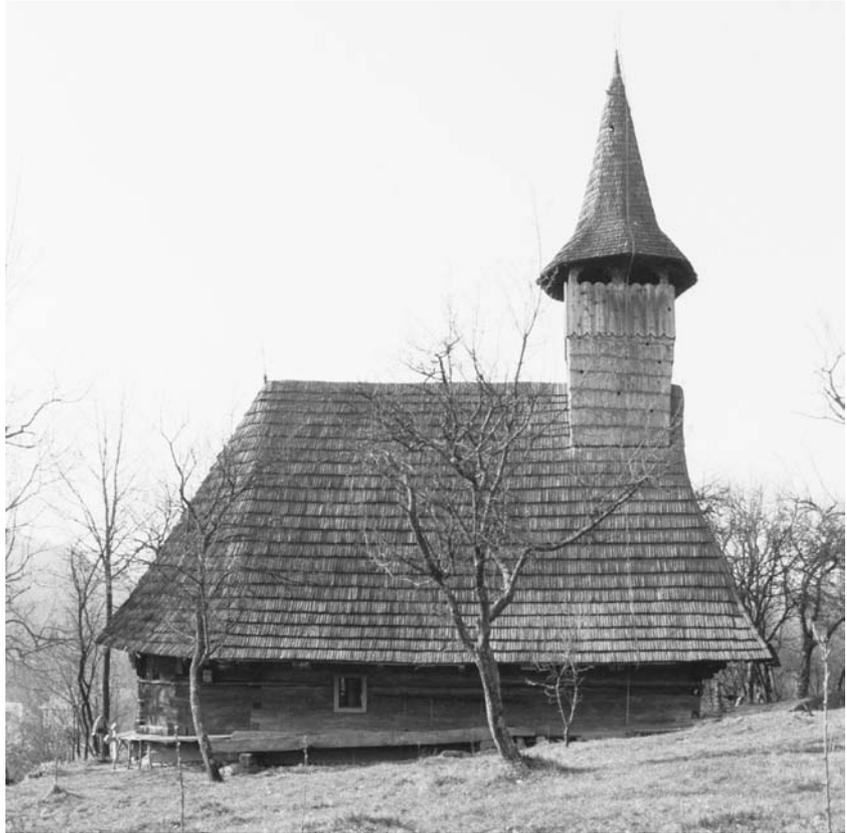
174 *Sârbi Susani*. View of the northern façade with the ancestor's table laid along the sill protected by the eaves. Photo: April 1995.

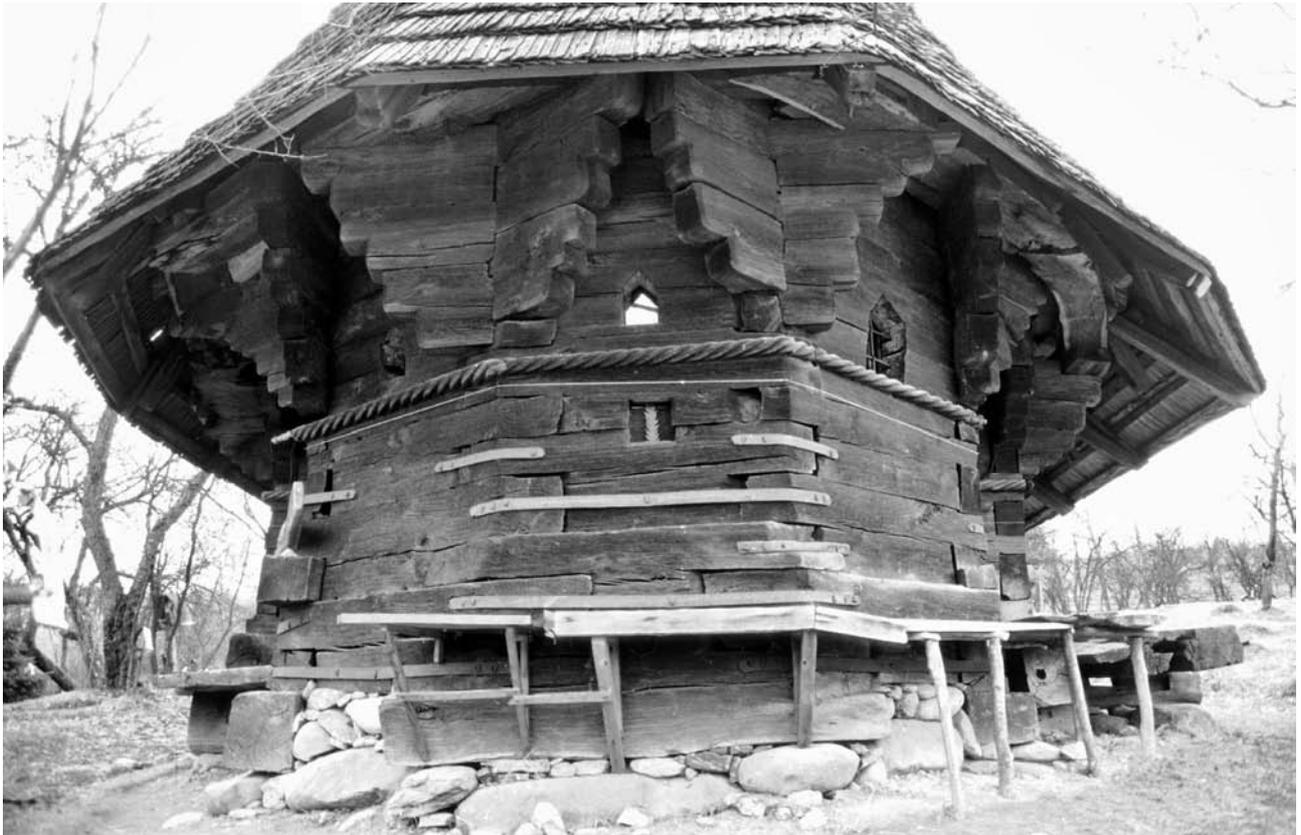
175 *Sârbi Susani*. The rear of the sanctuary with the joyful play of consoles under the eaves. The only original window seems to have been the square one below the moulding rope. The rope appears to have separated the earthly world from the heavenly one. Photo: Spring 1995.

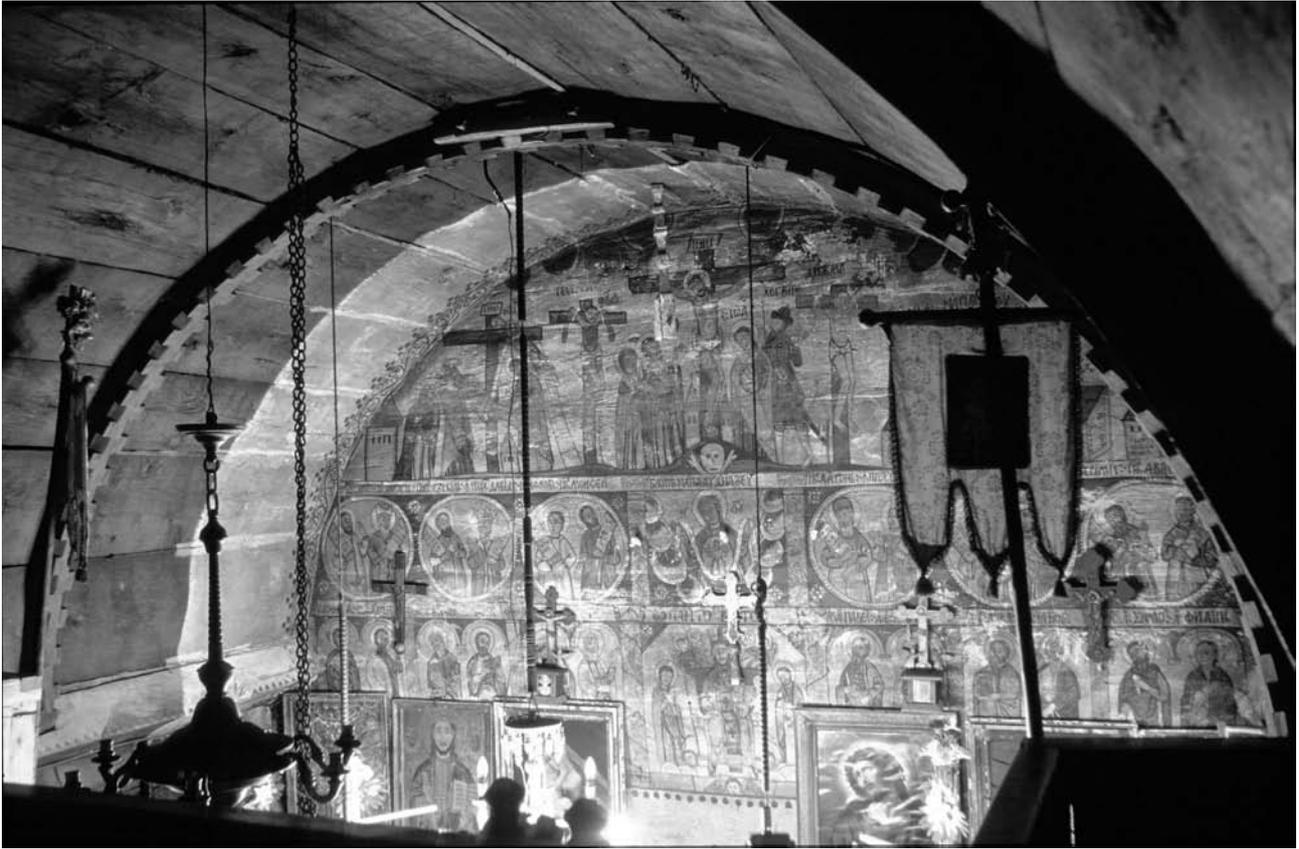
176 *Sârbi Susani*. The interior is dominated by the beautiful vault that closely follows the shape of an arch of a circle and the filigree decorations on the ribs and consoles. The eastern gable above the doors to the sanctuary was painted in 1760 by the local mural painter Alexandru Ponehalski. Photo: Spring 1995.

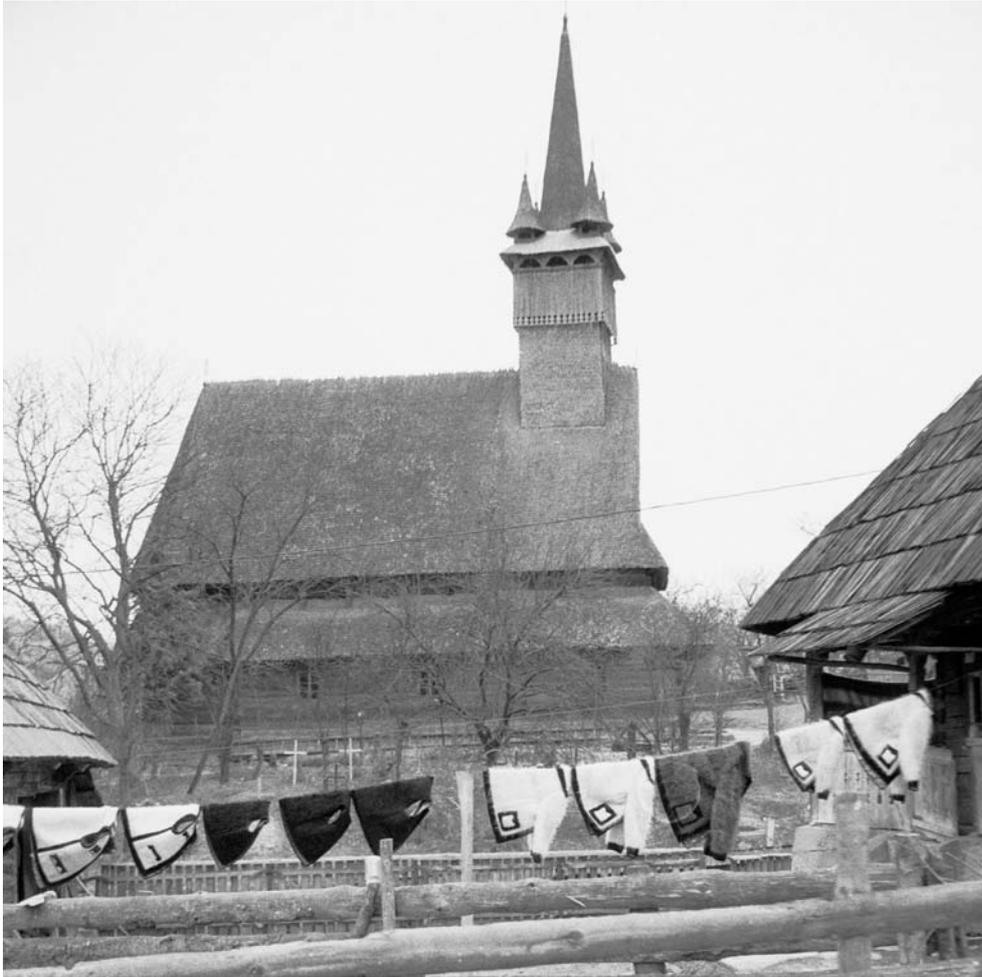
177 *Budești Josani*. The church as seen from the yards nearby. Photo: April 1994.

not wanted bells for a tower, iron for the hinges of the doors, carved stones for the altar table or glasses for the windows. Whatever was the situation, the carpenter had to solve the shortage of resources in a very traditional way, replacing the missing materials with pieces of wood. These could have been the reasons why the church from Sârbi Susani retains the most ancient features in the local architecture. Although he was limited in his work by the poor resources of his customers, the master carpenter succeeded to impress them and the communities around in such a degree that he was soon engaged to build the ambitious church in the neighbouring parish of Budești Josani (91- 92, 171 and 177-179), only 3 km away.

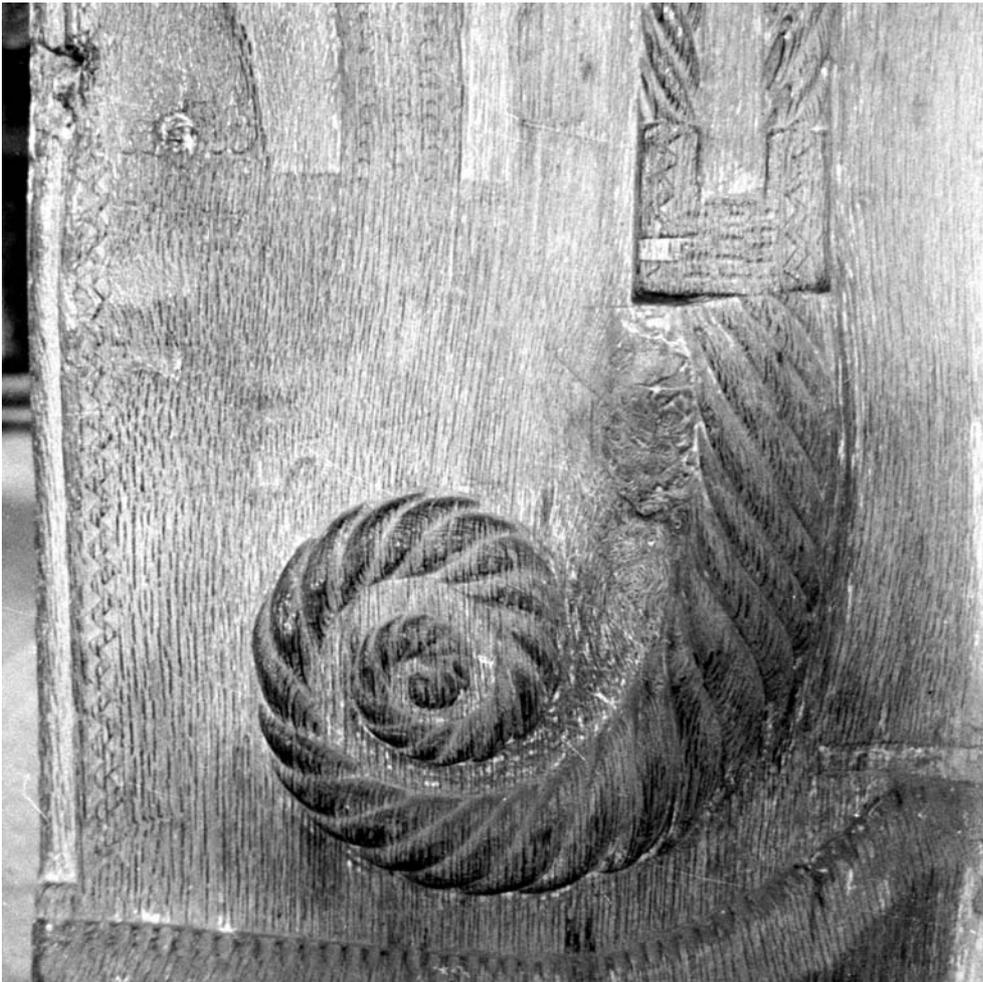
181 *Strâmtura*. Detail from the left jamb representing the horn of a ram. The indented line on the left, near the aperture, may indicate the life giving water of a spring. Photo: March 1995.

the second hand, there are some small but obvious formal differences from the familiar ones. The straight mouldings were each split into two thinner ropes, united and transformed at their turning bottom end into a horn of a ram (**181**). The horn do not change the sense of the message since, like the snake, it was also a symbol of the moon.¹²⁵ The separation in two ropes is visible even on other portals¹²⁶ but its sense waits for clarifications. Another evident difference is the lack of small cuts in between the main figures that so characteristically gave life to the compositions of the other three portals.

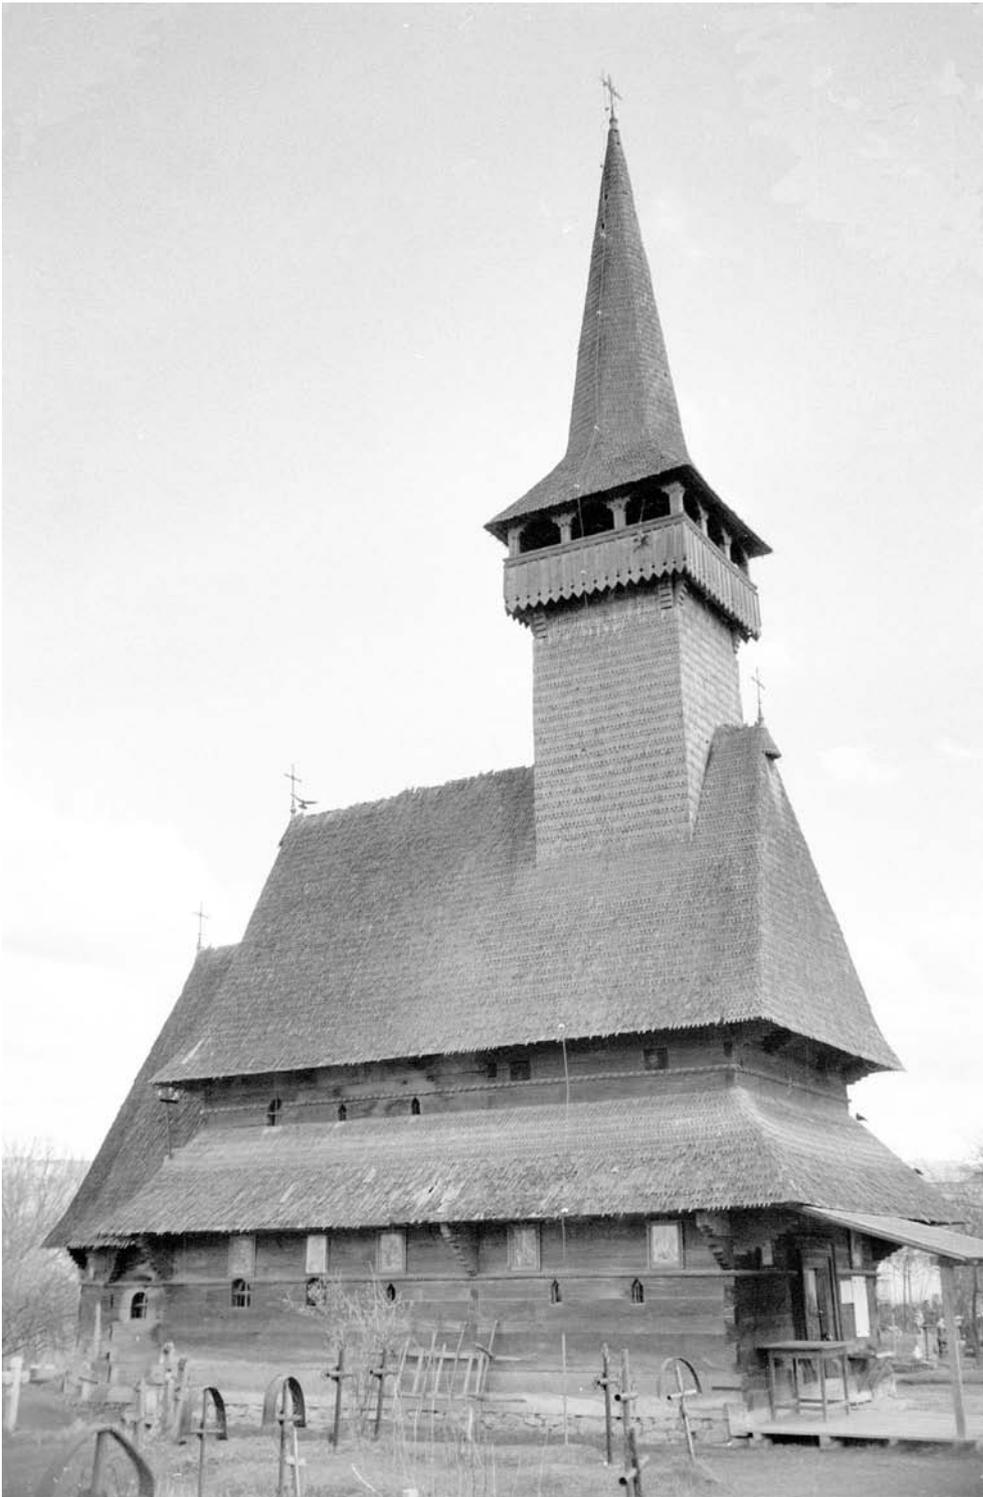
192 *Sat Şugătag*. The church is preserved in good condition. One of the specific features is the mouldings surrounding the log fabric on two levels, above both rows of windows. Wherever the horizontal mouldings appear they are cut above apertures indicating a symbolical distinction between the earthly world and the one above. Photo: April 1994.

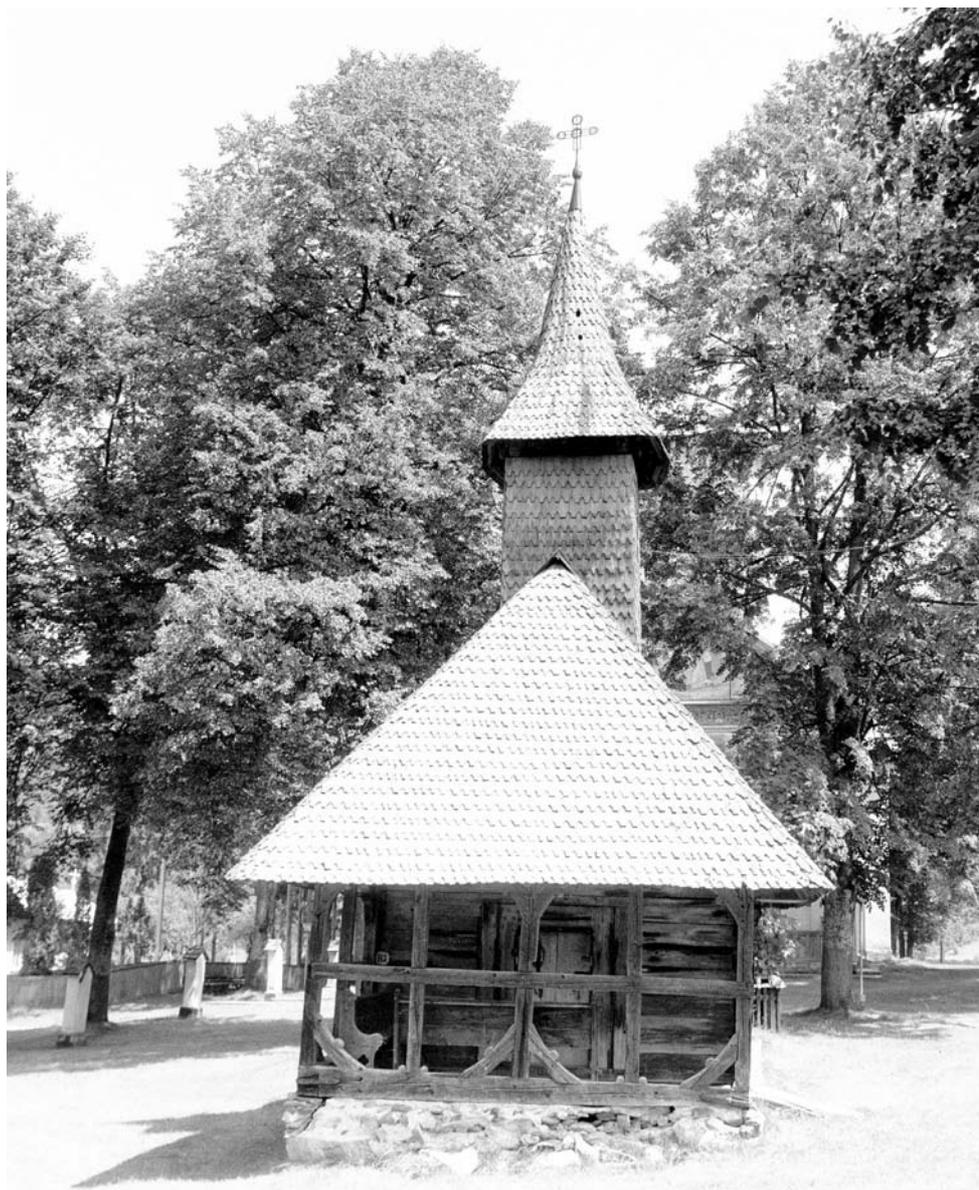
198 Moisei Monastery. After the disappearance of the traditional centre from Peri Monastery the strategically positioned Moisei Monastery took over as an important bridge between Southern Maramureş and Moldavia. The small sizes of the wooden church speak of the initial modest resources and the founder's uncertainty in its future. Photo: July 1995.

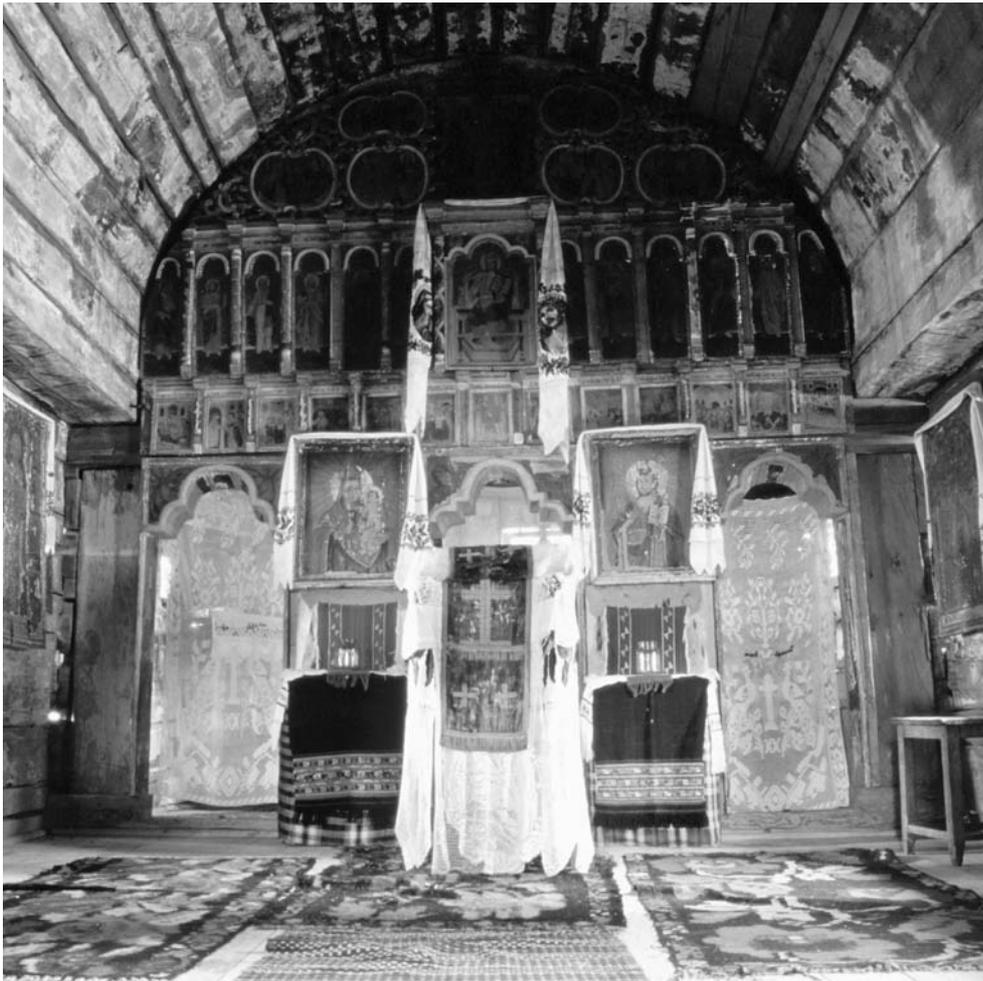
199 *Moisei Monastery.* Despite the small sizes, the vaulted nave (*at left*) appears quite roomy. The interior was refurnished and repainted sometime in the 19th century and with that occasion the iconostasis and the sanctuary behind seem to have been consistently transformed. The murals from the time of its consecration survived only under the icon screen. In exchange, the narrow and dark narthex (*bellow*) maintained much of its initial austere appearance. Photos: July 1996.

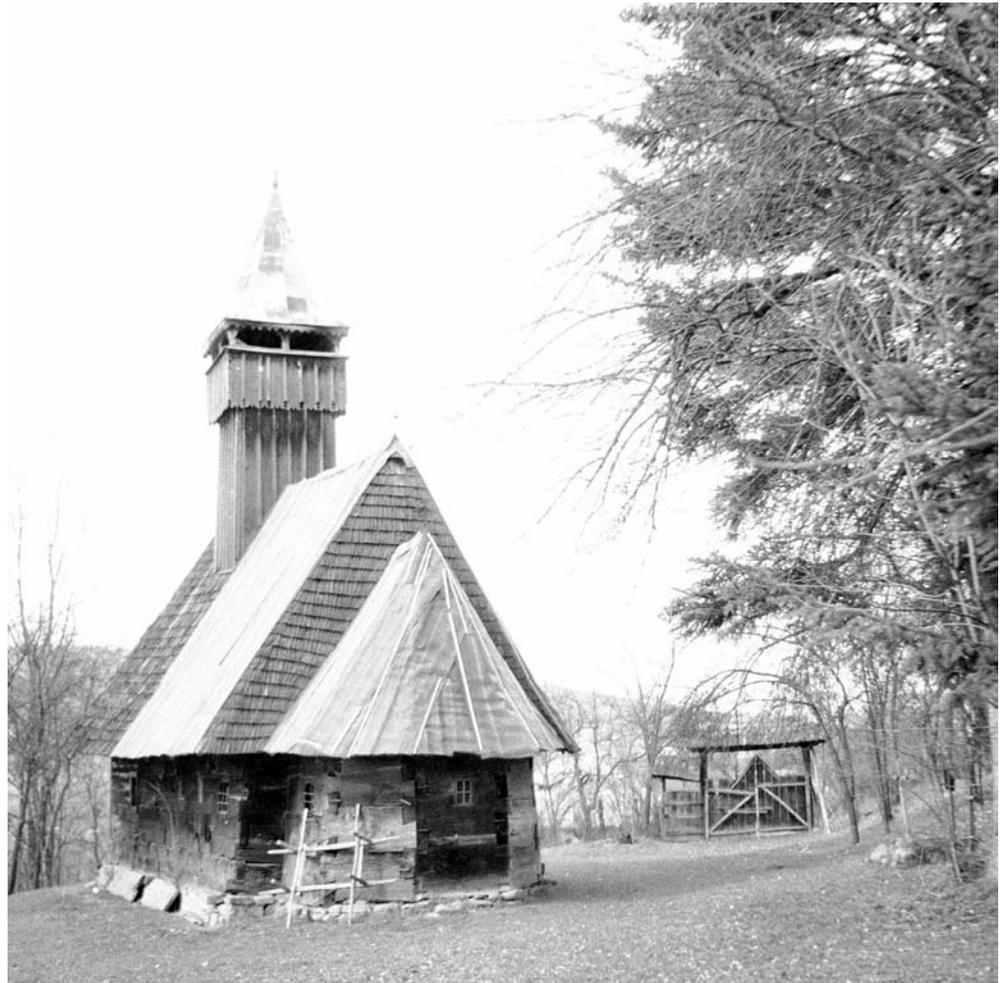
201 Giulești Monastery. The Romanian inscription with Cyrillic letters on the eastern wall of the sanctuary reminds: “*Pop Pătru founder of the monastery*”. From this firm statement we may suppose that Pătru was the Christian or the adopted monastic name of the founder Pop Lupu. Otherwise, who would have been allowed to change the identity of the real founder? In about the same place it was said to have been also carved the year of the foundation: 1692. From the monastery it survived only the small wooden church and the name for the entire settlement around. Tracing (scale 1:5) and photo from April 1994.

The widow priest Pop Lupu Sr de Giulești (1655-1731) erected a monastery in 1692 on his estate and lived there as a monk (201-205).⁶⁶ The monastery was consecrated by Iosif Stoica de Ciumulești (1690-1711),⁶⁷ the first bishop after the re-erection of the bishopric of Maramureș. Being a private foundation, the founder disposed of the monastery as an ordinary property, selling a piece of its land and bequeathing the remaining part to his descendants. By all probabilities the stone in front of the royal doors inside the small wooden church, dated from 1731, marks the privileged place where he was buried. In 1749, his son, priest Ștefan, and a nephew, deacon Andrei, offspring of a second son, Nicolae, continued to live in the monastery.⁶⁸ Andrei and the other direct descendants of the founder must have donated the monastery to the community of Giulești in 1753, yet, with the strict condition to recover their estates in case it would become abandoned.⁶⁹ As a result, after 6 decades and 2 generations, the monastery finally became a collective establishment. Thanks to this wider village protection the monastery was repaired in 1763,⁷⁰ even before the necessary extension and repairs of the medieval parish

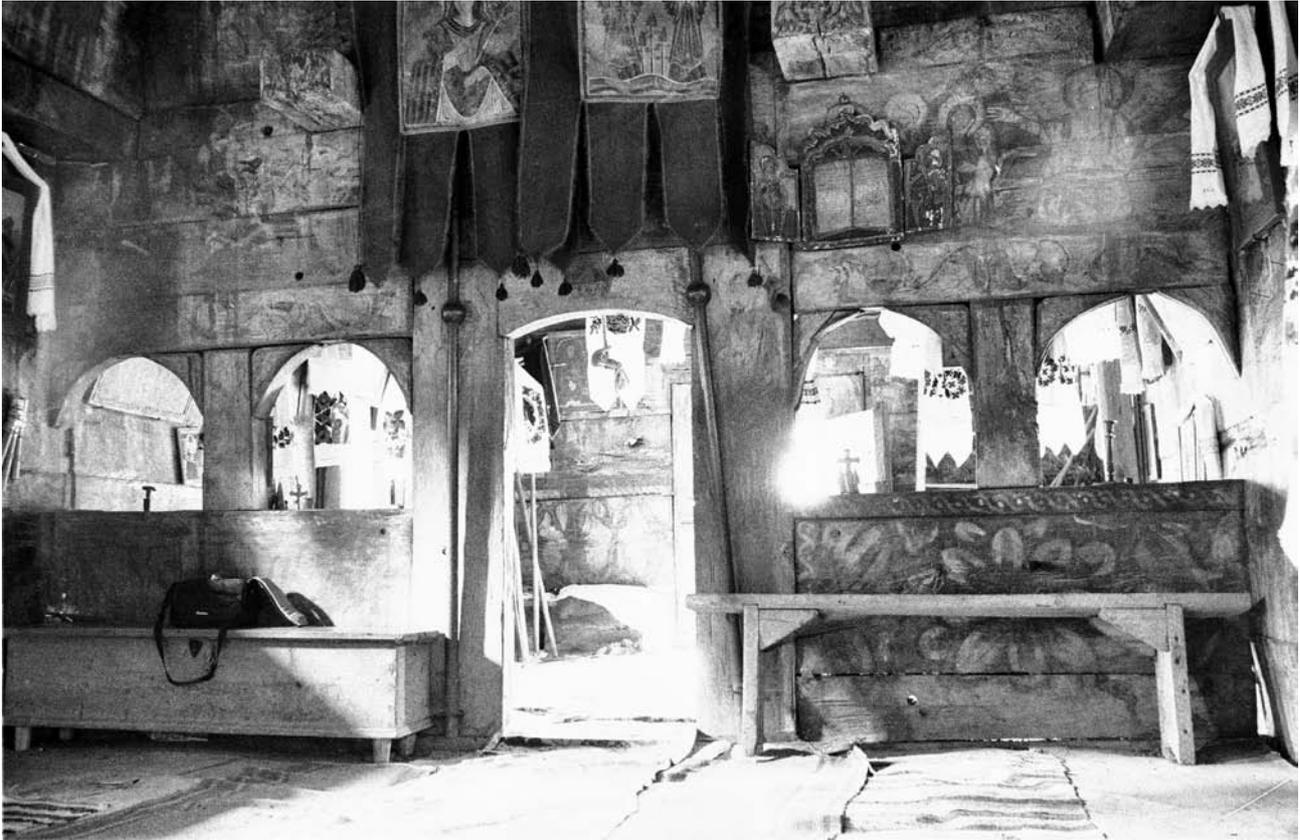
203 *Giulești Monastery*. The small narthex was provided with for that time generous openings in the inner wall. Photo: July 1995.

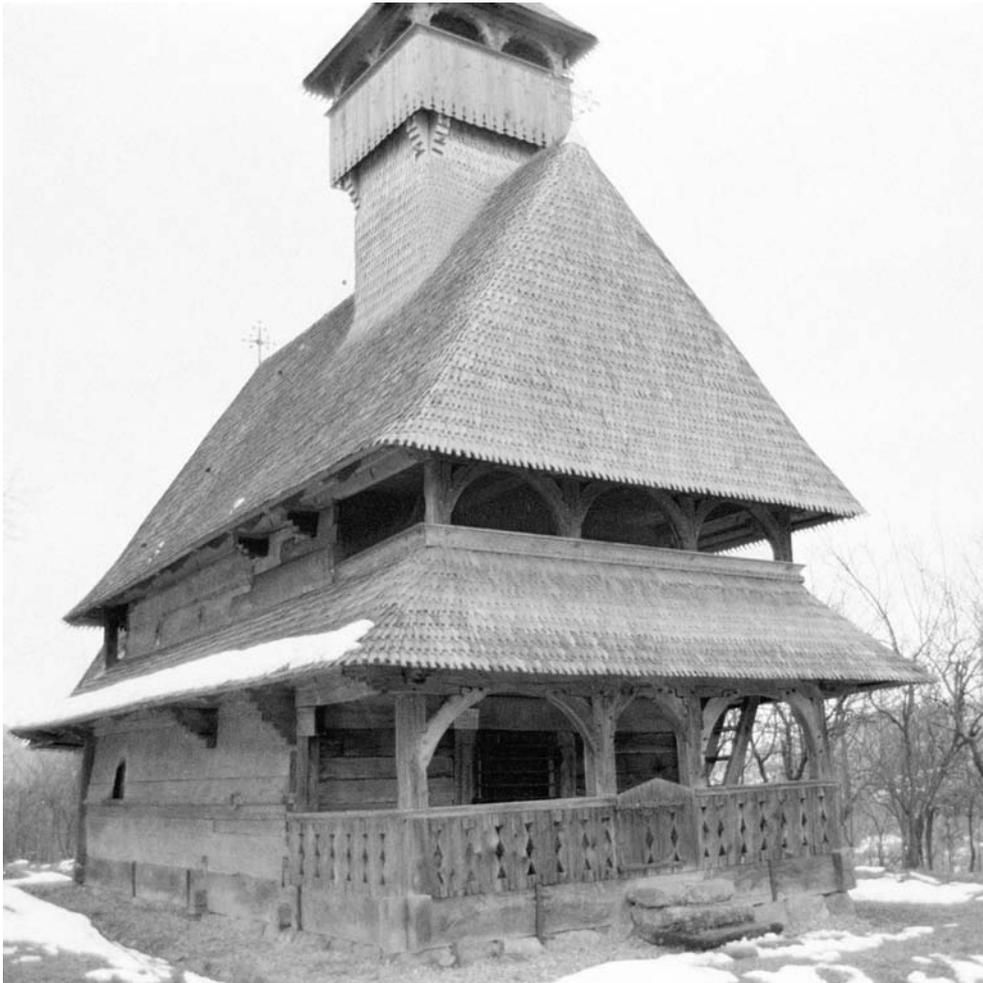
206 Bârsana. The former monastery church was brought inside the village, on Jbâr Hill, at the turn of the 18th century and it has been used after that as a chapel for the cemetery around. Photo: November 2002.

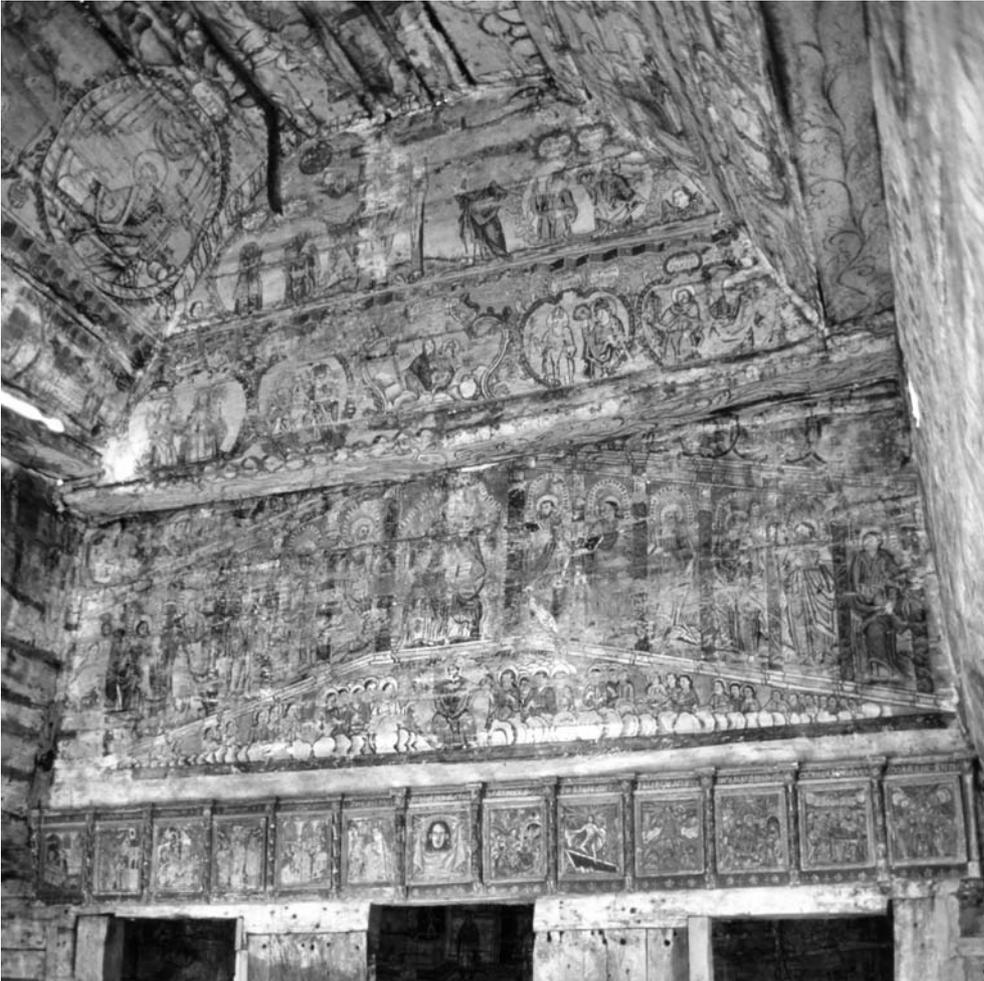
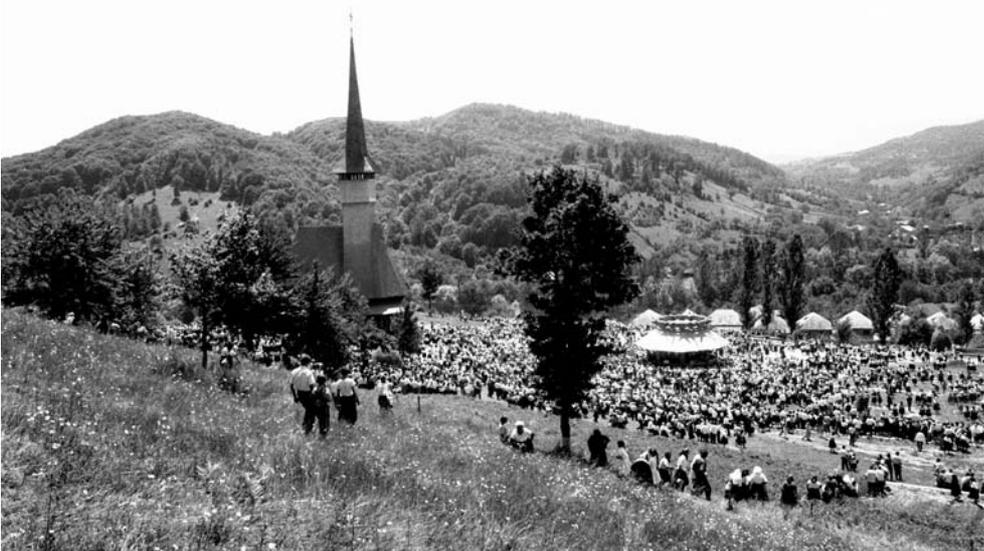
208 Bârsana Monastery. After its transfer from the old site outside the village (*bellow*) the church was refurbished and repainted. Due to rare use of the church the murals maintained much of their original colours (*above*), one of the main reasons this church was inscribed on the World Heritage List. In the last decade, a new monastery for nuns arose on the old site attracting during feasts crowds from near and afar. Photos: July 1997 (*above*) and June 1997 (*bellow*).

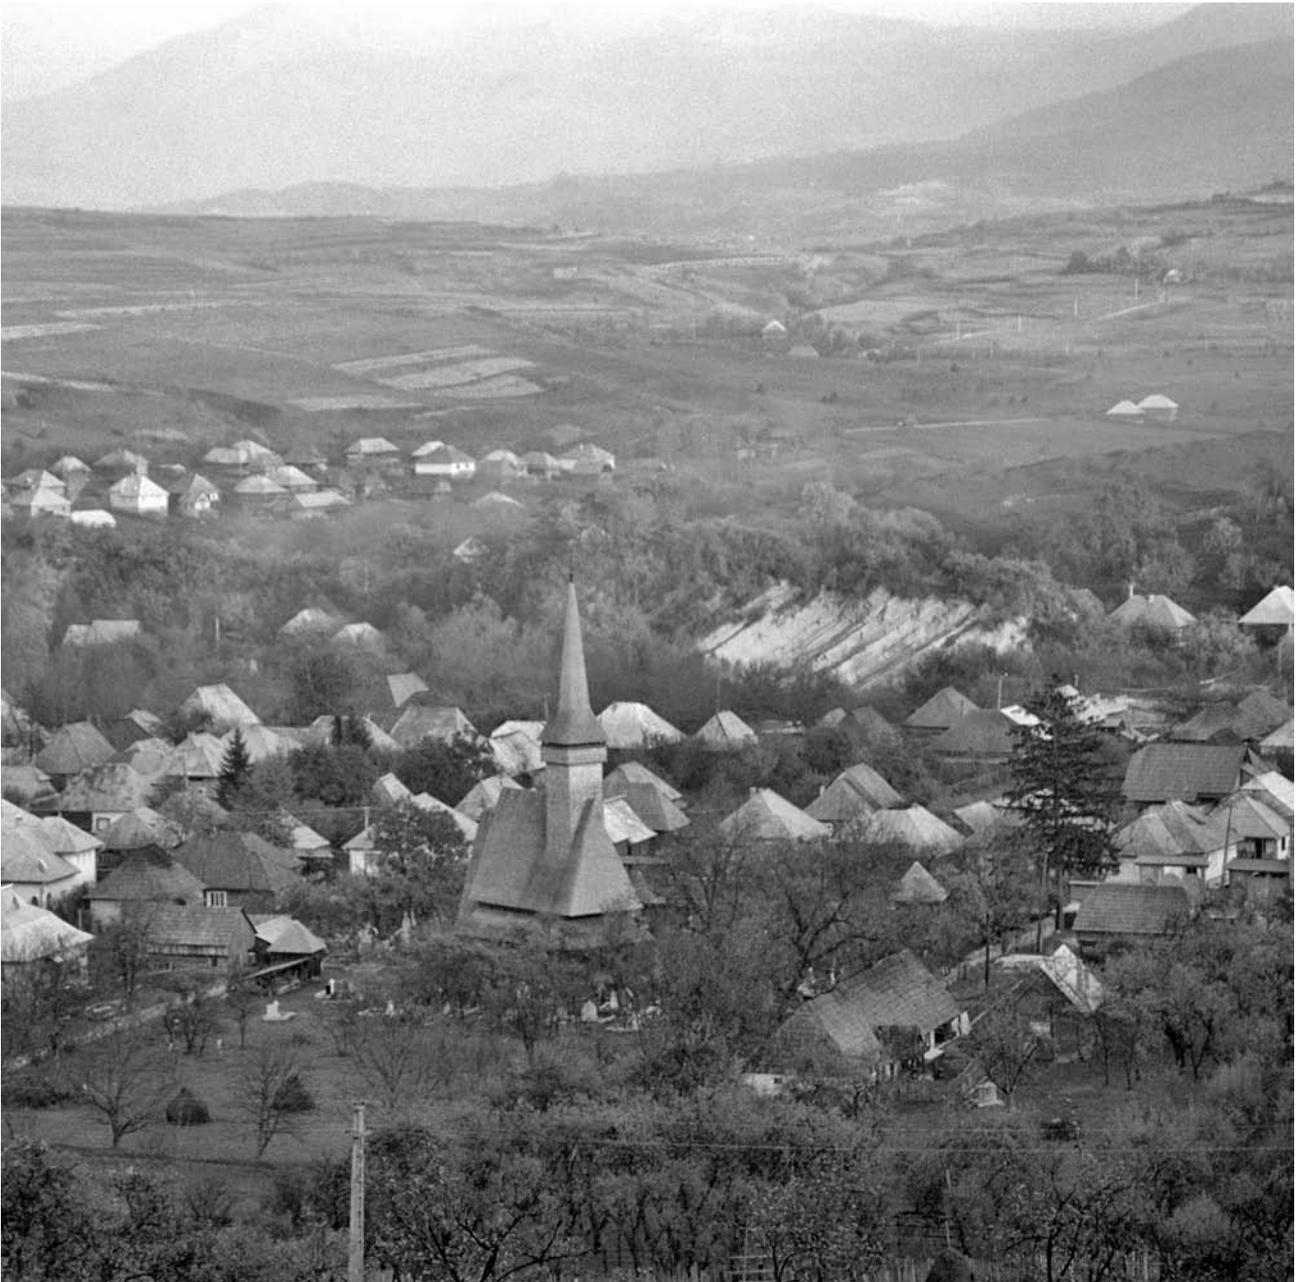
213 *Ieud Şes*. During the land survey from 1767 the noble village of Ieud was remarked for the good condition of the buildings (ÖStA-KA, K VII K, Beschreibung, 70). One of the few constructions that survived from that time is the elevated wooden church from Ieud Şes. Photo: October 2000.

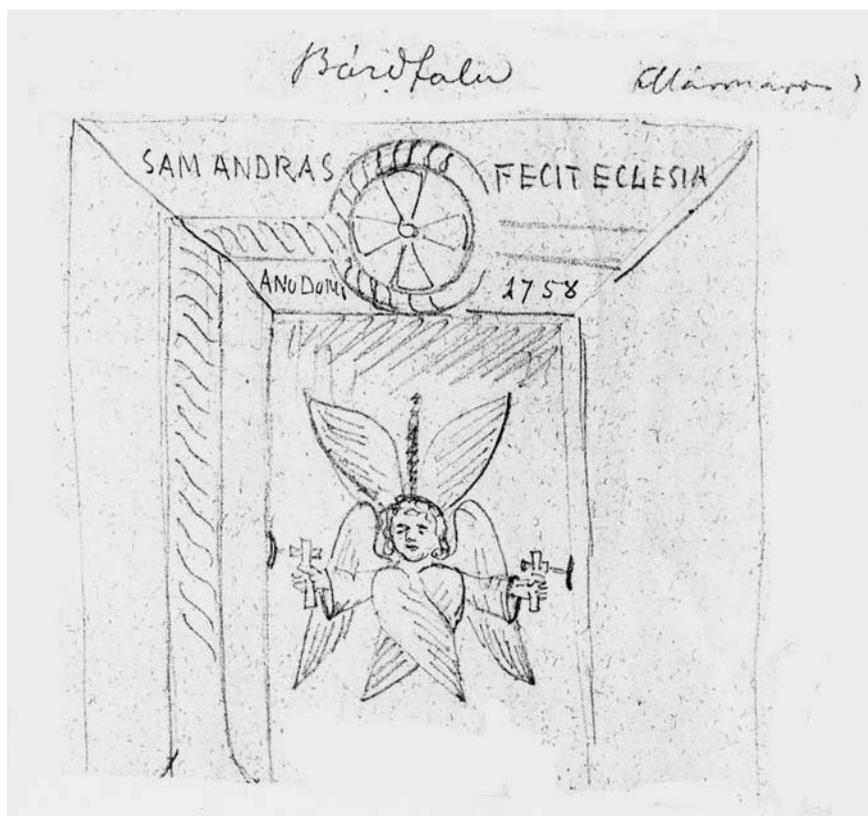
216 Berbești. The entrance portal with the signature after a drawing of Franz Schulz from 1862. The six-winged seraph in the aperture was actually a chandelier inside the nave, usually hanging in front of the iconostasis. KÖH, Térvtar 2004/13175.

In the vanished parish wooden church from Berbești (3-4 and 8) there was an inscription on the portal of the entrance with the following content: "*SAM Andreas fecit eclesia. Anno Domini 1758*" (216).¹⁴⁵ Who was this Andreas? Things are complicated by a similar inscription on the portal of the church from the serf village of Kalyny: "*Faciât eclesia Andreas 1756*".¹⁴⁶ Was he an itinerant carpenter or a noble founder? For the first, as we already remarked, a carpenter used to sign with the term of his profession after his name, i.e. carpenter or master. For the second, the different techniques in which the two churches were built speak, too, against the signature of a single carpenter. The church from Berbești was built with the most refined professional details while that from Kalyny presented quite roughly squared timbers with projecting joints. Accordingly, we might have one or two different noble founders with the name Andreas or Andras signing in both places.

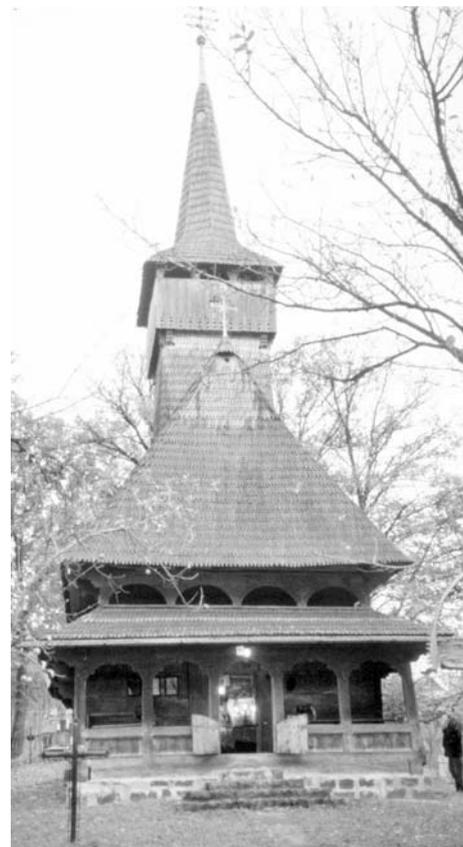
220 *Ferești*. After a steep path leading from the gate of the precinct, the church greets the visitor with its double porch from where a beautiful view opens over the surroundings. Photo: October 1997.

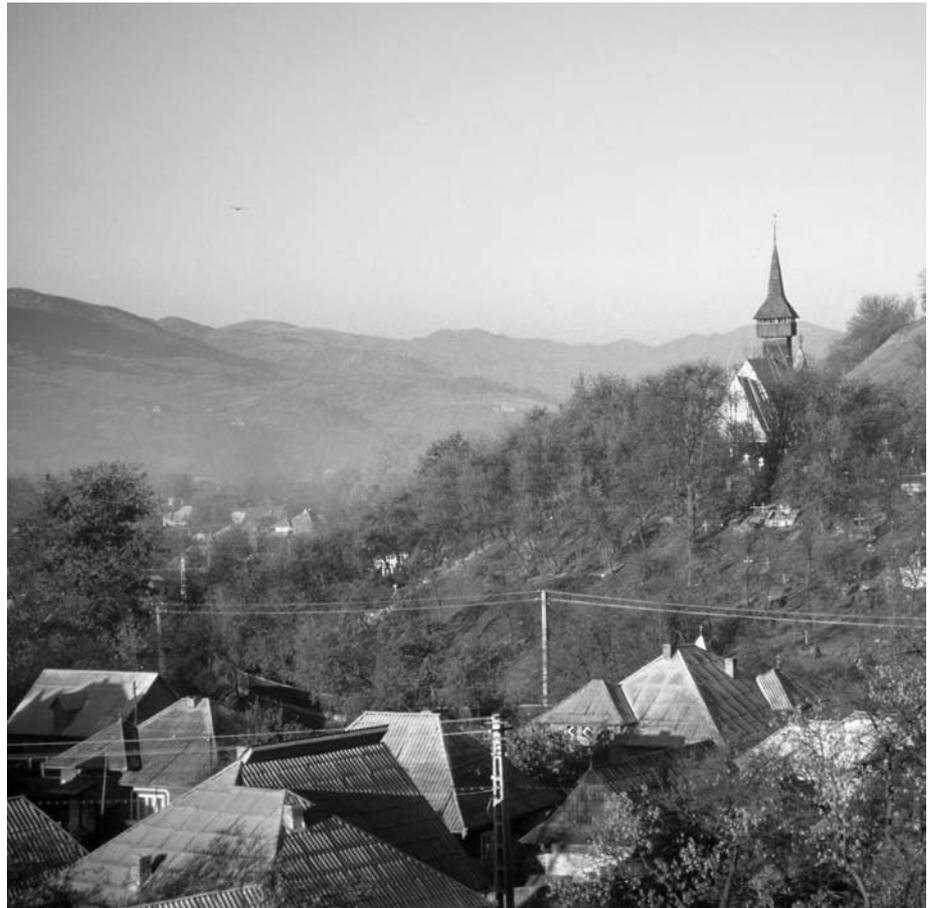
221 *Sălișteea de Sus Nistorești*. The village of Sălișteea de Sus was separated in two competing parishes with the construction of the church of the noble Iuga (Nistor) family on the left bank of the Iza River around 1680. In 1774 the church was patronized by the Iuga and Vlad families (MOL, C 99, XIA, Maramoros 1774, 52). Photo: October 2000.

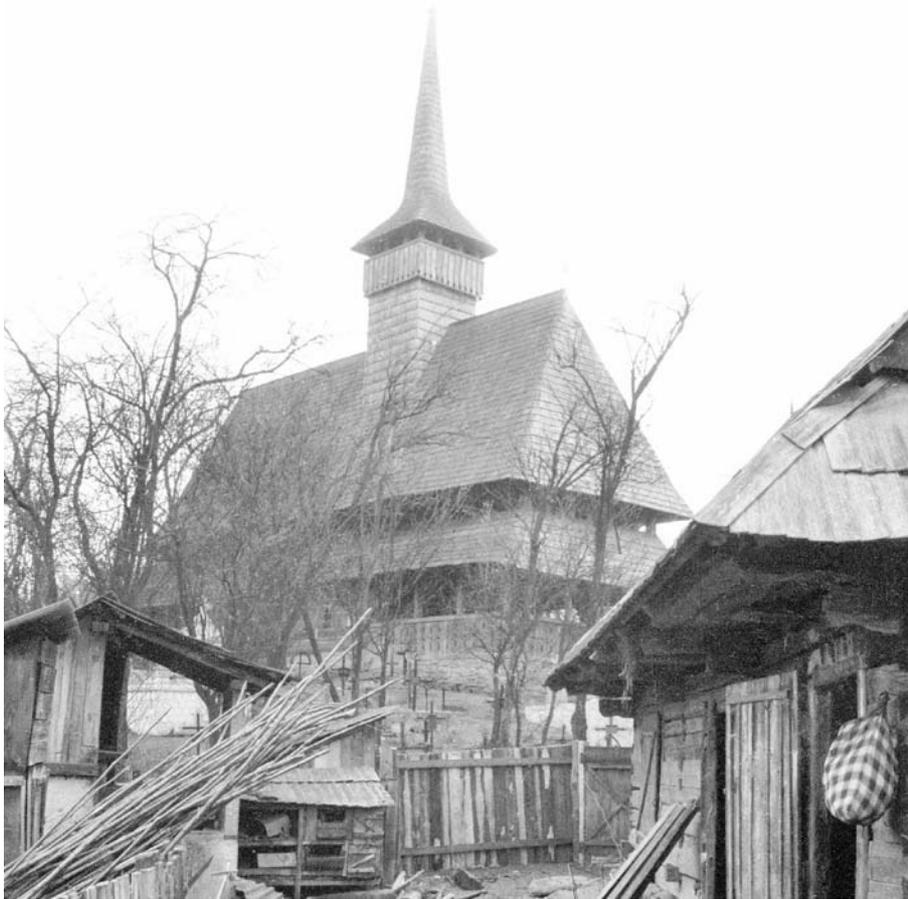
222 *Sălișteea de Sus Buleni*. After the Tatar raid from 1717 and the destruction of the older church from Buleni the villagers from Sălișteea de Sus were forced to use together the surviving church of the Nistor family, but open conflicts for supremacy, worsened during an Easter ceremony, led the nobles from Buleni to rebuild their own parish church. In 1774 the church from Buleni was patronized by the Vlad and Kiss families (MOL, C 99, XIA, Maramoros 1774, 52v). Photo: October 2000.

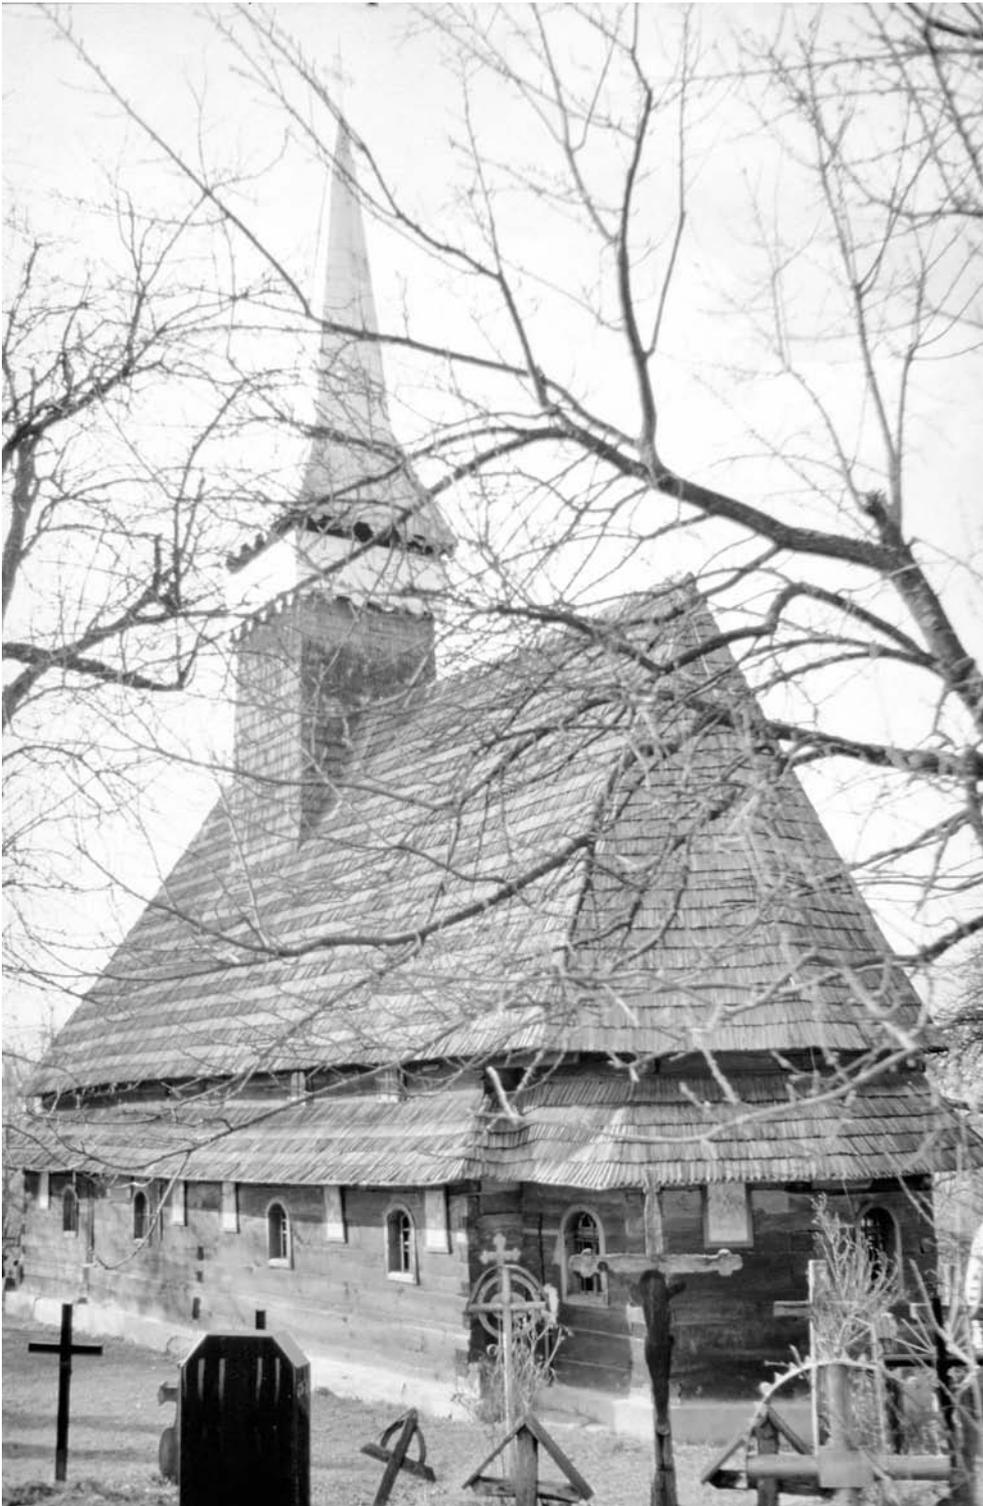
225 *Slatina*. The wooden parish church from 1790 was taken to pieces and transported by carts to Hoteni after a new stone church was consecrated in 1895 on the expenses of the Uniate bishop Mihai Pavel. In the poor village of Hoteni it replaced another wooden church, transferred in 1758 from Budești Vințești. Photo in Hoteni: February 1995.

wooden church from Budești Susani, former Vințești. After more than a century the parishioners from Hoteni replaced that church with another one obtained as a gift around 1895, this time from Slatina (225). From the noble village of Vișeu de Jos were transported two wooden churches, one to the serf village Bocicoel sometime in the 17th or 18th century, and the second one in 1899 to another poor community, in Botiza (189). The parishioners from Berbești gave away their old church to the neighbouring village of Vad around 1760. The new Uniate parishes formed in the royal towns of Sighet, Câmpulung and Teceu, all received abandoned monastery churches from the noble villages of Săcel (1748), Criciova (1767) and respectively

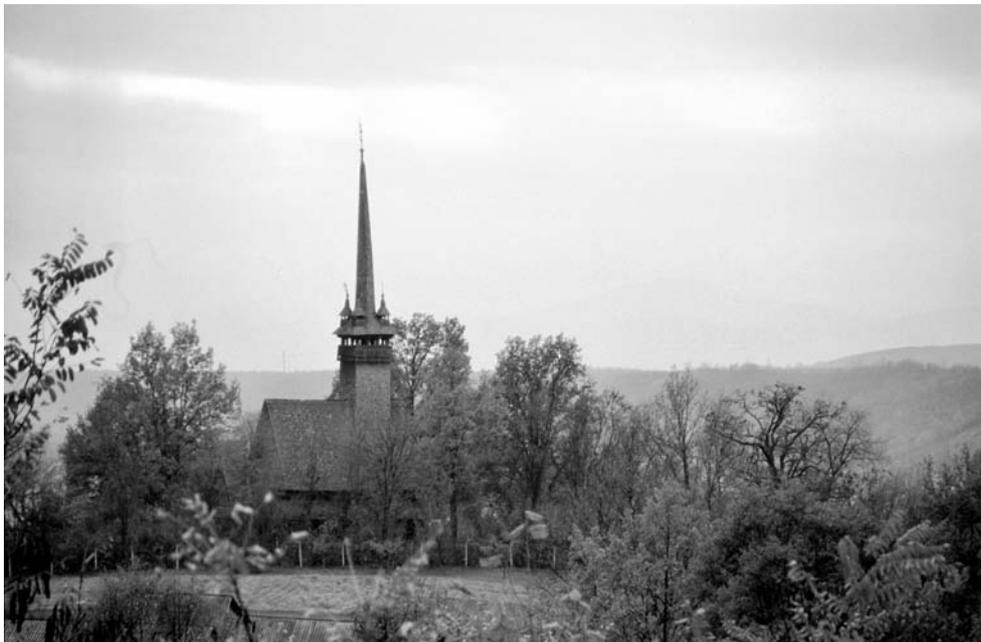
226 *Danylovo.* Two inscriptions, one in Latin and the other one in Church Slavonic, indicate the consecration date in 14 March 1779, but there are no references to builders or commissioners. Photo: October 2000.

The parish church from Danylovo was built in 1779, according to the two inscriptions above the portals, one in Latin and one in Church Slavonic (**64**, **68**, **123** and **226**). In 1769 the landowners were the Hungarian magnates Károlyi and Tholdy, as well as the nobles Szegedy, Georg and Nicholas Chernel. The two magnates did not pretend the patronage in 1774 and the parishioners cared of their parish alone.¹⁹⁹ Their old parish wooden church was narrow, incapable to receive the parishioners and, in addition, its “*deteriorated roof was no longer able to hinder the rain*”.²⁰⁰ A new parish church was thus welcomed. Unfortunately the parish regulation from 1786-89 did not mention the founder or at least if the right of patronage was pretended by someone after the recent construction. We are thus far left to use only our own imagination. It is not excluded, however, that the Hungarian landowners were asked by the parishioner to support them in their enterprise.

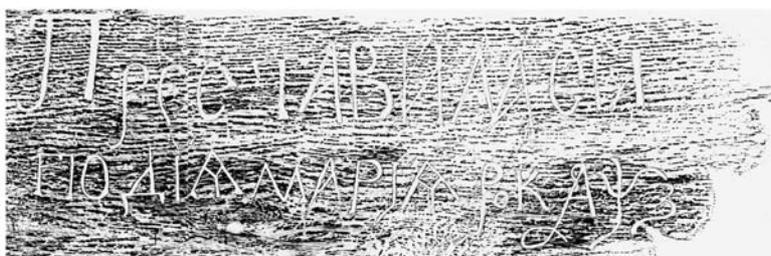
227 *Sokyrnytsia.* The inscription on the northern wall of the antechurch recording the death of a benefactor in 1707:

“Преставилася Продіа Маріа
рок ѿѿз”.
