Tracing a Sacred Building Tradition

Wooden Churches, Carpenters and Founders in Maramureş until the turn of the 18th Century

by
Alexandru Baboş

**Department of Architectural History, School of Architecture
Lund Institute of Technology, Lund University, Sweden**

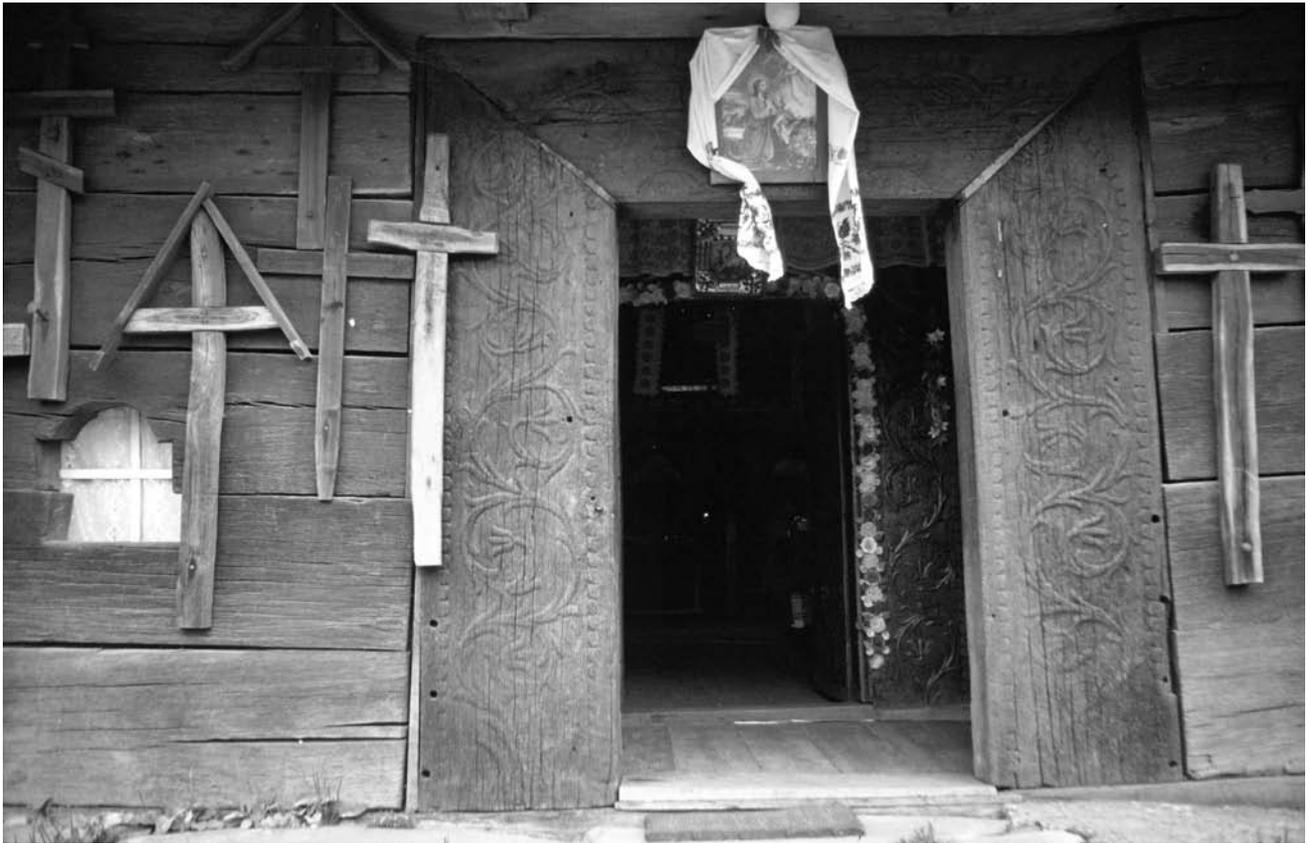
228 Steblivka. The parish church from the serf village of Steblivka was provided with richly decorated portals, a sign of costly investments and high prestige. Photo: July 1994.

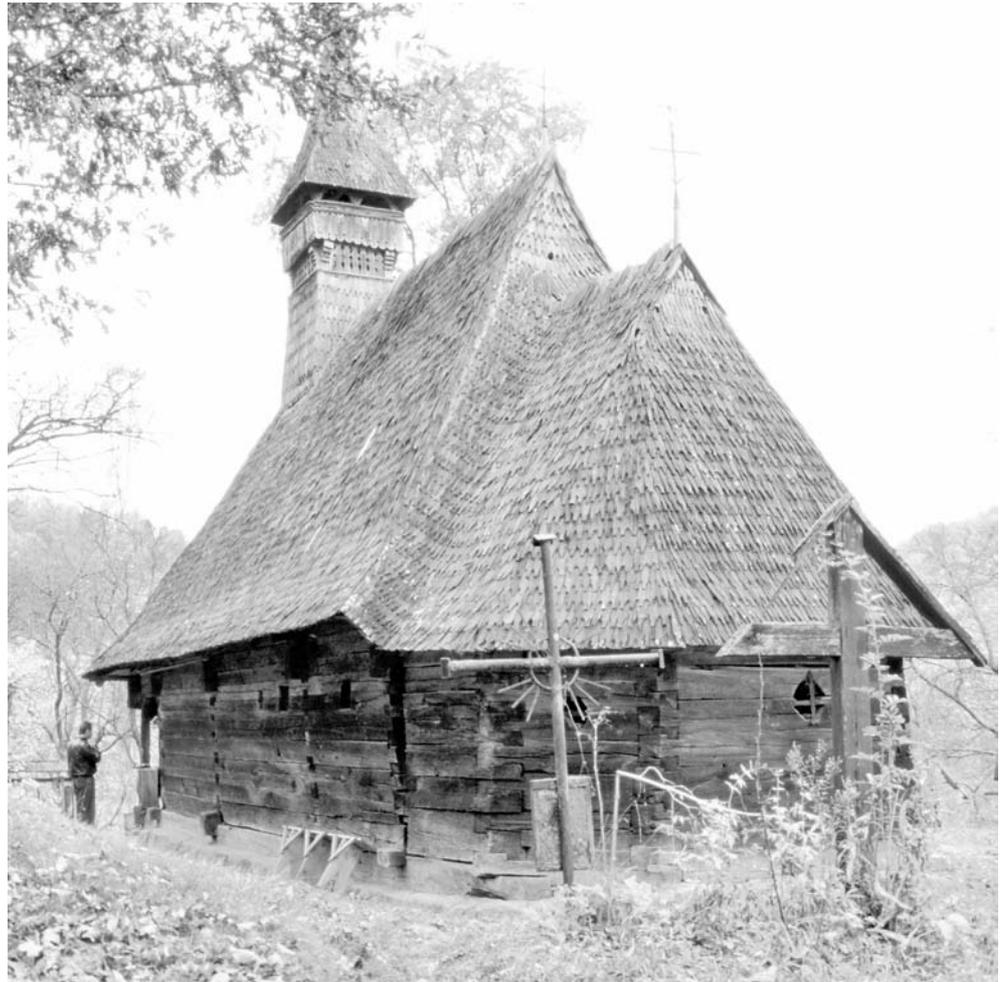
231 *Valea Stejarului*. The church was extended at the turn of the 18th century with a new sanctuary, a porch and a tower. Initially it looked in general lines just like a common house, *with a simple roof*, maybe thatched at the very beginning. Photo: October 1997.

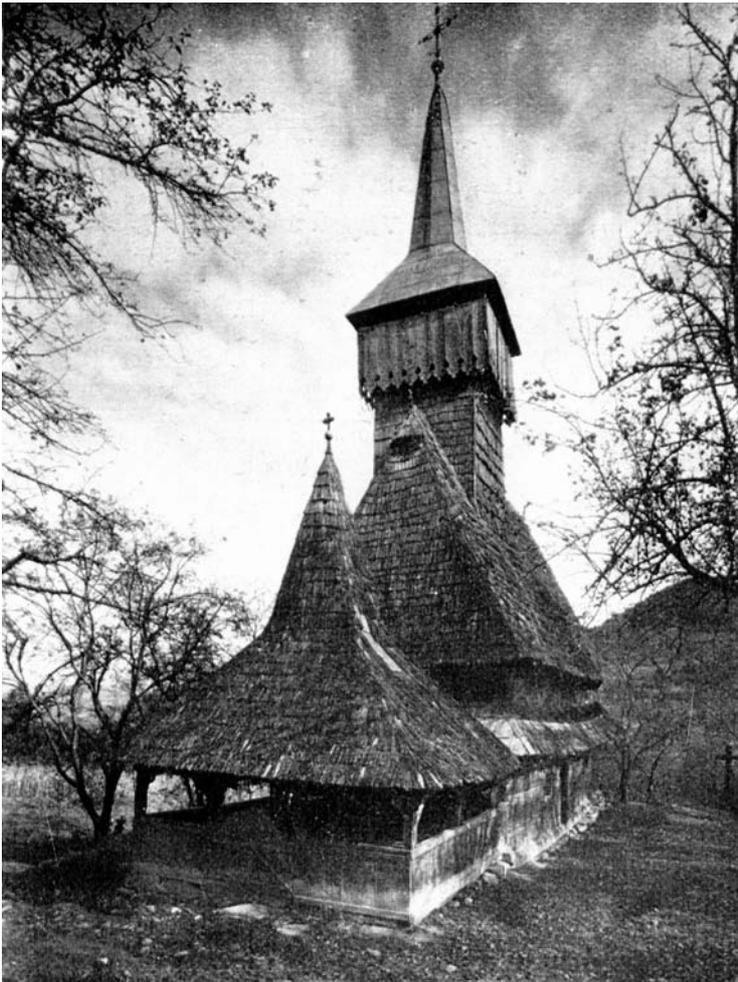
232 Văleni. This church *with two eaves* was transferred from the Cuhea Monastery in 1670s and served until 1947 for the parish from Văleni. A half century after its demolition, a few timbers reused in a secondary construction enabled its firm dendrochronological dating from the beginning of the 16th century, becoming the oldest known wooden church in Maramureș. Photo from 1937 (Brătulescu 1941, ill. 118).

The first known wooden church *with two eaves* was firmly dated from the beginning of the 16th century and it was initially erected in Cuhea, where it apparently replaced a ruined Gothic stone church and probably served as a monastery church (232).²⁰⁴ Beginning with the church from Botiza (1594) and especially during the 17th and 18th centuries, most of the new parish wooden churches were built *with two eaves*. Exception made only some poor or conservative parishes and most of the monastic establishments, which retained the simple roofs. The construction around 1621 of a church *with a simple roof* in the neighbouring serf village of Valea Stejarului (231) at the same time with one *with two eaves* in the noble village of Oncești (97) reveals how fashionable and also loaded with prestige the second variant might have been at that time.

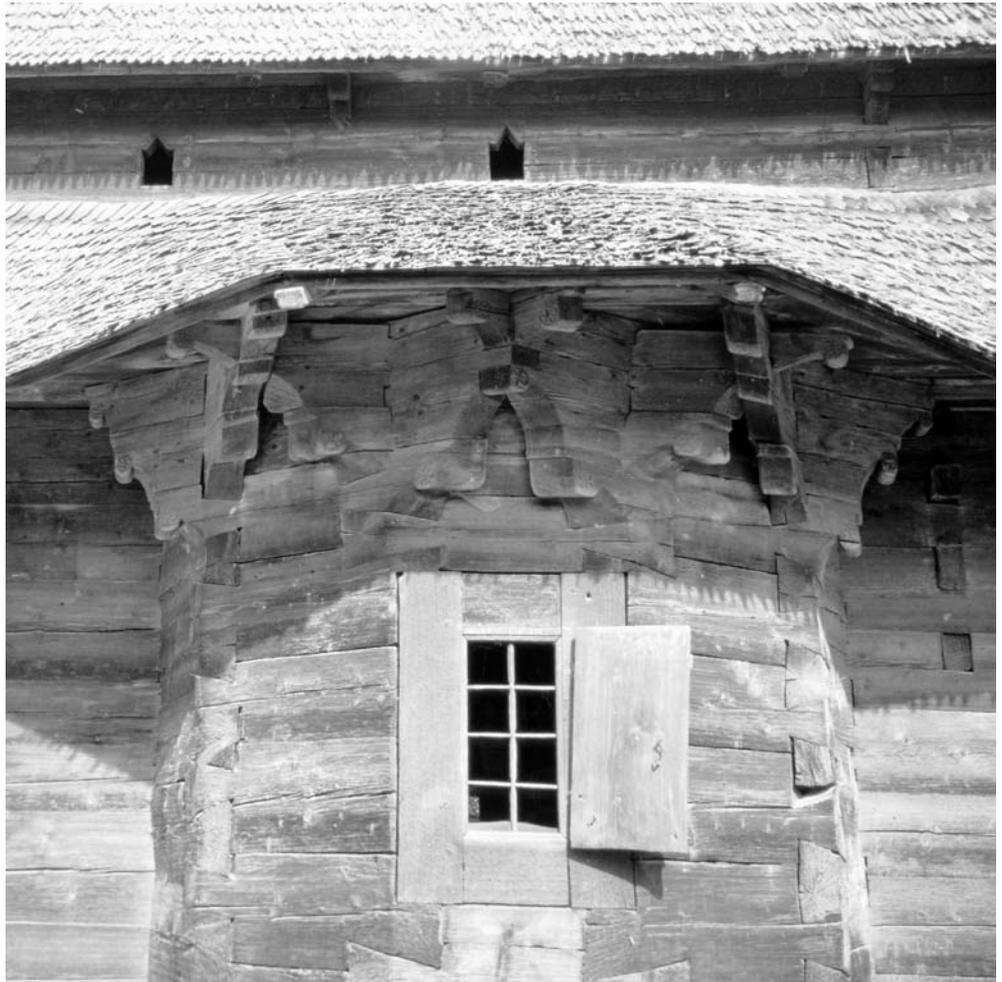
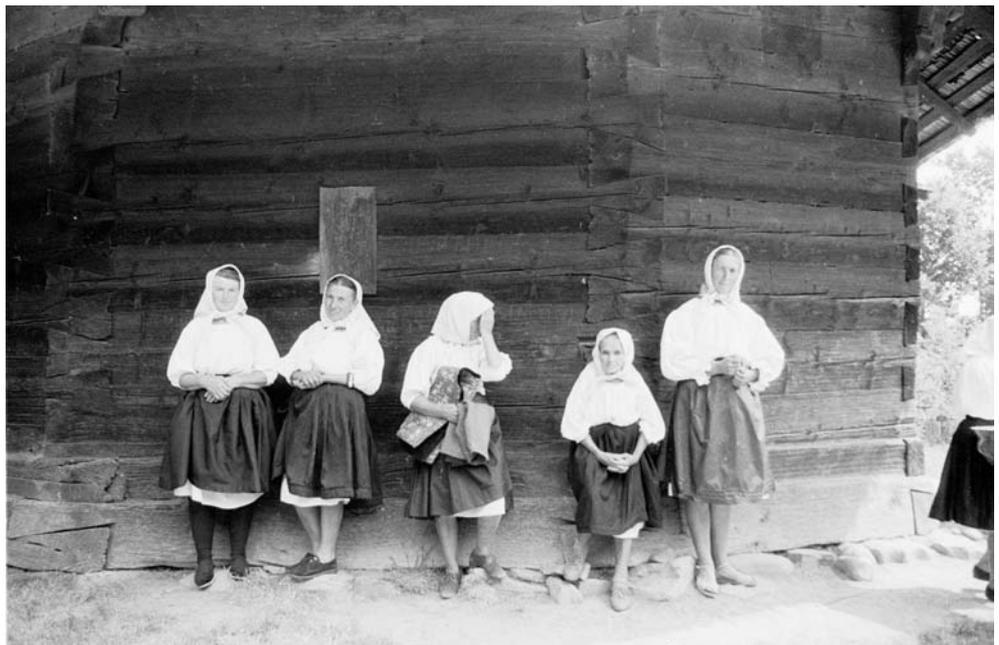
233 *Călinești Susani*. The most curious wooden church was built in 1784 in Călinești Susani where the lower part indicates a Moldavian connection while the upper part the local tradition. Photos: the southern apse from October 1997 (*above*) and the polygonal western end from August 1994 (*below*), both specific in the Moldavian wooden churches.

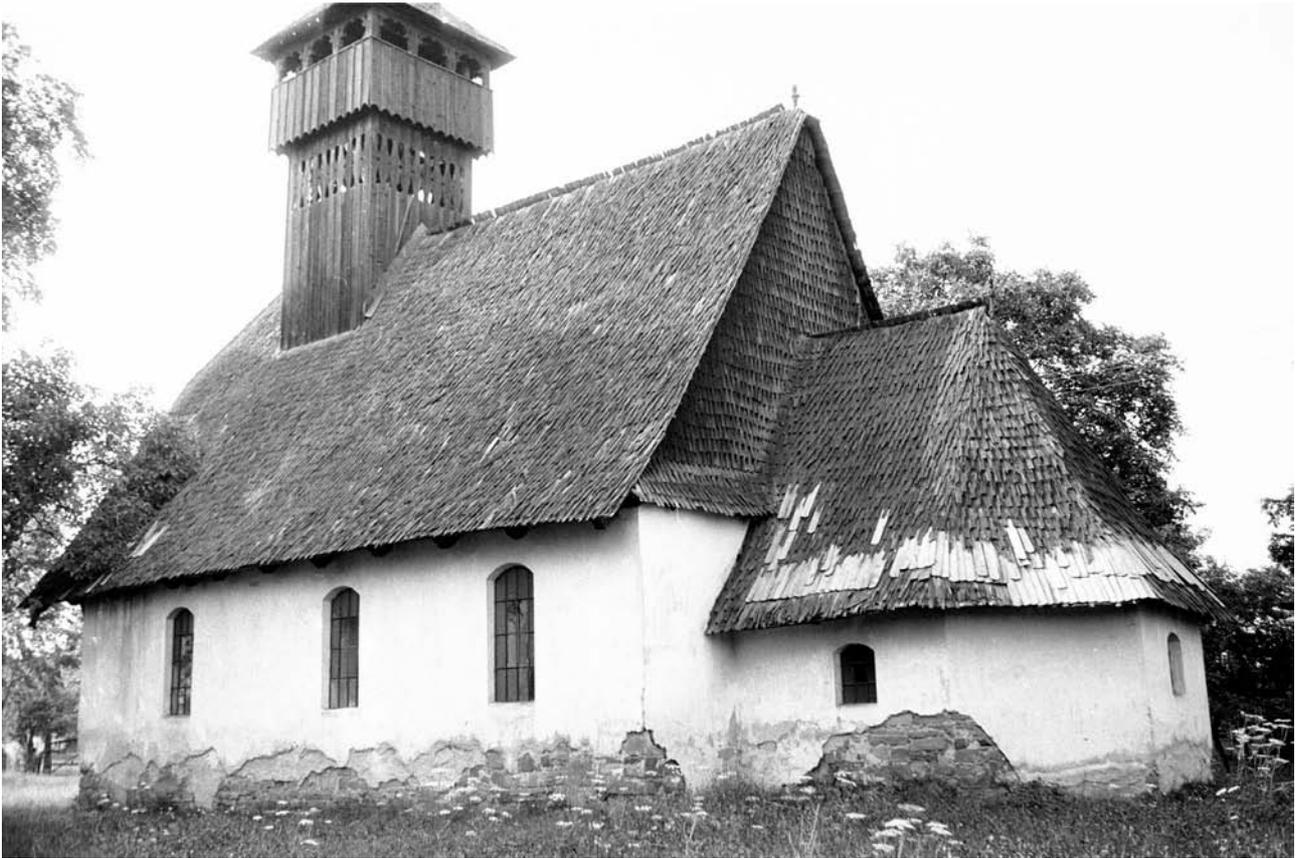
234 *Sarasău*. The sole medieval church of stone from an Easter community survives in Sarasău. However, the windows were enlarged and the tower rebuilt during comprehensive renovations in 1937. Photo: July 1994.

The single extant medieval stone church stands in *Sarasău*, considerably altered by the renovations and repairs from the 20th century (234-235). This seems to be a late medieval church, probably erected between the beginning of the 15th and 16th centuries. Among the known medieval stone churches this is the single one partitioned from the very beginning among women and men, just like the standing wooden churches. The church was planed 14 x 22 Royal ells (8.11 x 12.65 m) for up to 300 worshipers, which allowed the entire community to pray inside until the middle of the 19th century. The narrowed sanctuary was planed 8 x 8 R e with a polygonal outer shape. In elevation the nave was covered from the beginning with a vault of massive timbers and probably even the sanctuary had a small one. The eastern gable of the nave had only two doors to the sanctuary and the wall between women and men was closed by a massive door. Some very small windows let the light inside and the interior was by all probabilities painted. Above the women's church, a wooden tower was probably mounted from the beginning.²⁰⁷

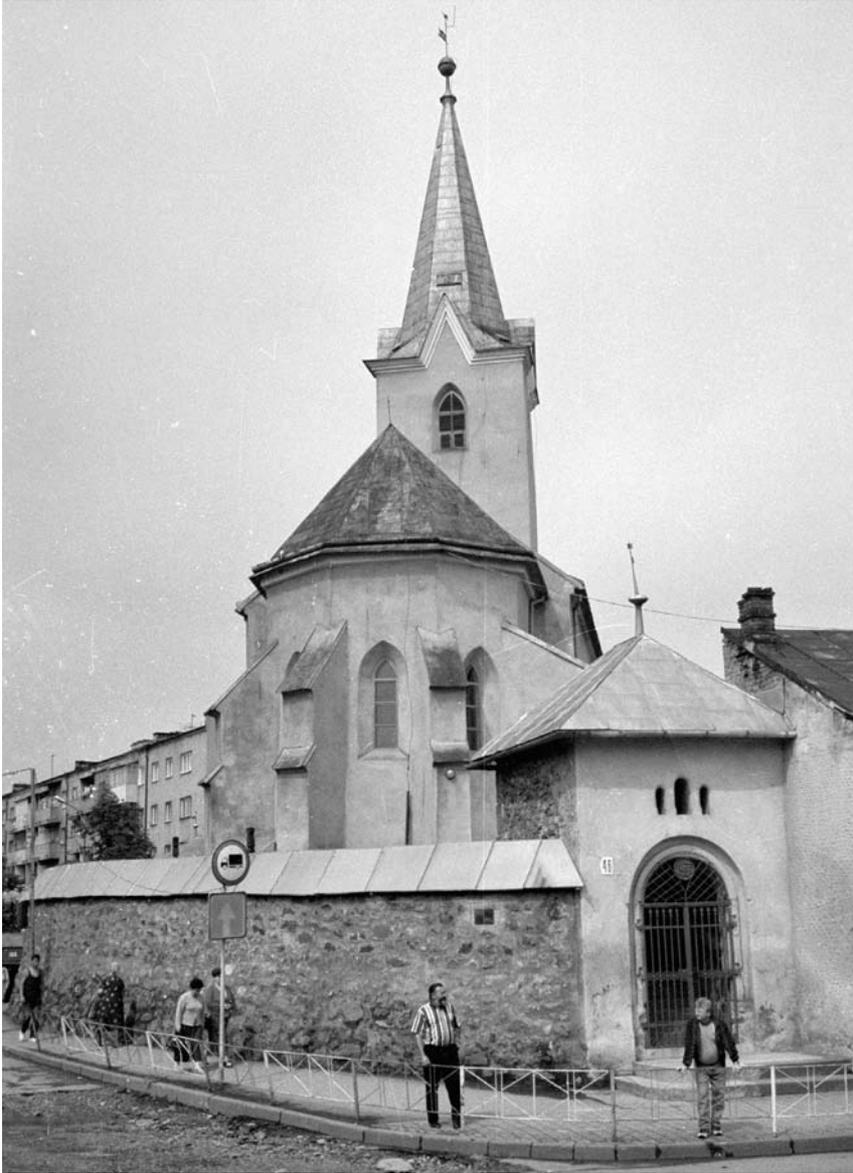
240 *Hust.* The medieval church went through several renovations that altered some of its characteristic features as for example the wooden gallery of the tower and especially the spire with the four turrets that so much inspired the builders of the wooden churches around. However, the original stone fabric survived in good conditions. Photo from July 1998 and Scale drawing of the plan from November 2002.

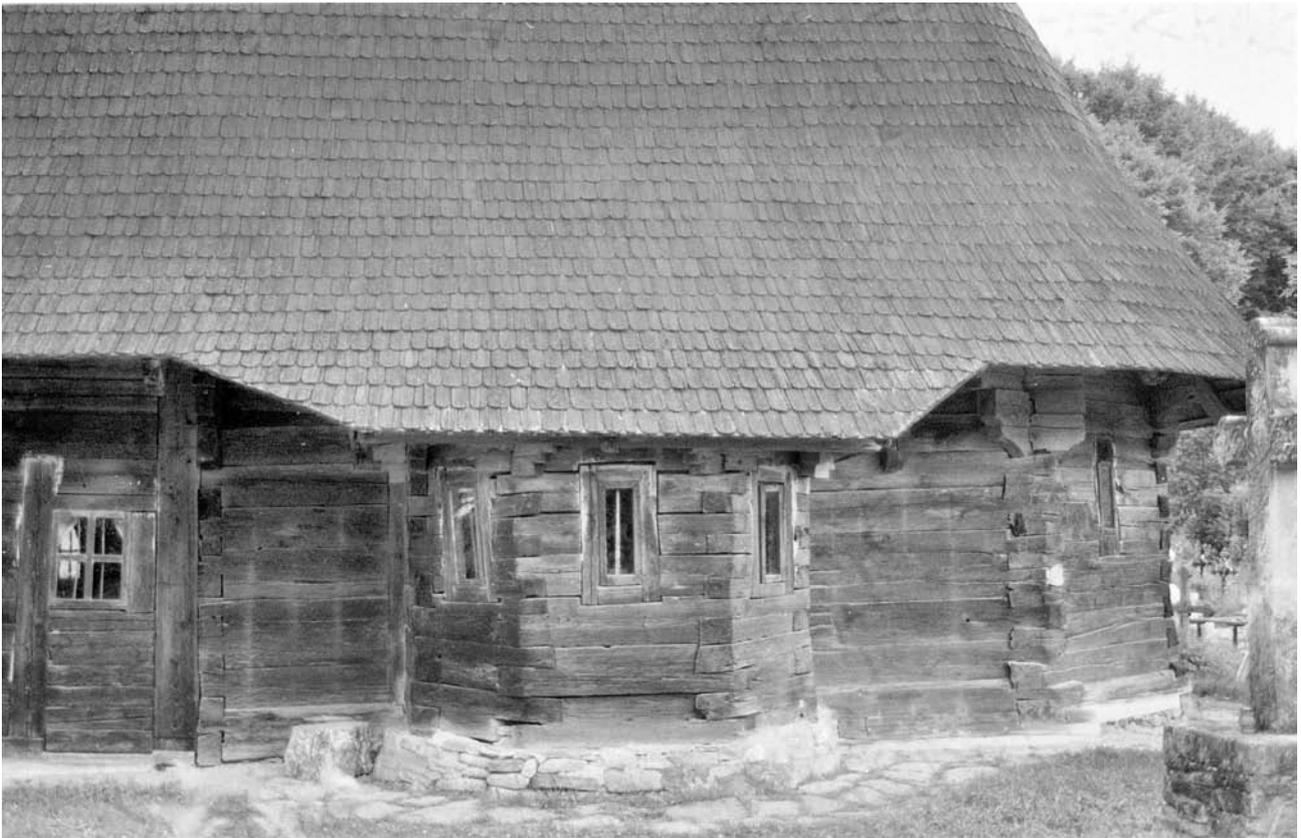
241 *Putna, Suceava County.* The medieval wooden church transferred from Volovăț to Putna Monastery is easy to distinguish from the later additions. The apse in the centre of the photo was added together with the narthex only in 1778. Photo: July 2002.

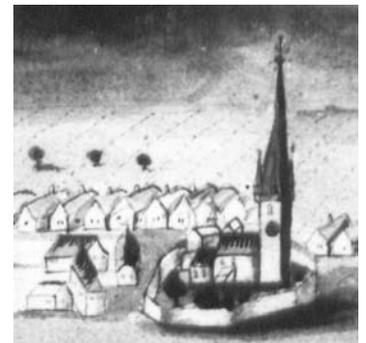
243 *Sighet*. The former medieval parish church was the most monumental and prestigious church of Maramureş, probably beginning with the 14th century. Scale drawing in Viennese fathoms or *klafters* (1 *klafter* = 1.896 m) by Trieb Mátyás in 1846 (left; KÖH, Tervtár K 3229). A sketch from 1744 captured above the tower a wooden gallery surmounted by an acute spire and four corner turrets (below; MOL, U et C, fasc. 220, no. 22, 511).

nobles gathering here every year for the county assembly and during regular markets. We do not need to search for a local transfer of features from this major stone construction to the modest wooden churches around because wooden basilicas were already known and build since earlier times in other parts of Europe.²³⁵ However, the prestige derived from the monumental stone basilica in the heart of the region might have stimulated the adoption of its wooden variant by the noble leaders of Eastern rite. The second factor might have been, thus, the circulation of a wooden variant of basilica in the sacred architecture from the Northern Carpathians. The most famous wooden churches somehow related with
